Runway event involving a Fokker F28, VH-JFB

Williamtown Airport, New South Wales, 26 August 2013

ATSB Transport Safety Report
Aviation Occurrence Investigation
AO-2013-133
Final – 10 December 2013

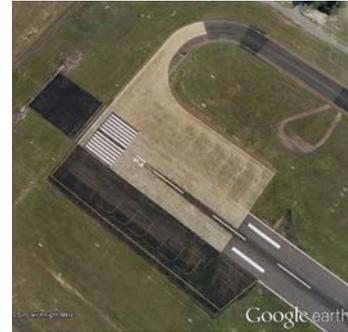
Runway 12 threshold

The aircraft was lined up on runway 12. At that time, the captain believed that the aircraft was lined up on the centreline as it was centrally located between two lines of runway edge lights and in the middle of an expanse of concrete.

At 2003, the captain commenced the take-off run. Immediately after, the captain noted that the ground area to the left of the runway centreline lights ahead was a different colour than that on the right. He then realised that he had lined up on the runway edge lights. The captain rejected the take-off and steered the aircraft to the right, toward the actual runway centreline.

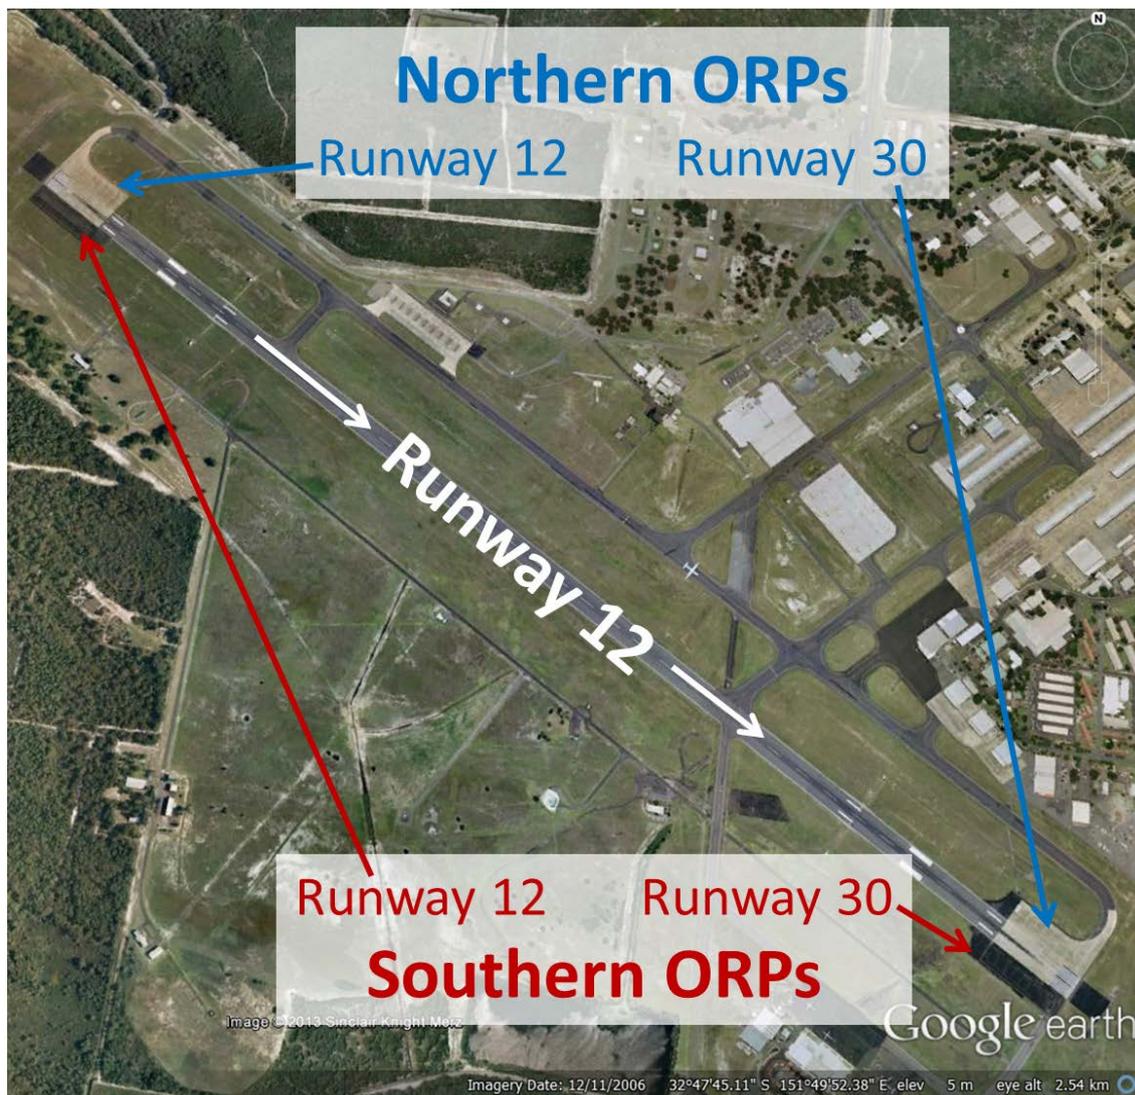
Figure 1: Williamstown Airport showing location and colour of ORPs and runway 12

Williamstown Airport was owned and operated by the Department of Defence, and had one runway aligned 12/30. The runway had an operational readiness platform (ORP) at each end of runway 12/30, on both sides (Figure 1). The ORP was a wide section of tarmac adjacent to the runway threshold, used by military aircraft. The ORPs on the northern side of the runway and both thresholds were concrete; an uneven grey colour. The ORPs on the southern side and the majority of the runway were tarmac, black in colour.

The runway had white runway edge lighting, but was not fitted with runway centreline lighting. For the portion of the runway adjacent to the ORPs, the runway edge lighting was recessed.

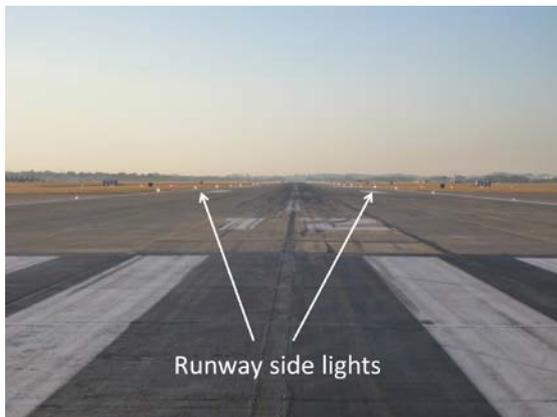
Figure 4: Runway centreline in daylight

Last light² had been at 1755 and the crew reported that the night was very dark. The captain, who was designated as the pilot flying, had not previously operated from Williamtown at night and was used to operating from runways with centreline lighting. The crew were aware of a Notice to Airmen (NOTAM)³ that had been issued for Williamtown, stating that the centreline markings on runway 12/30 were faded.

The Department of Defence advised the ATSB that, at the time of the incident, remediation works were planned to address the faded centreline markings. These works consisted of repainting the runway centreline markings and refreshing the taxiway lead-in lines with black contrast lines to highlight the markings. At the time of publication, the remediation works had been completed.
