# Runway incursion between a Fairchild SA227, VH-UZP and a Bell 47G, VH-UTF

Ballina Airport, New South Wales, 9 October 2013

**ATSB Transport Safety Report**  
Aviation Occurrence Investigation  
AO-2013-177  
Final – 20 January 2014

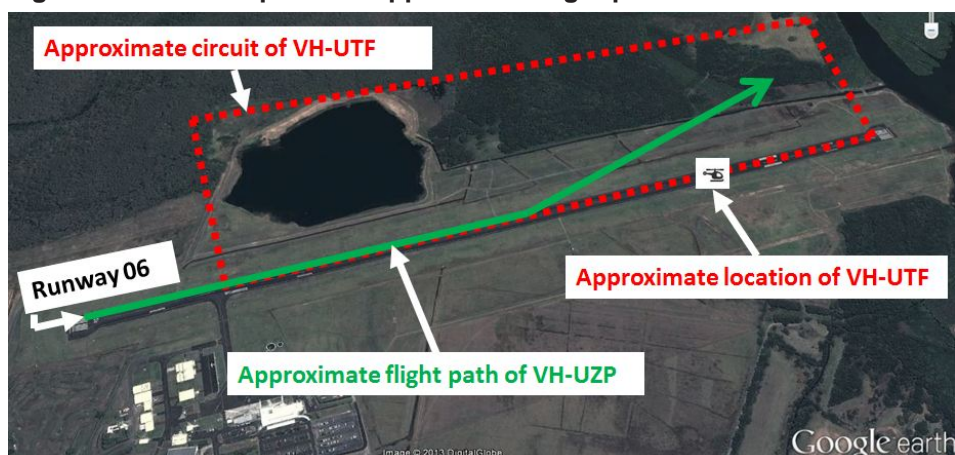
**Figure 1: Ballina Airport and approximate flight paths**

At about 1723, the pilot of UTF broadcast turning onto a left base for runway 06. Soon after, UTF landed about two-thirds of the way along the runway and came to a stop, facing east (Figure 1). The instructor briefed the pilot prior to commencing a further circuit.

At about 1728, the pilot of UZP looked along the runway and commenced the take-off run. Just prior to rotation, he sighted UTF stopped on the runway, towards the departure end. He elected to continue the take-off and increased the climb angle to provide separation with UTF.
