Wheels-up landing involving a Beech 95-B55, VH-TLP

St Helens aerodrome, Tasmania, 20 October 2013

ATSB Transport Safety Report
Aviation Occurrence Investigation
AO-2013-191
Final – 20 January 2014

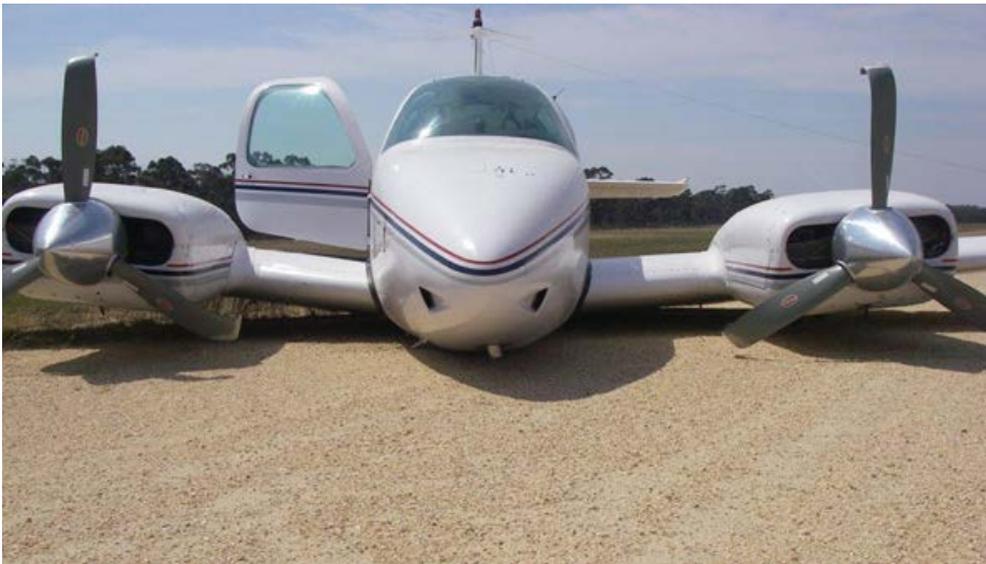
Figure 1: Aircraft damage

As the aircraft touched down, the pilot realised that the landing gear was retracted. The aircraft slid along the runway and came to rest about 600 m from the runway end. The aircraft sustained substantial damage (Figure 1).
