Australian Transport Safety Bureau

Runway undershoot involving a Cessna 404, VH-HAZ

Darwin Airport, Northern Territory, 29 October 2013

ATSB Transport Safety Report
Aviation Occurrence Investigation
AO-2013-197
Final – 20 January 2014

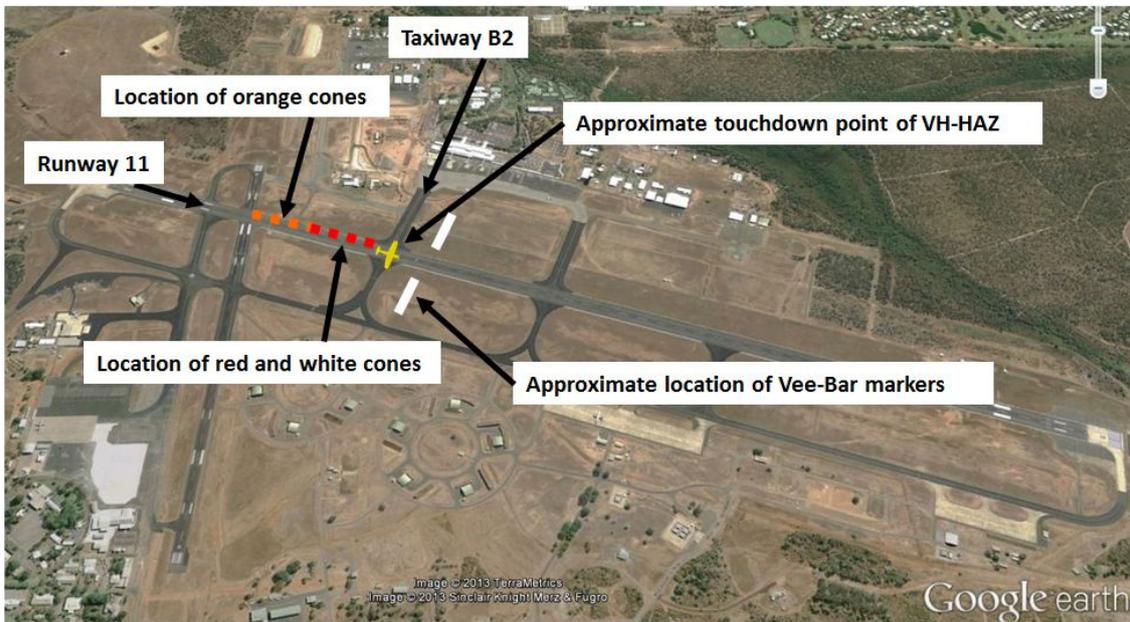
Figure 1: Location of runway works markings

At about 0745, the aircraft departed from the 'Bravo 2' intersection on runway 11 and the pilot reported that he did not observe any markings indicating the location of the displaced threshold.

While on approach, at about 200 ft above ground level (AGL), the pilot observed orange cones (works limit markers) and red and white cones (unserviceability markers) on the runway. He adjusted the aircraft's descent profile, aiming to be over the red and white cones at about 50 ft AGL. He then focused his attention on landing. The aircraft touched down near the 'Bravo 2' intersection (Figure 1).

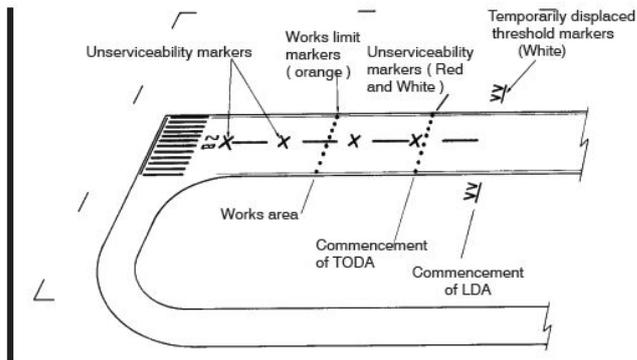
Figure 2: Displaced threshold markings

- a. a series of inverted 'V' markings (white) painted across the runway; or
- b. one or two white Vee-Bar markings located on both sides of the runway (Figure 2); or
- c. at military controlled aerodromes (such as Darwin), for short periods and dependent on military operational requirements, four white cones situated on both sides of the runway.

- the runway works had been underway for the previous three weeks, with the threshold regularly displaced during that period
- there was a hump in the runway, just before 'Bravo 2', and the Vee-Bars were located on the downhill side of the hump; he did not see them at any stage during the landing
