Collision with terrain involving a Robinson R44, VH-UGC

Mount Buller, Victoria, 6 November 2013

ATSB Transport Safety Report
Aviation Occurrence Investigation
AO-2013-203
Final – 20 January 2014

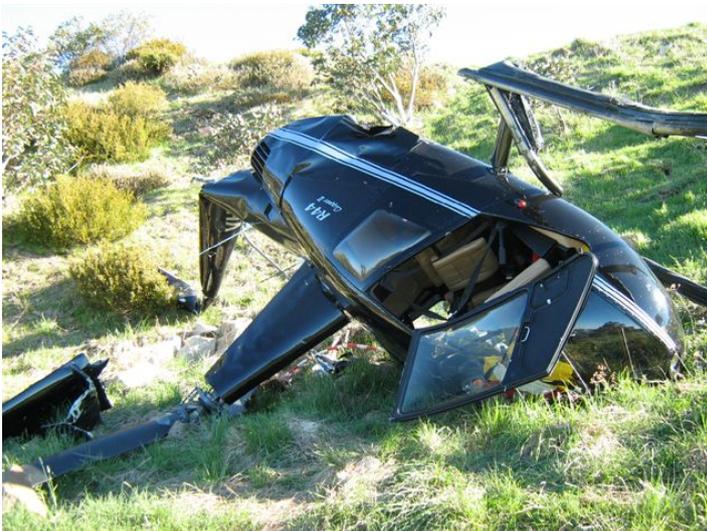
Figure 1: Damage to VH-UGC

As the front of the helicopter's skids were about to touch down, the pilot applied full forward cyclic,⁴ and reported experiencing mast bump.⁵ In response, he raised the collective. The low rotor revolutions per minute (RRPM) horn then sounded and the pilot reported that the helicopter felt as if it was going to fall backwards. The helicopter rolled onto its side and came to rest about 9 m down an embankment. The helicopter was substantially damaged⁶ (Figure 1) and the pilot and passengers were able to exit the helicopter uninjured.

Mount Buller helipad was at an elevation of 5,400 ft above mean sea level. The pilot reported that the helicopter was at a gross weight of about 1,048 kg when it landed. When the pilot attempted to increase power, the engine was already producing the maximum continuous power available for the altitude and prevailing conditions.
