Aircraft separation issue involving an Ayres S2R, VH-WBK and an unmanned aerial vehicle

37 km SSW of Horsham aerodrome, Victoria, 12 September 2013

ATSB Transport Safety Report
Aviation Occurrence Investigation
AO-2013-167
Final – 19 March 2014

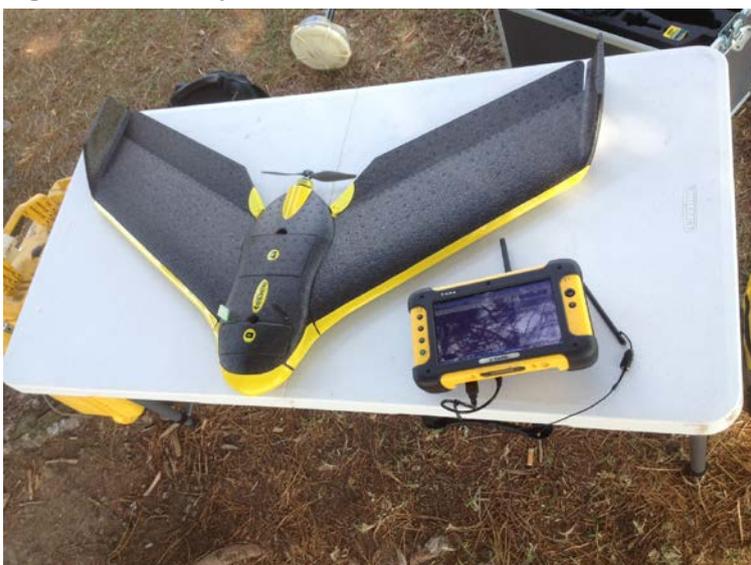
Figure 1: Sensefly eBee 178

At about the same time, the operator of an unmanned aerial vehicle (UAV), Sensefly eBee 178 (Figure 1), arrived at the 'Iluka Echo' (Echo) mine site to conduct an aerial photography survey of the site. After having completed his pre-flight preparations and a risk assessment of the operation, the operator heard an aircraft operating about 1-1.5 km away on a neighbouring property to the north-east of the UAV launch site (Figure 2).

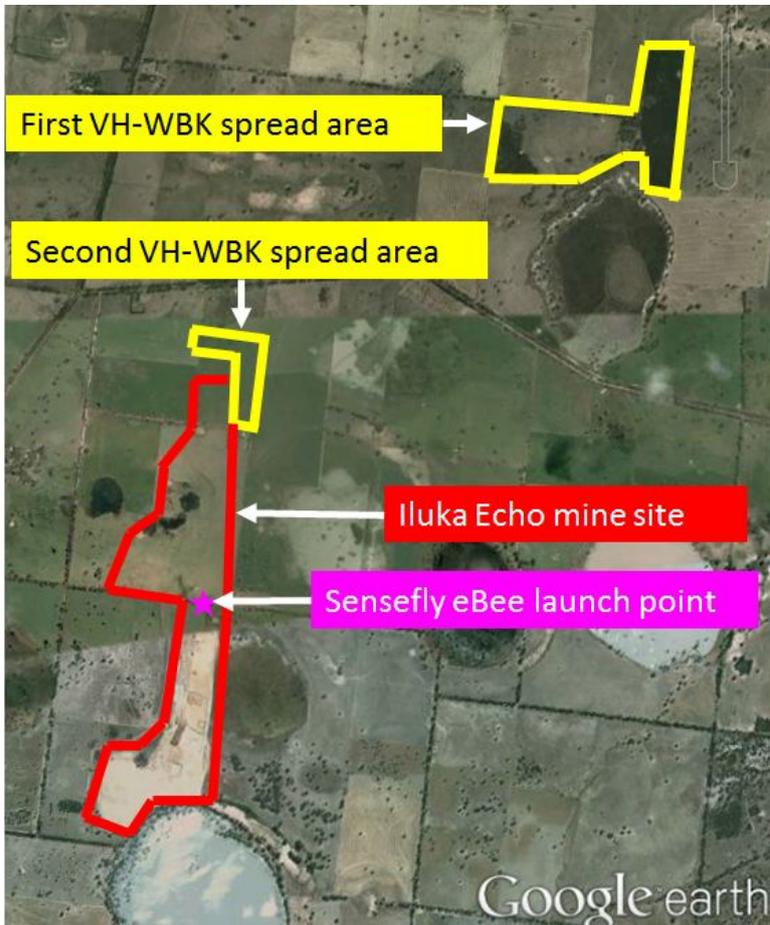
Figure 2: Operating areas for VH-WBK and the UAV

At about 1000, the UAV operator heard increasing noise from WBK and observed the aircraft cross the site boundary from the north, conduct a 180° turn about 150 m north of the UAV, then complete one full 360° turn before it departed again to the north. At the time, the UAV was on approach to land, at about 380 ft AGL. The operator immediately put the UAV into a holding pattern to maintain its current position. He estimated WBK was at about 100-150 ft AGL and came within about 100 m horizontally of the UAV. He attempted to contact the pilot of WBK on the radio but did not receive a response.

The pilot of WBK reported that, after completing spreading on the first paddock, he then returned to the airstrip about 3 NM to the north-east, where the aircraft was re-loaded with fertilizer. He subsequently spread the fertilizer on the second block, about 2 NM south-west of the first area, operating at about 50-100 ft AGL. He finished operating in the area by about 1200. He reported sighting a white vehicle on the road on the mine site, but did not see the UAV at any time. The next day the UAV operator contacted the pilot of WBK and advised him of the incident.
