Ground proximity event between Dornier DO228, VH-VJN and a vehicle

Brisbane Airport, Queensland, 8 October 2013

Aviation Short Investigation

AO-2013-179

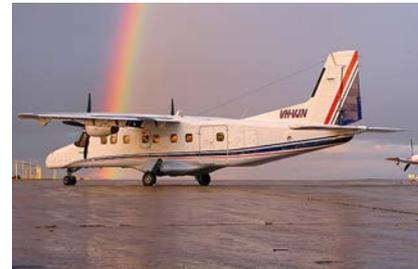
On the evening of 8 October 2013, at about 1842 Eastern Standard Time (EST),¹ a Dornier DO228 aircraft, registered VH-VJN (VJN) (inset photograph), was taxiing to the company hangar at Brisbane Airport, Queensland after the completion of a charter flight.

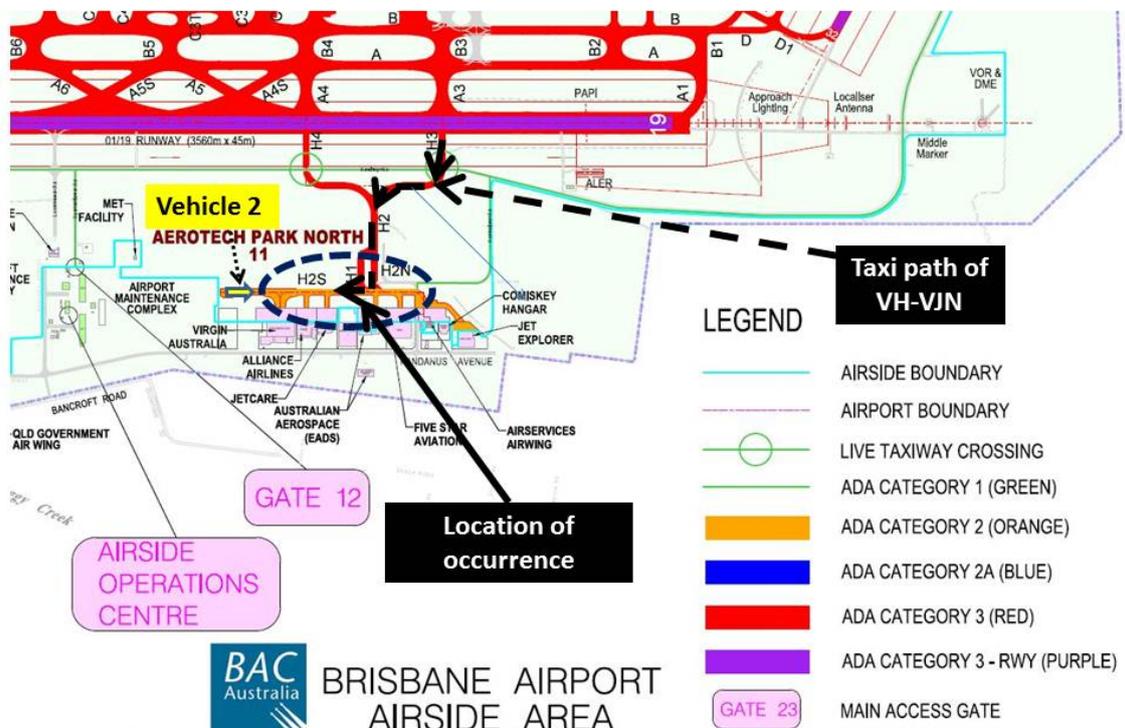
Figure 1: Brisbane Airport

The crew taxied VJN via taxiway 'Hotel 3' (H3), 'Hotel 2' (H2), and then via a right turn onto 'Hotel 2 South' (H2S) (Figure 1). As per company policy, the aircraft was taxied at a maximum speed of 9 kt during turns. During the 90° turn from H2 to H2S the pilot saw a vehicle approaching from the opposite direction along H2S. The vehicle had headlights on, but no flashing light. The captain reported he manoeuvred the aircraft to the right by 2-3 m and braked firmly. During this manoeuvre the captain observed the vehicle brake, and turn right onto the grass. The vehicle passed close to the aircraft's left wingtip.

- BAC constructs roads that would mitigate vehicles traversing the aprons of taxiways H2S and H2N.
- To consider if the Hotel taxiway system and the nearby Mike taxiway system be restricted to Category 3 (currently Category 2)⁵ and above authority to drive airside (ADA) holders, thus requiring an ATC clearance to operate in the area.
