Loss of ground control involving Air Tractor AT-502B, VH-FLH

Near Deniliquin, New South Wales, 21 October 2013

ATSB Transport Safety Report

AO-2013-188

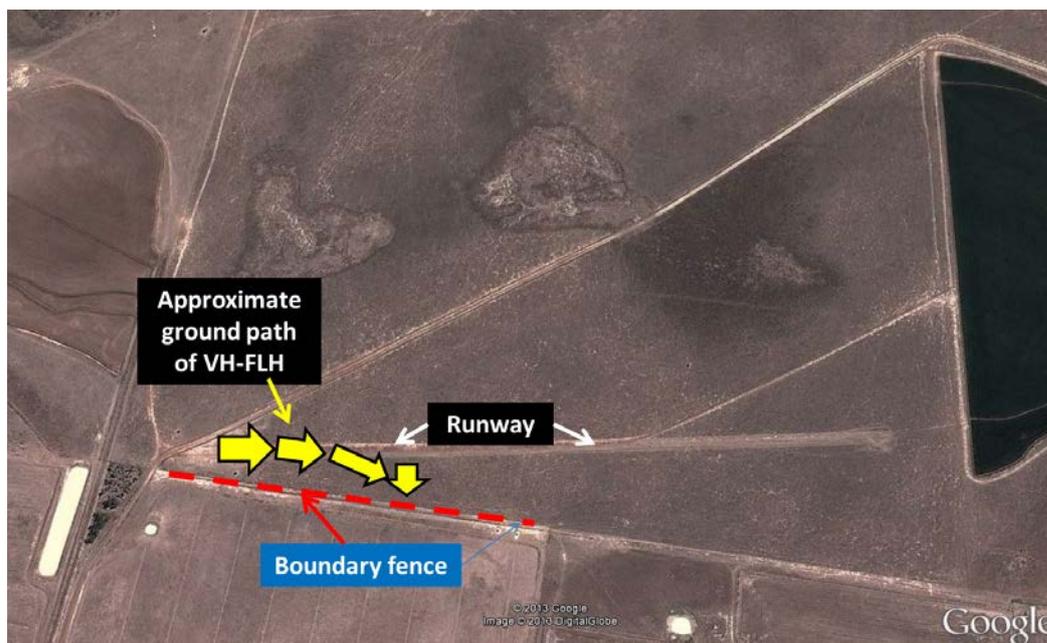
Figure 1: Accident site

The airstrip was east-west in orientation and about 964 m long. As it was located in a paddock, it had a relatively flat and firm surface with a boundary fence running along the southern side of the strip (Figure 1).

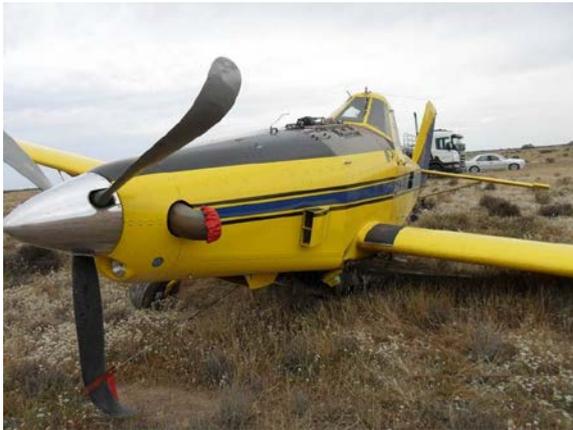
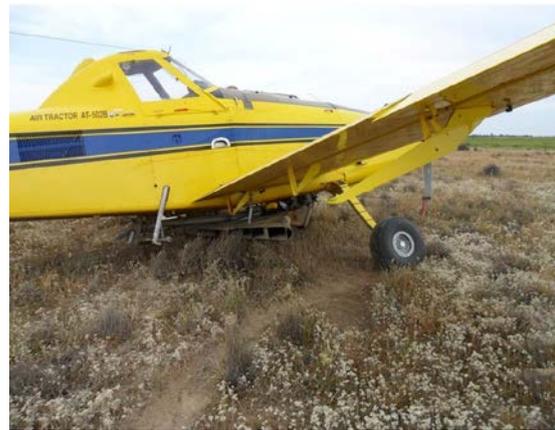
Figure 2: Damage to VH-FLH

During the landing, the main wheels touched down first, followed by the tail, which was locked into place. Shortly after, the aircraft suddenly veered right about 45°. The pilot considered a go-around, but was concerned that the aircraft would not clear the boundary fence (Figure 1). Consequently, he elected to continue the landing and selected reverse thrust, applied left brake, left rudder and left aileron in an attempt to re-align the aircraft with the runway. The aircraft did not slow down as the pilot expected. The wheels began to 'grab' and the left undercarriage leg became detached which caused the aircraft to rotate facing about 90° away from the runway. The left wingtip and propeller subsequently contacted the ground. The pilot shut down the aircraft and exited. The pilot was not injured, but the aircraft was substantially damaged (Figure 2).

A post-accident engineering inspection conducted by the operator did not identify any mechanical issues with the aircraft. The operator suggested that a sudden wind gust may have contributed to the accident, or that a brake may have locked during the landing.

Based on the information provided, the Australian Transport Safety Bureau (ATSB) was unable to determine what led to the loss of ground control.
