Unintentional release of the freefall lifeboat from the bulk carrier *Aquarosa*

Indian Ocean, 1 March 2014

ATSB Transport Safety Report
Marine Occurrence Investigation
307-MO-2014-002
Preliminary – 31 March 2014

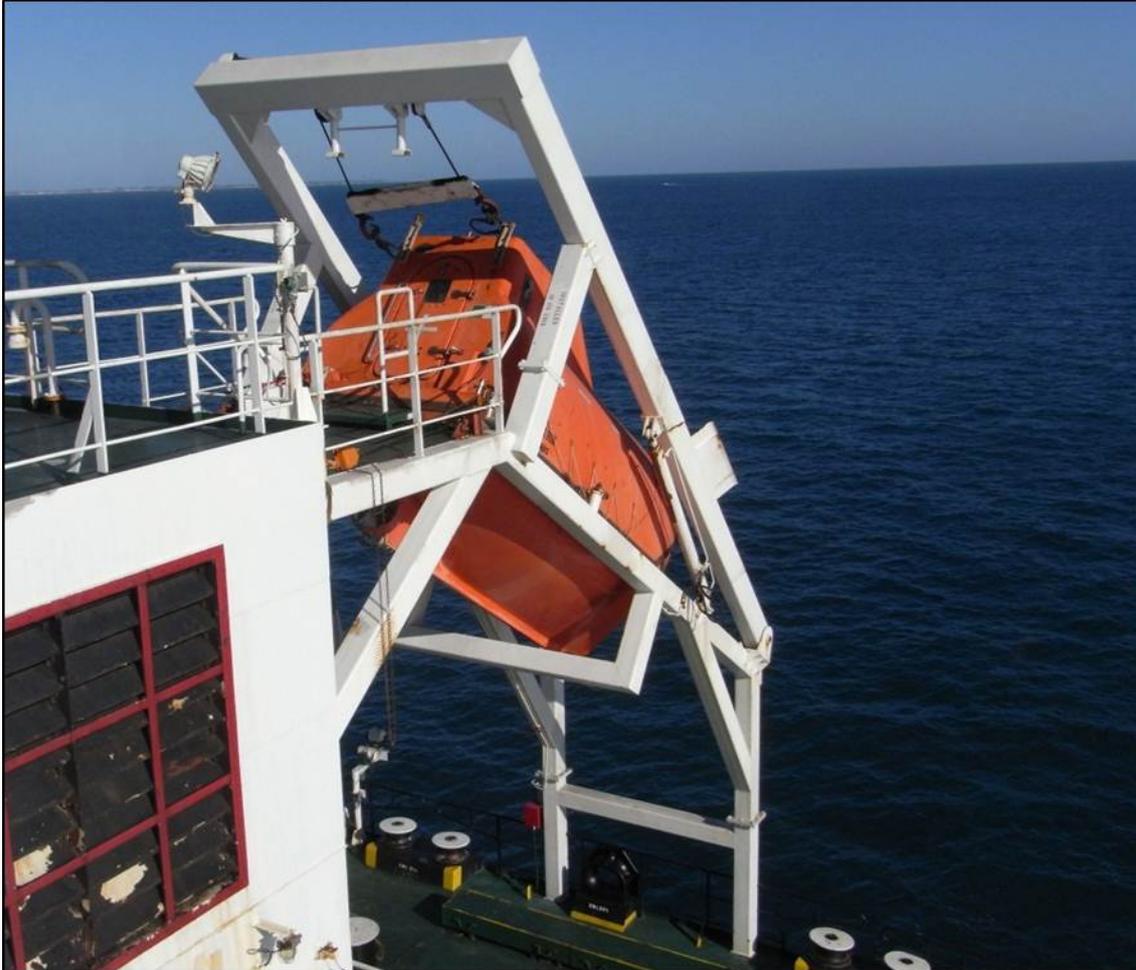
Figure 2: *Aquarosa's* freefall lifeboat

At about 1100,² the third engineer and the supernumerary chief engineer went to the freefall lifeboat (Figure 2). They verified that the simulation wires securing the boat to the ship were fitted and then removed the hook release lock pin which was attached by a lanyard to the entry door and entered the lifeboat. Once inside, they carried out a general inspection of the lifeboat's machinery and equipment. When the checks were completed, they left the boat.

move down the launching rails. Knowing that the boat had been released and that he was unable to make the exit, he took a seat and attempted to fit the seatbelt. As the lifeboat moved down the launching rails, the simulation wires parted and the boat launched from the stern of the ship.³

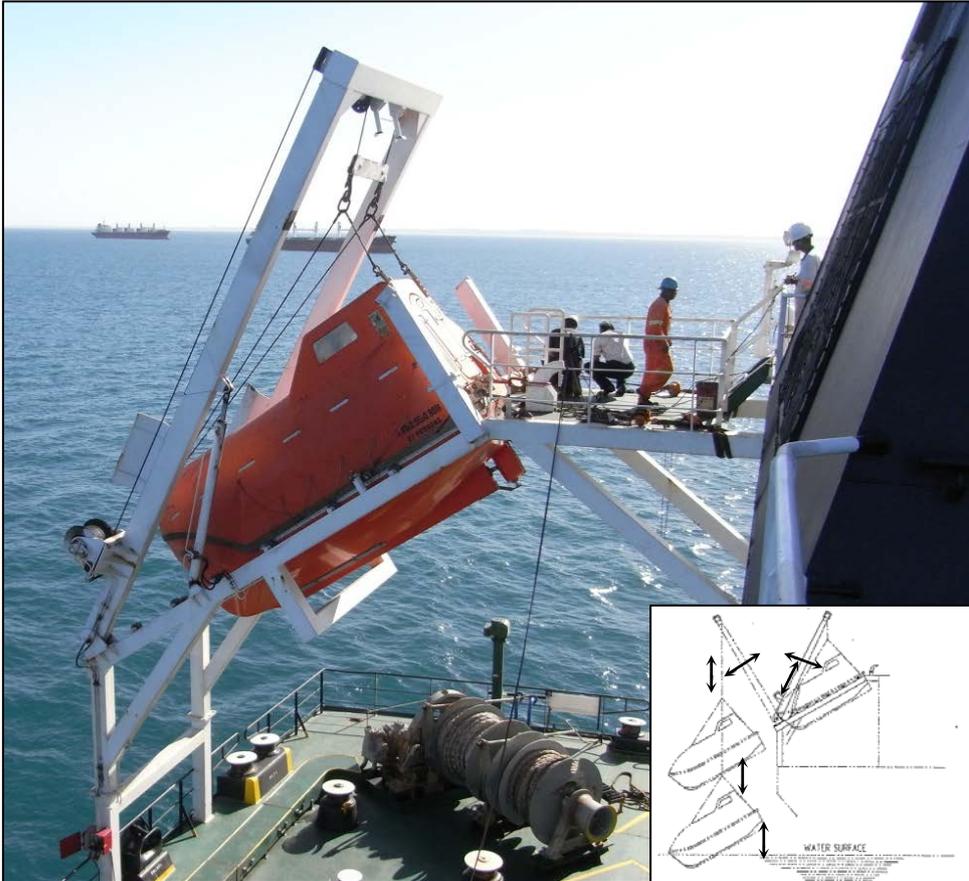
Figure 3: *Aquarosa's* freefall lifeboat arrangement with appliance operating action (inset)

The lifeboat was housed in a Jiangsu Jiaoyan Marine Equipment Company JYF55 type launching appliance (Figure 3) which included provision for controlled lifting and lowering of the lifeboat into and out of the launching frame. This system included a davit and winch with a maximum hoist load of 42 kN⁶ and maximum working load of 55 kN.

Under normal (ready for use) conditions, the freefall lifeboat was positioned in the launching arrangement with its side rails sitting on rollers fitted in the ramp section of the launching frame. The lifeboat was attached to the ship solely through ring links connected to a fixed hook on the ship and the release hook on the lifeboat (Figure 4).

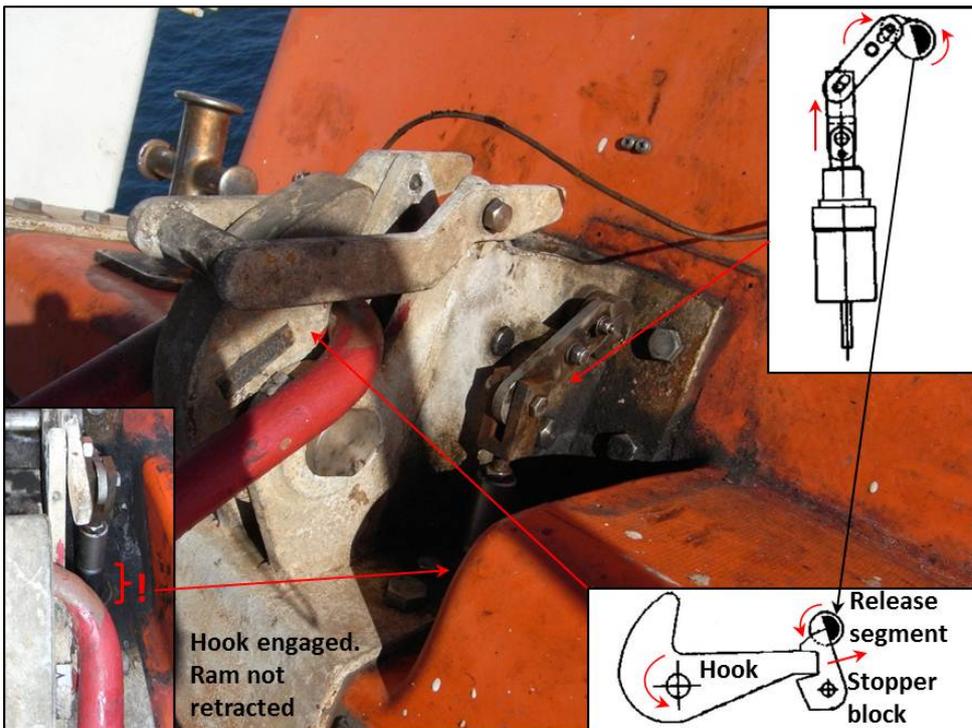
Figure 4: Freefall lifeboat release hook

A security pin was fitted into the lifeboat release hook to prevent the hook from opening and the unintentional release of the boat. This pin was attached by a lanyard to the entrance door of the lifeboat and arranged such that the pin had to be removed from the hook before the door could be opened and the lifeboat entered.

The lifeboat was fitted with a Jiangsu Jiaoyan Marine Equipment Company model JX-4 hook device and release mechanism (Figures 4 and 5). The system comprised the release hook mechanism located at the stern of the lifeboat, the hook hydraulic actuating cylinder and two hand operated pumps, one adjacent to the coxswain's position and an emergency pump to be used in case the coxswain's pump failed. A short section of ring links connected the release hook to a fixed strong point on the ship's structure.

Inspection of the lifeboat, its release mechanism and analysis of the available evidence showed that the actuating cylinder ram did not always retract fully into the cylinder without some external force being applied. Furthermore, it was found that the hook stopper block (Figures 4 and 5) could be repositioned sufficiently to engage the hook and prevent it opening without the actuating cylinder ram being fully retracted. In such cases, with the hook reset, the hydraulic pump recirculation valve could be closed trapping the system in this position.

In such circumstances, the release hook could be activated with a reduced number of operations of the hydraulic pump because the actuating cylinder ram had less distance to travel before it released the stopper block and the hook.

It is likely that this is what happened when the lifeboat release system was reset following the tests in Singapore. Then, on 1 March, the second engineer only had to operate the pump handle three or four times for the actuating cylinder ram to move far enough to release the stopper block and the hook.

On board *Aquarosa*, a safety pin that can be placed into the release hook when entering the boat for inspections and maintenance has been made up. Tool box meetings are now required before entry into the lifeboat to carry out maintenance and procedures which list the checks that are to be made prior to any lifeboat maintenance being carried out have been implemented. Further, the master's permission is now required before the lifeboat release system hand pumps are operated. Warning signs have been placed at the pump locations stating this requirement.

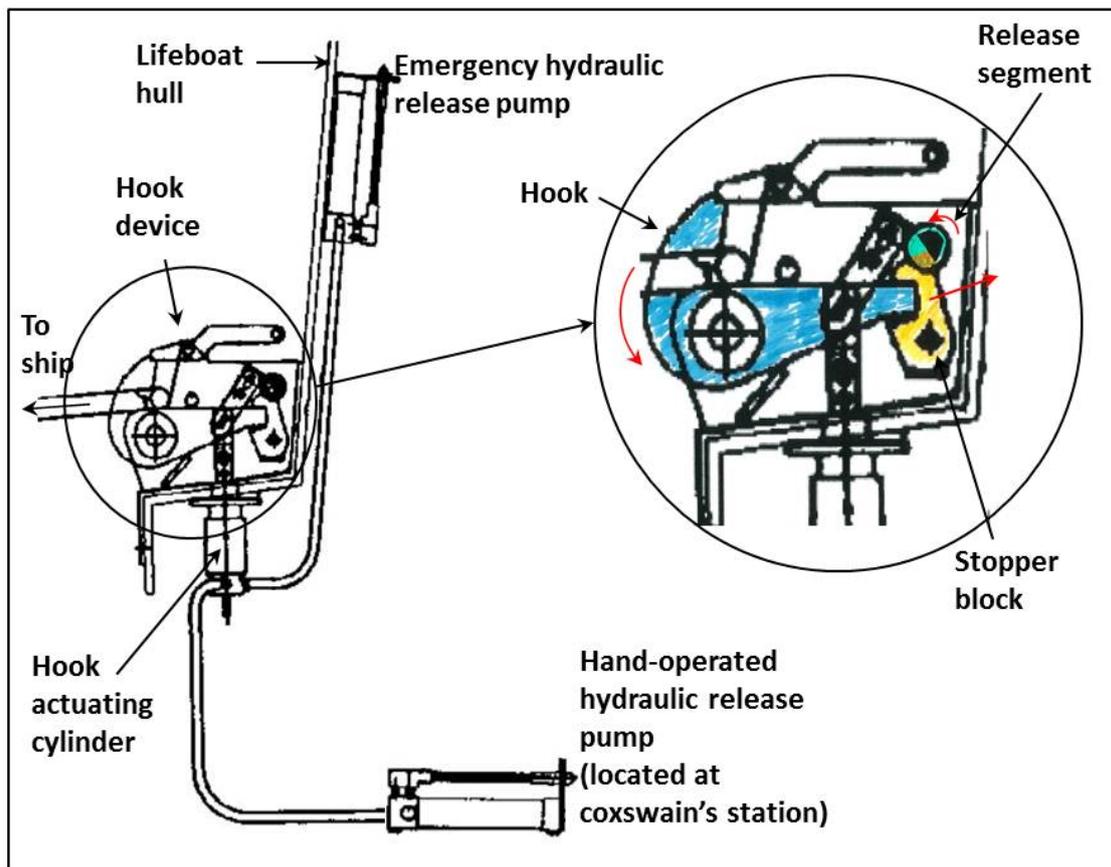
Figure 5: Freefall lifeboat hook release system

To release the boat normally, the hydraulic pump handle needed to be operated 10-12 times (according to the operating manual) to extend the actuating cylinder ram which, through a series of linkages, released the hook stopper block. The hook was then free to rotate and release the ring link connecting the lifeboat to the ship. The pump also had a small valve on its body which when opened allowed the oil to circulate back to the oil reservoir without pressurising the discharge line. This valve had to be closed for the system to actuate the hook. The valve was, therefore, normally left in the closed position ready for use.

After the hook was released, it had to be reset before the lifeboat could again be secured in place. To do this, the hydraulic oil which had been pumped into the hook actuating cylinder had to be returned to the oil reservoir. This was achieved by opening the recirculating valve, positioning the ring link in the hook and then engaging the tail of the hook in the stopper block. The release segment could then be rotated into position by retracting the actuating cylinder ram, to lock the stopper block in place.

Once the hook was reset, the hydraulic pump recirculating valve had to be closed. This locked the oil in the system and the links in position. An indicator on the side of the hook provided a visual confirmation that the hook was in the correct position.

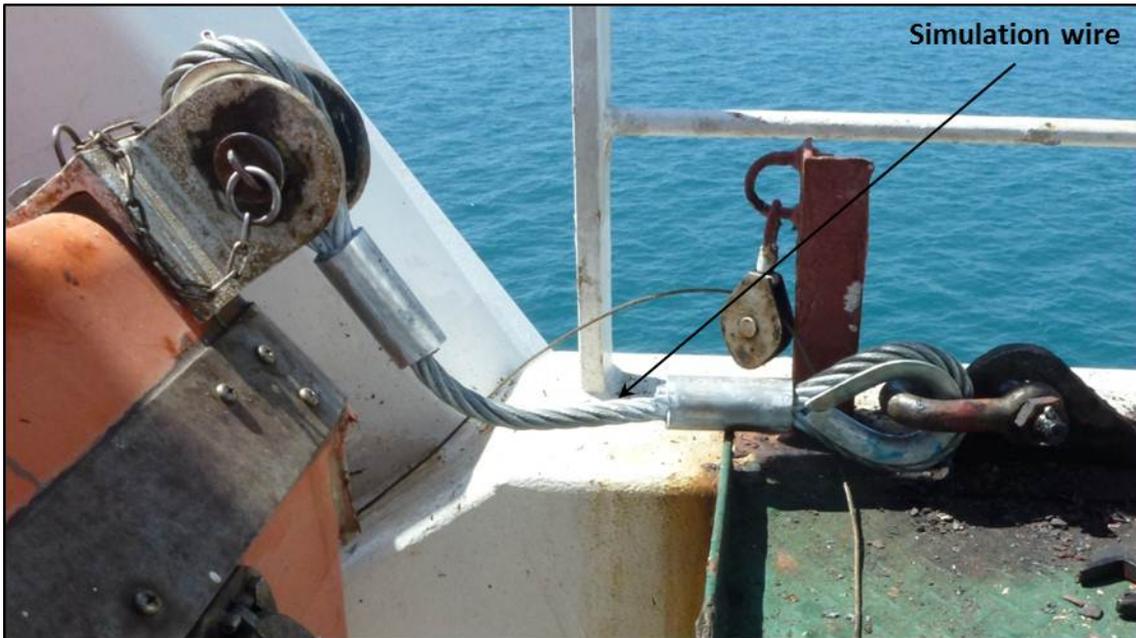
Figure 6: Aft lashing arrangement showing one of the two simulation wires

Initial analysis also indicates that the two simulation wires, which were designed to hold the lifeboat when the hook was released during a simulated release, failed at a load significantly below their rated safe working load.

In addition to the release hook attachment, the lifeboat was also fitted with an aft lashing unit which consisted of securing points on the port and starboard quarters. A wire rope could then be attached to these points and secured to eye plates that were welded into the lifeboat launching frame deck (Figure 6).

With the lifeboat secured to the ship via the release hook and links, the aft lashing unit wire ropes (known as simulation wires) were slack. This arrangement was designed so that the operation of

the release hook could be tested without launching the lifeboat over the stern of the ship. With the simulation wires attached, the hook could be tripped and the lifeboat would move about 150 mm down the launch ramp, at which point, the slack in the simulation wires would be taken up and the boat would be stopped. The lifeboat could then be repositioned and the hook reset.
