Fuel exhaustion event involving a Hughes 269C, VH-HAK

55 km NE Launceston Aerodrome, Tasmania, 23 February 2014

ATSB Transport Safety Report
Aviation Occurrence Investigation
AO-2014-030
Final – 8 April 2014

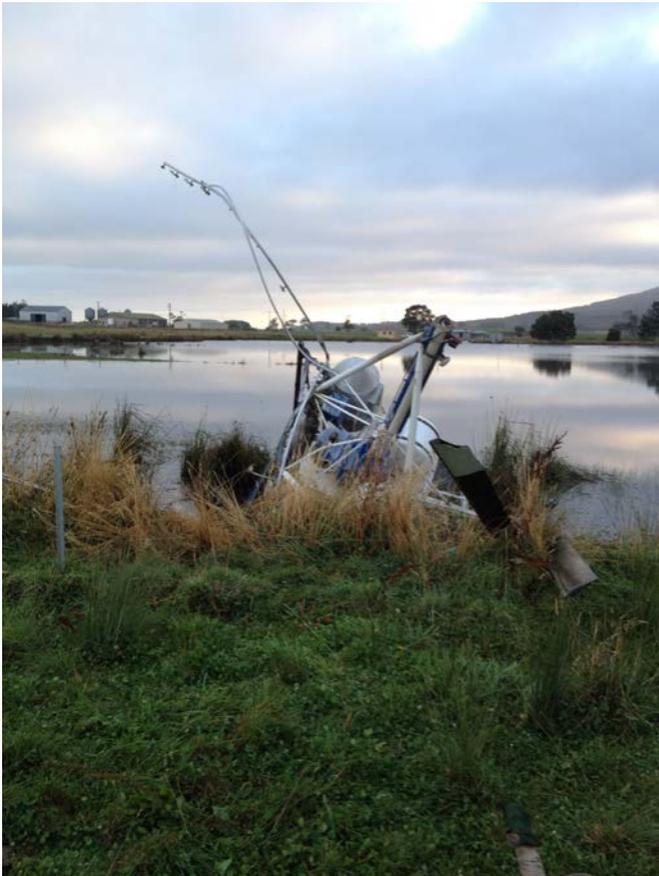
The helicopter took off and climbed to about 20 ft above ground level. When about three quarters of the way across the dam, the engine stopped due to fuel exhaustion. The pilot conducted a forced landing onto the edge of the dam, with part of the helicopter sinking into the water and mud. The main rotor blades collided with the embankment resulting in substantial damage (Figure 1).

Figure 1: Damage to VH-HAK
