Operational event involving a Boeing 737, VH-VUZ

Near Launceston, Tasmania, 4 January 2013

ATSB Transport Safety Report
Aviation Occurrence Investigation
AO-2013-041
Final – 26 May 2014

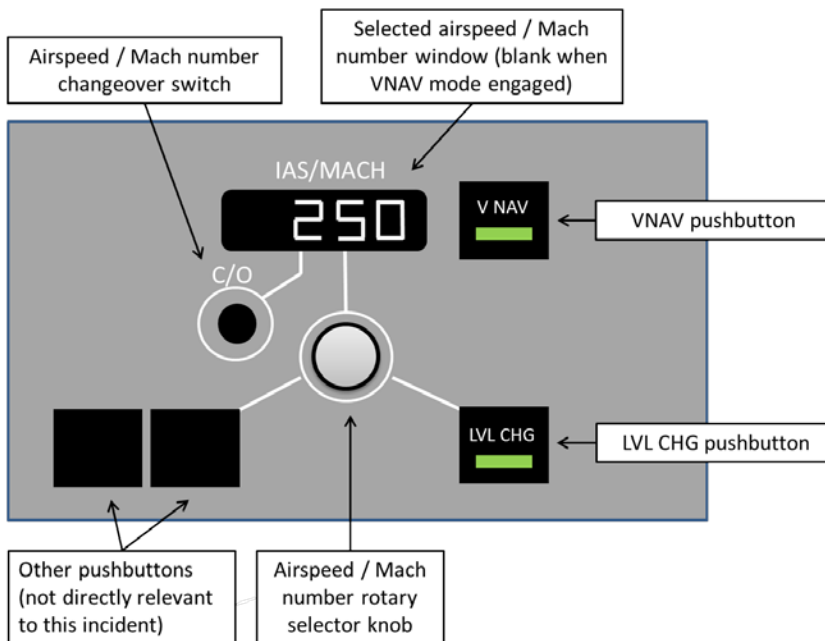
Figure 1: Representation of relevant part of MCP

VNAV mode is selected by pressing the VNAV pushbutton on the MCP (Figure 1). When selected, a green bar on the VNAV pushbutton illuminates. During a climb in VNAV mode, the flight mode annunciator (FMA)¹¹ indication at the top of each pilot's primary flight display indicates N1¹² as the auto-throttle mode and VNAV SPD (speed) as the vertical auto-flight mode (Figure 2).¹³ During a climb in VNAV mode, the indicated airspeed/Mach number (IAS/MACH) window on the MCP is blank, while the FMC target speed is displayed on the primary flight display airspeed indicator.

LVL CHG mode is selected by pressing the LVL CHG pushbutton on the MCP (Figure 1). As with the VNAV pushbutton, a green bar illuminates on the pushbutton when LVL CHG is selected. The airspeed control knob on the MCP is then used to select the required climb airspeed or Mach number, which is displayed in the corresponding IAS/MACH window. The changeover (C/O) switch on the MCP is pushed to cycle the IAS/MACH display between indicated airspeed and Mach number. During this occurrence, the switch from indicated airspeed (250 kts) to Mach number (Mach 0.62) occurred automatically at about FL 260 as the aircraft climbed.

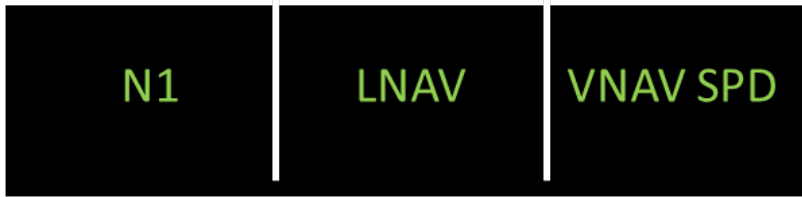
Figure 2: Representation of the FMA during climb in VNAV and LVL CHG modes

Example of FMA annunciations during a climb in VNAV mode. In this case, VNAV SPD indicates that the auto-flight system is following the FMC-computed speed profile. N1 indicates that the auto-throttle system is commanding a set engine speed limit and LNAV (lateral navigation) indicates that the auto-flight system is following a programmed lateral track.

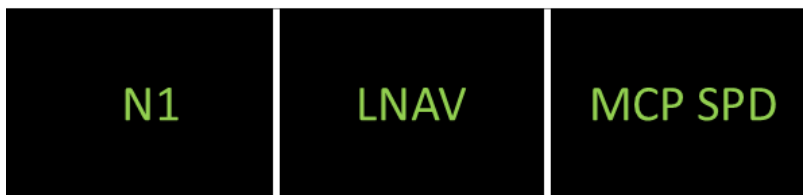
When LVL CHG mode is selected, the FMA indicates N1 as the auto-throttle mode and MCP SPD (speed) as the vertical auto-flight mode (Figure 2).

Example of FMA annunciations during a climb in LVL CHG mode. In this case, MCP SPD indicates that the auto-flight system is in LVL CHG mode maintaining the speed set on the MCP. As above, N1 indicates that the auto-throttle system is commanding a set engine speed limit and LNAV indicates that the auto-flight system is following a programmed lateral track .

Since this occurrence, the operator has introduced a policy requiring that FMA changes be announced by the PF (with some exceptions), and that the pilot monitoring should announce any FMA changes missed by the PF. While this action may not directly address the possibility of continued operation in an unintended mode, it is likely to have a positive impact on overall flight mode awareness, and lead to improved crew communication with respect to the status of the auto-flight system. The operator also included auto-flight system mode awareness as a briefing item during a subsequent recurrent training program during 2013, to further highlight the importance of mode awareness to all flight crew.
