Pre-flight planning event involving a Boeing 737, VH-VUC

Darwin Airport, Northern Territory, 14 October 2013

ATSB Transport Safety Report
Aviation Occurrence Investigation
AO-2013-195
Final – 17 June 2014

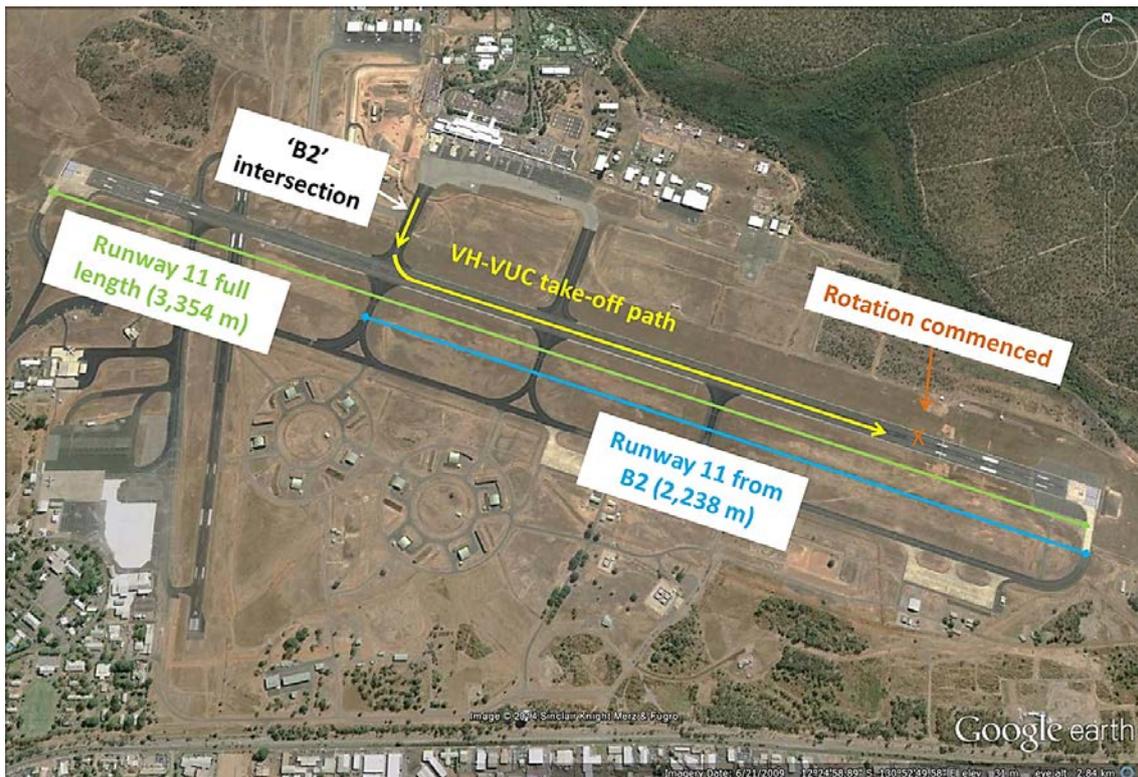
Figure 1: VH-VUC take-off

² The operator specified take-off run available (TORA) for the full length of runway 11 was 3,354 m, while the TORA for the intersection departure from B2 was 2,238 m.

Shortly after, at dusk, the aircraft was taxied to the B2 intersection holding point where the crew were advised by air traffic control of two inbound aircraft, which would delay a full runway length departure. Consequently, the crew elected to depart from the B2 intersection. The FO re-programmed the FMC with the take-off performance data previously transcribed on the TODC for that departure and subsequently cross-checked by the captain.
