Runway excursion involving a Cessna 172, VH-MKQ

13 km SW of Launceston, Tasmania, 30 April 2014

ATSB Transport Safety Report
Aviation Occurrence Investigation
AO-2014-080
Final – 14 July 2014

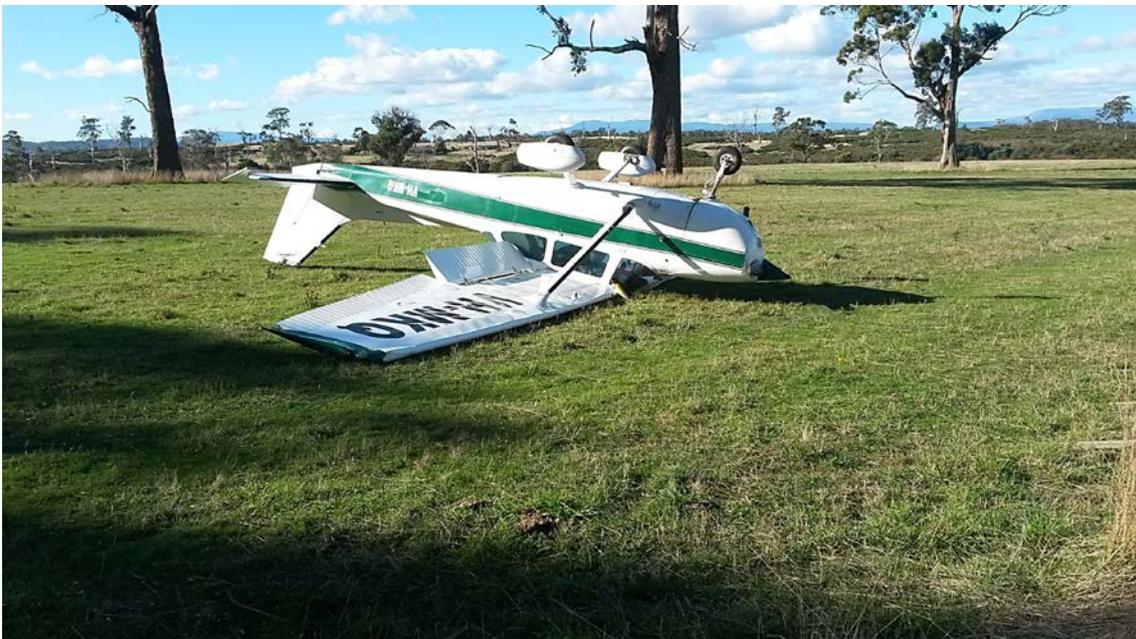
Figure 1: Damage to VH-MKQ

The pilot selected the fuel mixture to idle cut-off and the engine stopped. The aircraft collided with the fence and the nose landing gear entered a ditch. The aircraft nosed over and came to rest inverted. The aircraft was substantially damaged (Figure 1) and the pilot was uninjured.
