Derailment of freight train 3MP9

East of Malbooma, South Australia, 10 April 2014

ATSB Transport Safety Report

RO-2014-006

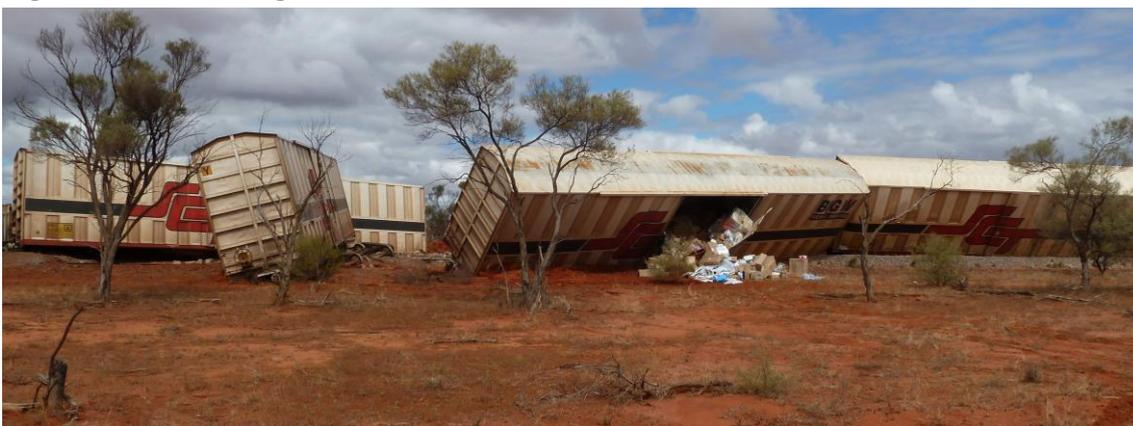
The second driver, accompanied by another driver who had been resting in the crew van, then walked further back along the train and found another separation between wagons and a wagon that had derailed a wheel. In the distance, they could also see a further series of wagons lying on their sides to the north of the track (Figure 2).

Figure 2: Derailed wagons north side of track.

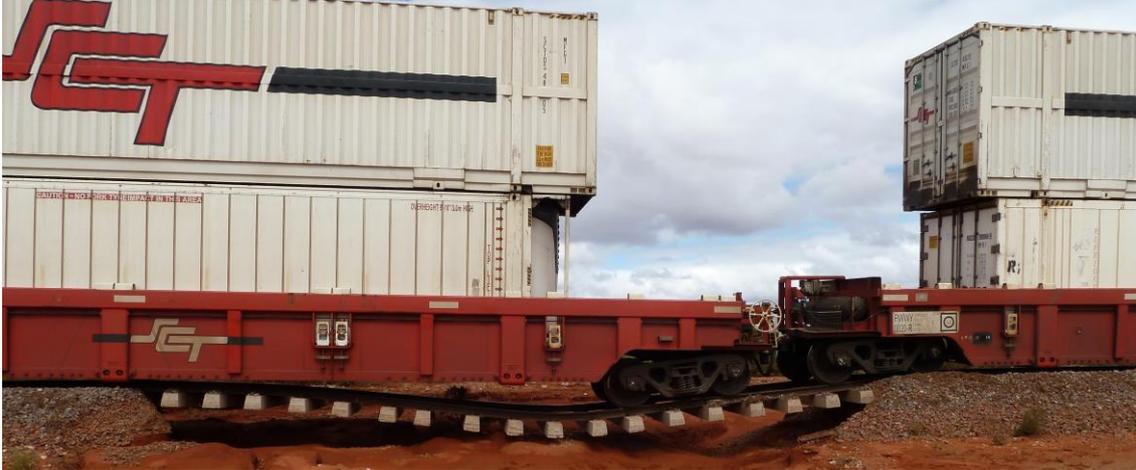
At about 0124, the track supervisor arrived at the derailment site and reported to the NCO that approximately 40 sleepers were undercut, the ballast had been washed away by the floodwaters and sections of the train remained suspended on skeletal track (Figure 3).

Figure 3: Well wagons suspended on skeletal track near point of derailment.

About 8 m before the double box concrete culvert at the 535.150 km mark, it was evident that an eddy current⁷ had formed before the water was redirected through the culvert. The circular motion of the eddy current progressively eroded the track formation and ballast, weakening the track structure and causing it to slump. The water level continued to rise with excess water flowing over the track and into the stream exiting the culvert on the north side. The track formation continued to erode after the train had derailed, leaving a double stacked container well wagon suspended on a 13 m section of skeleton track structure (Figure 3).

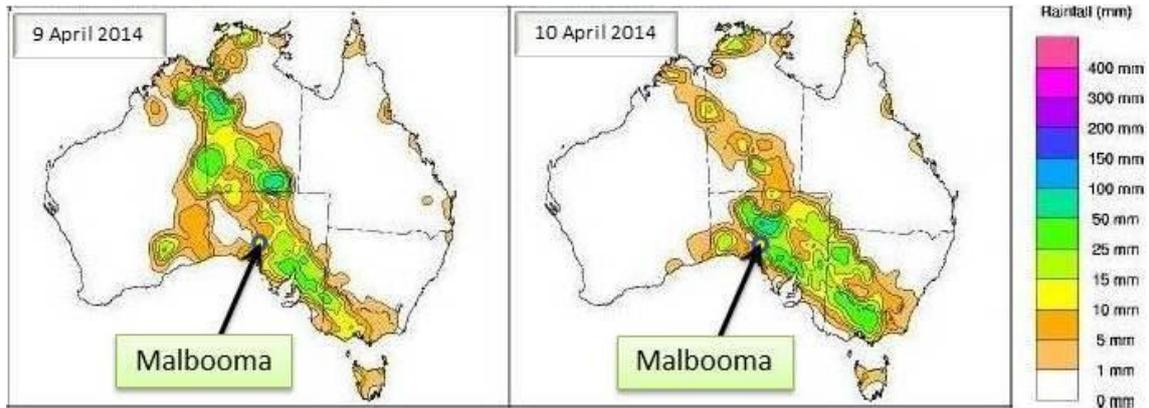
The rainfall persisted, breaking April daily rainfall records over many inland areas of South Australia (Figure 4). The BoM data showed that rainfall in South Australia was 257% above average in April 2014.

Figure 4: Daily rainfall intensity maps - April 2014

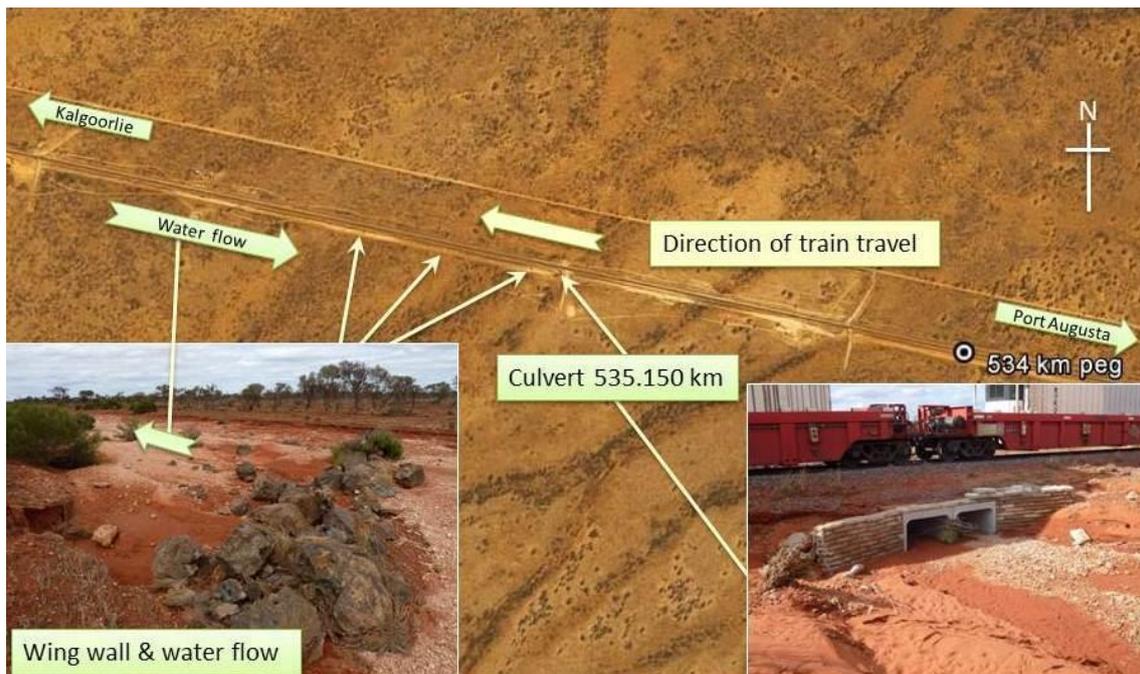
The under track drainage system installed between Tarcoola and Malbooma consisted of culverts of varying types including concrete box, rail deck, corrugated steel pipe and reinforced concrete pipe. The type of culvert installed near the point of derailment was a double span 1500 mm concrete box culvert (Figure 5).

Figure 5: Derailment location showing barrier wall, diversion channel and culvert near 535.150 km.

To protect the track formation from water scouring, the ARTC had constructed a barrier wall embankment parallel to the track and about 6 m from its southern side. The embankment was formed using compacted earth and was about 1.5 km long, 4 m wide and 1 m high (Figure 8) with wing walls (Figure 7) constructed at intervals of about 250 m to direct water away from the track structure. Near the east end of the barrier wall, a mounded end wall was constructed to re-direct water at an angle of about 90 degrees toward the railway and the double box culvert located at the 535.150 km mark.

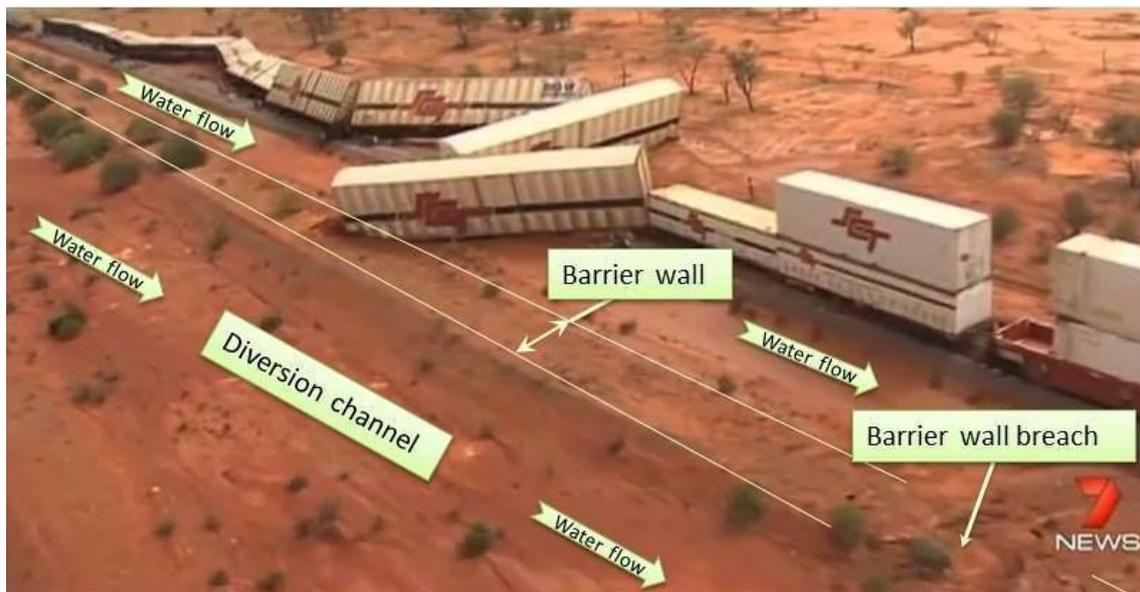
Between 9 and 10 April, the significant water run-off from the catchment flowed towards the barrier wall on the south side of the track. As the water accumulated and flowed along the barrier wall in an easterly direction, the volume of water increased to the point where the wing walls were unable to interrupt and divert the flow. As a consequence, the water over-topped and eroded the barrier wall allowing excess water from the diversion channel to flow between the barrier wall and the track formation (Figure 6). The barrier wall was breached in two places between the 536 km post and the culvert, allowing the water to flow against the railway track formation.

Figure 6: Water diversion channel and barrier wall near the point of derailment
