Engine failure involving a Cessna C206, VH-YOT

4 km ENE Newman Airport, Western Australia on 17 February 2014

ATSB Transport Safety Report
Aviation Occurrence Investigation
AO-2014-025
Final – 6 August 2014

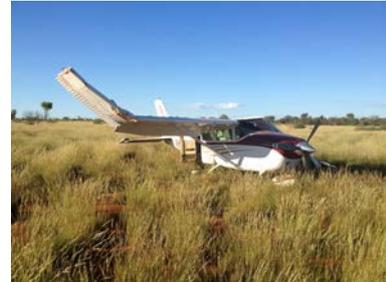
VH-YOT

On landing, the left wing impacted a tree and the aircraft spun around 180 degrees. The left wing was bent obstructing the only cockpit exit door. The fuel system had been disrupted and fuel was quickly entering the cockpit area. The pilot shut down all remaining systems and climbed into the rear section of the aircraft. The forward section of the cargo door was obstructed by the flaps in the full down position. The pilot exited the aircraft through the rear section of the cargo door and was not injured. The aircraft was substantially damaged (Figure 1).

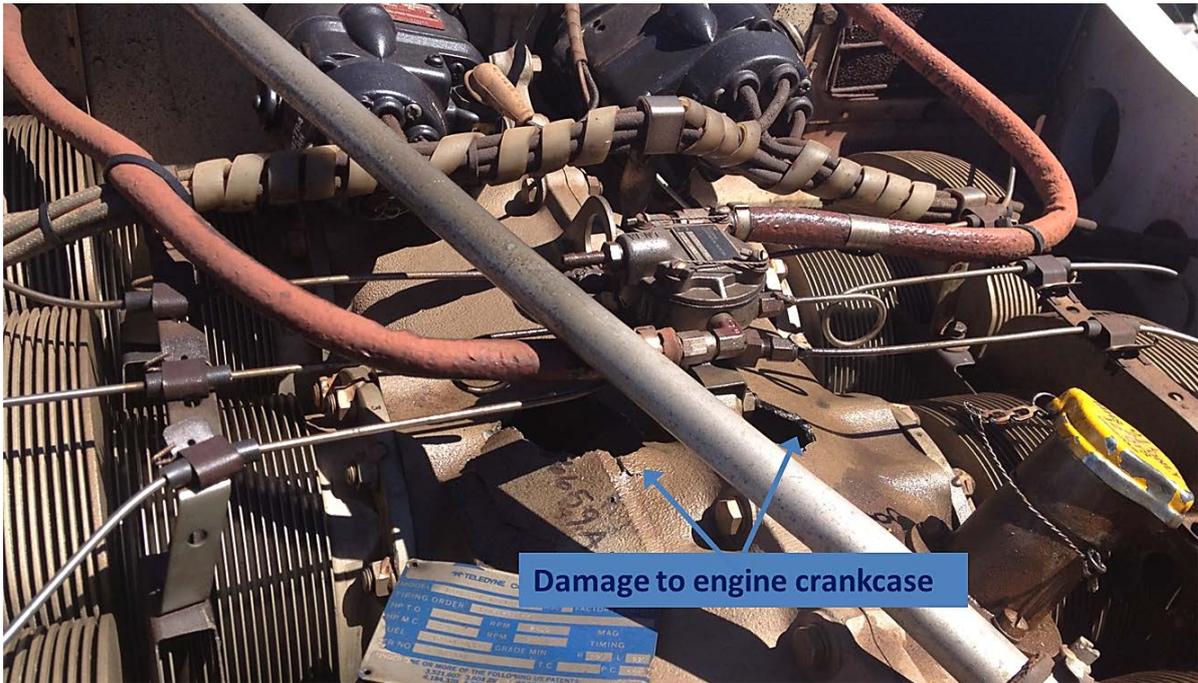
Figure 2: Damaged engine

A subsequent examination of the engine found that there were two holes in the engine crankcase halves (Figure 2). An internal inspection revealed that the number four cylinder connecting rod had failed. The engine had been overhauled by the manufacturer and the engine had failed at about 1016 hours since overhaul. It was also found that there was no major maintenance conducted on the engine or any history of operational issues.
