Near collision involving a Beech BE76, VH-SRO and a Cessna 172, VH-EEM

27 km S Archerfield Airport, Queensland, 30 May 2014

ATSB Transport Safety Report
Aviation Occurrence Investigation
AO-2014-100
Final – 6 August 2014

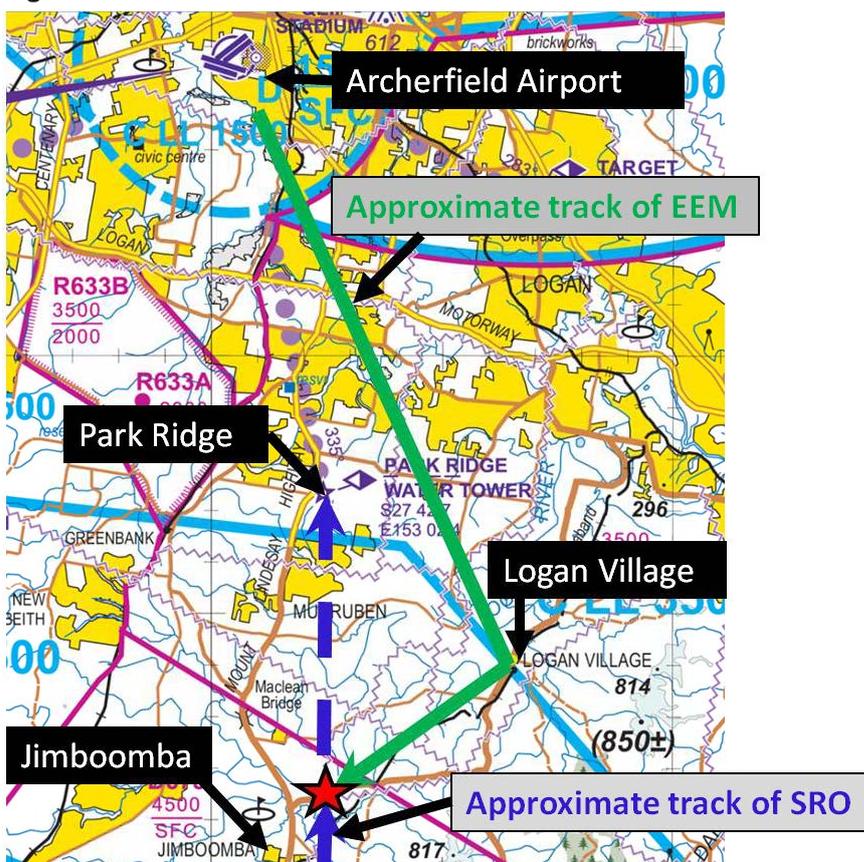
Figure 1: Aircraft tracks overlaid on Brisbane visual terminal chart

On 30 May 2014 at about 0900 Eastern Standard Time (EST), a Beech BE76 aircraft, registered VH-SRO (SRO), departed Archerfield Airport, Queensland, for a local flight to the training area south of the airport, with an instructor and a pilot in command under supervision (ICUS) on board. At about 0920, the student pilot of a Cessna 172 aircraft, registered VH-EEM (EEM), departed Archerfield for a solo local area flight. The student's planned route was to track 135° (south-east) outbound from Archerfield at 1,000 ft above mean sea level (AMSL), and when overhead the Logan Motorway, climb to 2,500 ft AMSL and track towards Logan Village. At Logan Village, the student pilot climbed the aircraft to 3,000 ft AMSL and practiced turns before tracking towards Jimboomba (Figure 1). The pilot of another aircraft in the vicinity broadcast on the area frequency and the student pilot of EEM sighted that aircraft and responded.

After completing training exercises at 3,000 ft AMSL south of Jimboomba, the pilots of SRO commenced tracking north towards Park Ridge to return to Archerfield. At about 0940 EST, while at 6 km south of Park Ridge and 3,000 ft AMSL, the instructor in SRO sighted EEM on a

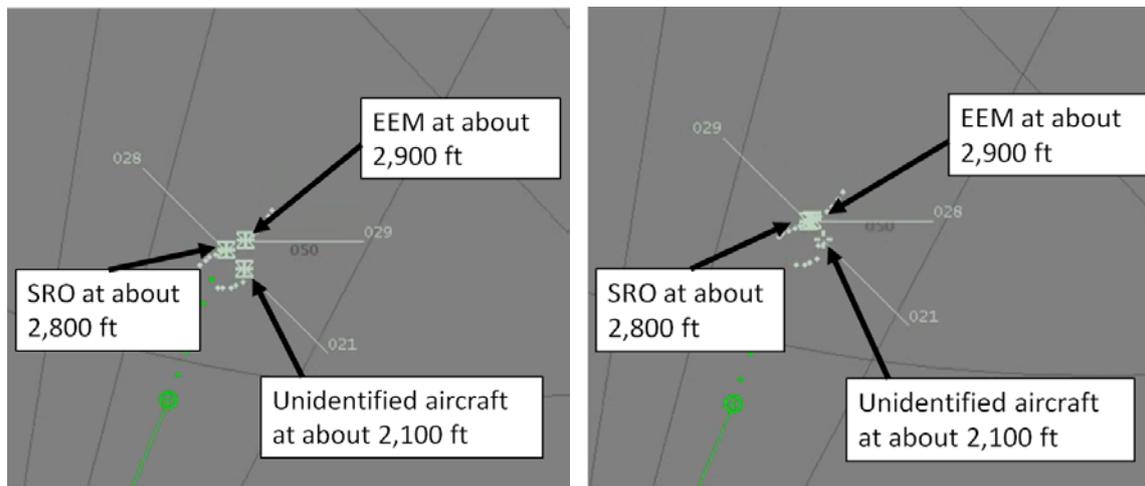
Figure 2: Radar display of the incident

converging heading in his 1 o'clock position,¹ and immediately took control of the aircraft from the pilot under supervision. He conducted a descent and estimated that EEM passed about 50 ft above SRO and about 100m away horizontally. The student pilot of EEM observed SRO pass below and to the right.

Radar data provided to the ATSB by Airservices Australia indicated that EEM passed about 100 ft over SRO (Figure 2), with aircraft altitudes unverified.

As a result of this occurrence and following discussions with the Civil Aviation Safety Authority (CASA) and Airservices Australia, the operator has implemented a new procedure for company pilots on entry to the southern (D673) and eastern (D666, D675) training areas. At the standard departure points from Archerfield Airport, pilots are to contact Brisbane Centre ATC on frequency

125.7 MHz and request traffic in their destined training area. Company pilots will be reminded that this action is in addition to the need to maintain an effective lookout for other aircraft.
