Loading issue involving a Boeing 737, VH-VZO

Canberra Airport, Australian Capital Territory, 9 May 2014

ATSB Transport Safety Report
Aviation Occurrence Investigation
AO-2014-088
Final – 3 September 2014

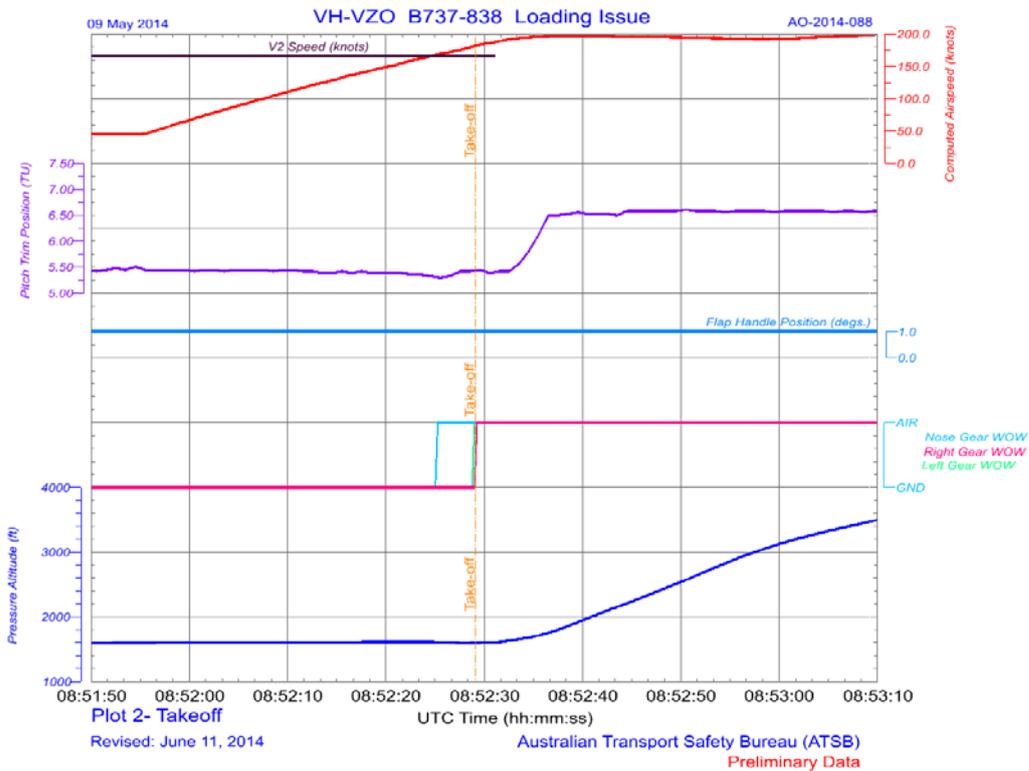
Figure 1: Flight data for the take-off phase

During the take-off, the aircraft appeared nose-heavy. To rotate the aircraft and lift off from the runway, the captain found that significant back pressure was required on the control column. Conscious of the potential of striking the aircraft tail on the runway if too much back pressure was applied to the controls, the captain maintained steady back pressure to ease the aircraft into the air. The aircraft exceeded the calculated take-off safety speed (V_2)¹ by about 25 kt. At $V_2 + 25$ kt, an exceedance was later detected during analysis of the aircraft quick access reference (QAR) data (Figure 1). The aircraft climbed at a higher initial climb speed than normal, which resulted in a slightly reduced climb gradient, but the crew did not receive any terrain or other warnings.

As the aircraft became airborne, the captain trimmed the stabiliser to relieve some of the back pressure. He advised the first officer that a fair bit of back pressure had been required for the take-off, and the first officer suggested it may have been due to the Flap 1 setting and that the group of children may have contributed. The crew did not experience any further issues during the flight.

A post-flight review determined that the final load sheet overstated the aircraft take-off weight by about 3.5 to 5 tonnes and the take-off stabiliser trim was out by about 1 unit. The captain reported that the weight discrepancy, if known, may have required a change in the electronically generated approach speed based on the load sheet weight, of about 1-2 kt, and no issues or abnormal indications occurred during the approach.
