Loss of separation assurance involving a Boeing 737, VH-XZA and a Fairchild SA227, VH-ANW

near Darwin Airport, Northern Territory, 2 June 2014

ATSB Transport Safety Report
Aviation Occurrence Investigation
AO-2014-102
Final – 3 September 2014

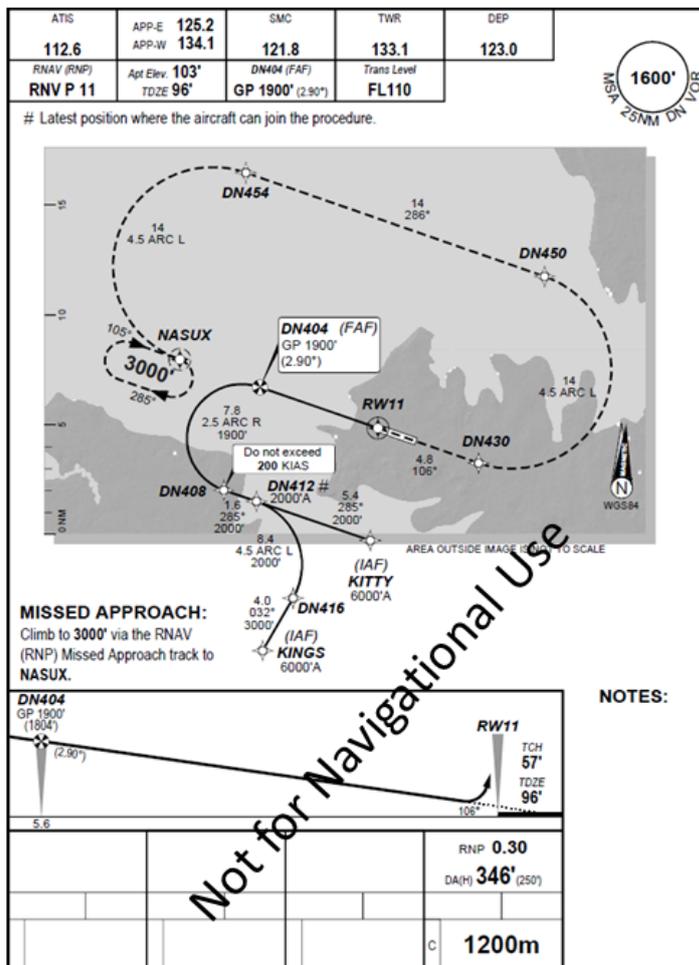
Figure 1: Darwin RNAV-P (RNP) RWY 11¹

On 2 June 2014, at about 1200 Central Standard Time (CST), the approach controller at Darwin Airport, Northern Territory, was processing the arrival of a Qantas Boeing 737 aircraft, registered VH-XZA (XZA), and an Airnorth Fairchild SA227, registered VH-ANW (ANW). When about 34 NM south-east of Darwin on a standard arrival route (STAR), XZA was cleared by the approach controller to descend to 3,000 ft and to conduct an Area Navigation 'P' (RNAV-P) approach to runway 11, via the 'KITTY' initial approach fix (IAF) (Figure 1).

¹ Figure 1 is an excerpt from the Airservices Australia RNAV – P (RNP) runway 11 approach chart. The crew involved in this incident were using a chart provided by Jeppesen, but relevant details are identical.
