Near collision involving B200 Kingair VH-SBM, and Piper Saratoga, VH-XKS

Normanton Airport, Queensland, 4 March 2104

ATSB Transport Safety Report
Aviation Occurrence Investigation
AO-2014-039
Final – 3 September 2014

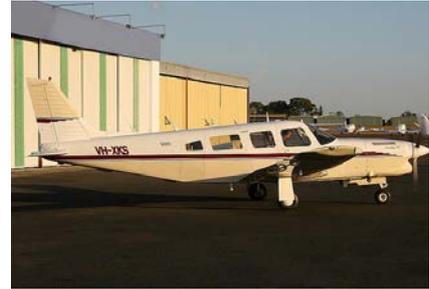
Piper Saratoga, VH-XKS

He reported it was the movement of the Saratoga turning onto final approach which caught his eye, as the aircraft’s fawn colour (see inset) blended in with the muddy flood waters that were widespread around Normanton at the time.

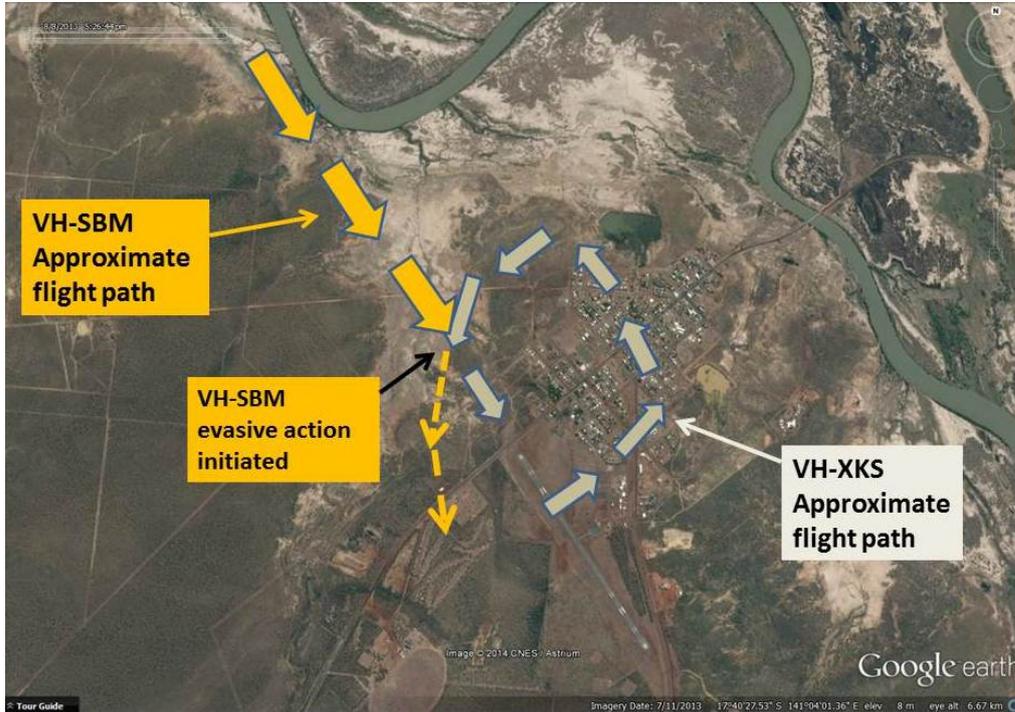
Figure 1: Flight paths approaching RWY 14 at Normanton

The Saratoga was fitted with two very high frequency (VHF) radio systems: Comm 1, which was available through the Garmin 300 GPS; and Comm 2, a KX165 Nav/Comm set. The pilot broadcast his taxiing, backtracking and departure calls at Mareeba, using Comm 2¹. The aircraft remained outside controlled airspace (OCTA) for the flight, but the pilot continued to maintain a listening watch on the relevant area frequencies. At about 11.5 NM from Normanton, the pilot used Comm 2 to broadcast on the local common traffic advisory frequency (CTAF), and advised that XKS was inbound. At Normanton, he positioned XKS to overfly the runway and join the circuit on crosswind for runway 14 (Figure 1).

After obtaining the Normanton automatic weather information service (AWIS³) information, which reported the wind at Normanton as predominantly crosswind, the crew elected to make a straight in approach to runway 14 (Figure 1). With about 10 NM to run, and at 3,000 ft, SBM was established on the approach. At 5 NM with the aircraft configured for landing, and all external lighting operating, including landing lights and strobes, the pilot made another broadcast on the Normanton CTAF. At 3 NM from the runway threshold he again broadcast on the CTAF. He received AFRU beepbacks⁴ for both of these calls.

Descending through 800 ft, the PIC was looking at the flap lever and decided to delay taking the last stage of flap for another few seconds, when he noticed movement in his left periphery below him. He then saw the Saratoga in a left turn onto final for runway 14. The Saratoga was partly

obscured by SBM’s engine nacelles, but was on a converging track about 50 ft below, and less than 50 m laterally.
