Collision with a tree involving a Cessna 172, VH-EEC

19 km NNW Albany, Western Australia, 13 July 2014

ATSB Transport Safety Report
Aviation Occurrence Investigation
AO-2014-124
Final – 3 September 2014

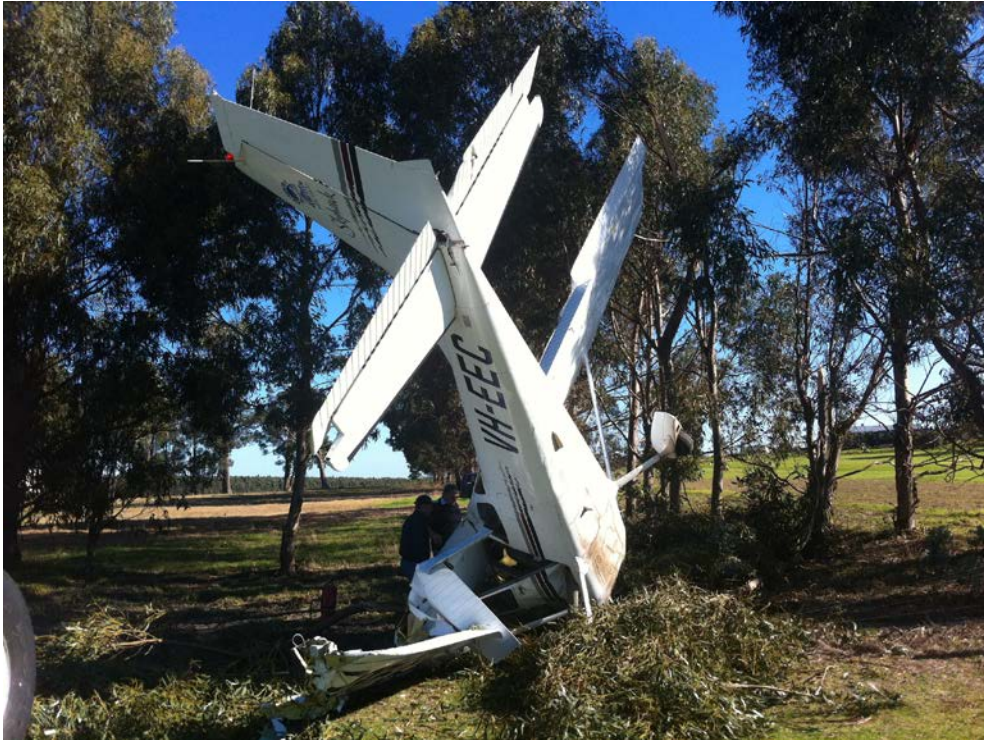
Figure 2: Accident site

When established on final for runway 06, the pilot reported that he had selected two stages of flap and had the aircraft stabilised at about 65 kt. When about 50 ft above ground level, the pilot reported that the aircraft encountered a wind gust which carried the aircraft about 30 m to the right. The pilot moved the aileron controls into wind and applied full power to commence a go-around; however the aircraft's right wing collided with trees on the right side of the landing area. The pilot reported that the right wing may have stalled as he applied full right aileron. The aircraft fell to the ground resulting in substantial damage (Figure 2).
