ATSB TRANSPORT SAFETY REPORT
Aviation Occurrence Investigation AO-2008-008
Interim Factual Report

Engine failure – Jabiru, NT

11 February 2008

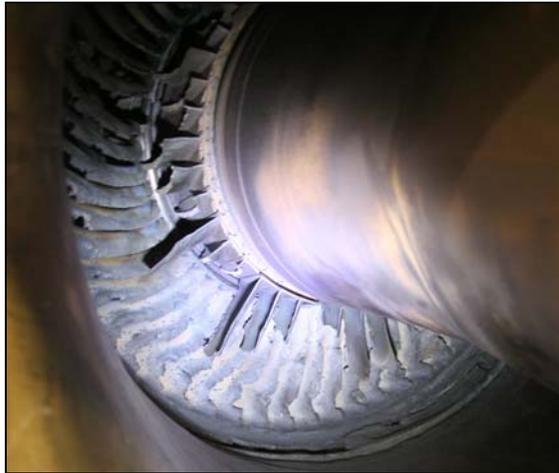
personnel reported that, on inspection, there was visual evidence in the engine exhaust of catastrophic damage to the power, or hot section of the engine (Figure 1).

Figure 1: View looking into the exhaust of the left engine

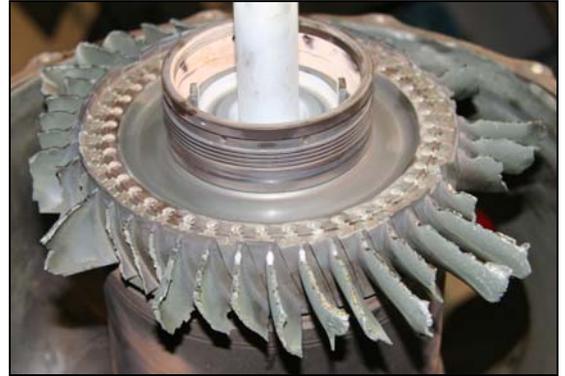
The engine disassembly, examination and inspection confirmed catastrophic damage to the power section of the engine. That included to the:

- exhaust duct
- hot section shroud housing
- hot section shroud segments
- power turbine housing
- power turbine 1st and 2nd stage vane rings
- 1st stage power turbine disc blades
- 2nd stage power turbine disc blades (Figure 2).

Figure 2: Power turbine disc 2nd stage

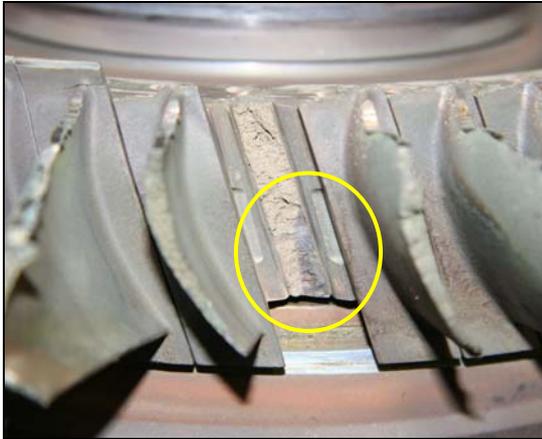
Further examination of the, 2nd stage power turbine disc² indicated that one of the disc blades had released at the 'fir tree' area or base of the blade. The fracture surface of the blade indicated that it may have failed as a result of a pre-existing anomaly (Figure 3).

Figure 3: 2nd stage power turbine blade fracture surface (potential pre-existing anomaly indicated)

The 2nd stage disc was installed during the power section overhaul on 25 May 2005, at 8,951 CSN³. On 8 February 2007, during the last maintenance to the engine, the disc had accumulated 3,411.0 hrs TSO and 2,954 CSN, indicating a total of 11,905 CSN.

³ The time before overhaul limit of the disc was 15,000 CSN.
