ATSB TRANSPORT SAFETY INVESTIGATION REPORT

Aviation Occurrence Investigation – AO-2008-010

Mid-air collision

Mid-air collision
54 km NNW of Gascoyne Junction, WA
13 February 2008
VH-OUS, Piper PA-18 Super Cub
VH-ZDP Robinson Helicopter Company R44
Raven

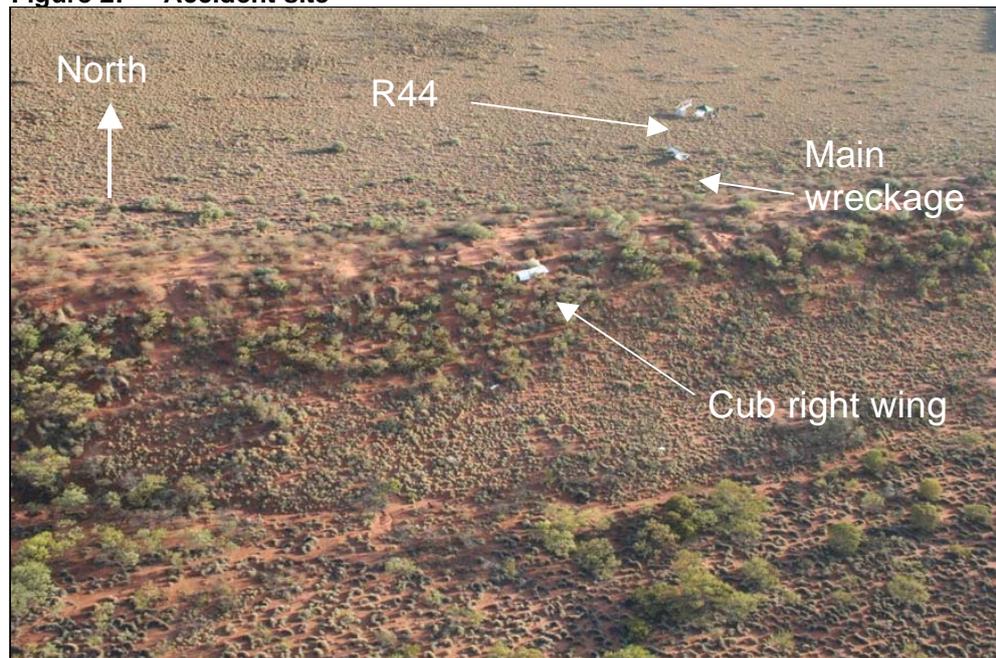
Figure 2: Accident site

The accident occurred over relatively flat terrain, characterised by regular sand ridges that were 20 m high and orientated approximately east to west (Figure 2). The accident site was about 1,150 ft above mean sea level (AMSL).

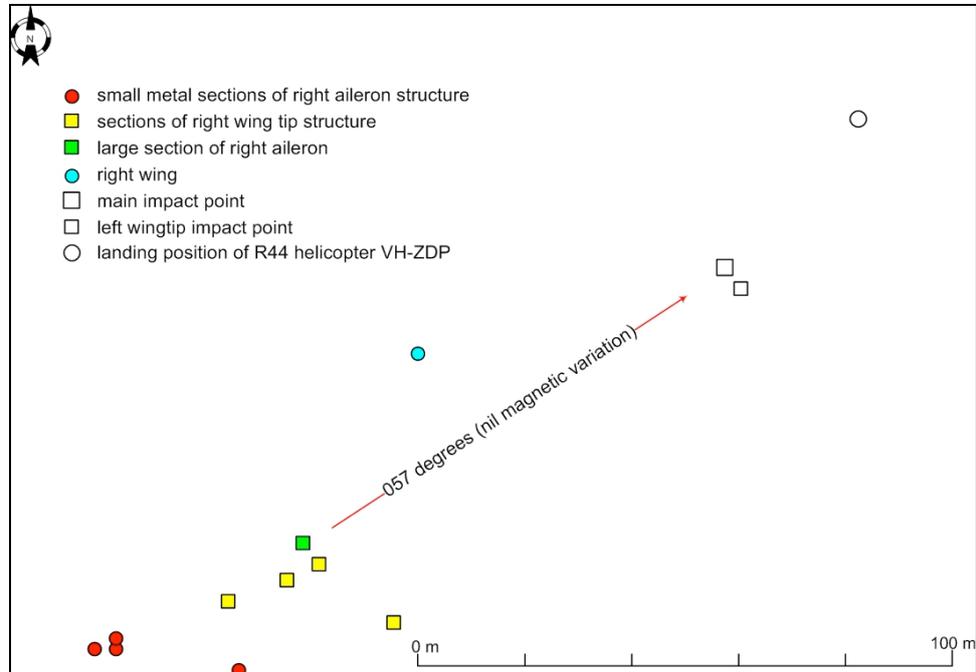
Figure 3: Aircraft wreckage plot

The wreckage trail of the Cub was orientated about 057 degrees and extended about 130 m across a sand ridge. The wreckage trail comprised the right wing and associated aileron and wing tip structure, and the main wreckage (Figure 3).

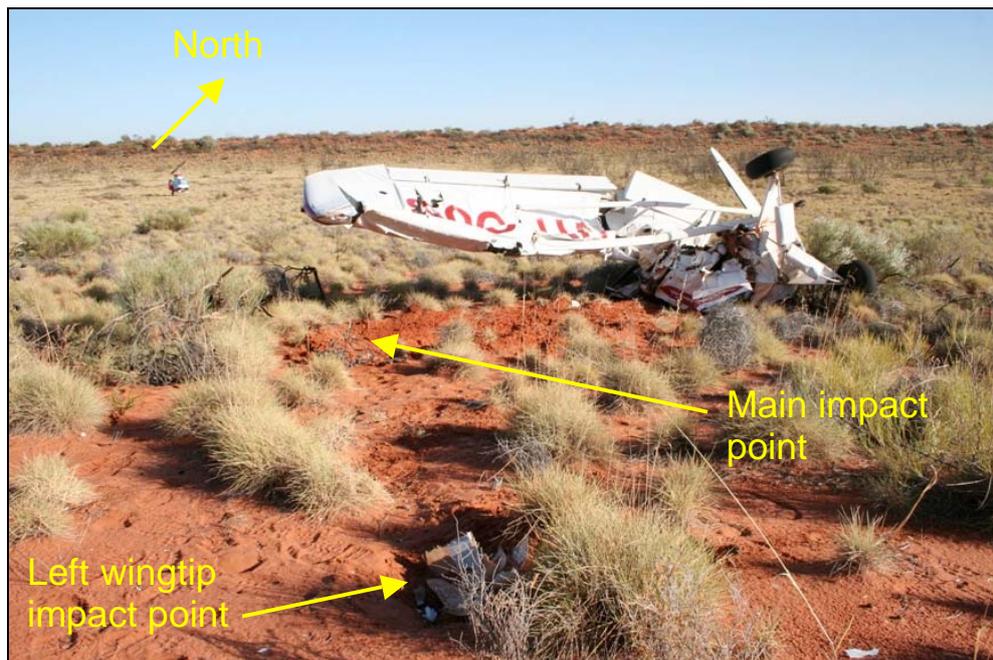
Figure 5: Piper Super Cub wreckage

Examination of the Cub indicated that contact damage was limited to the right wing structure consistent with the R44 main rotor blades impacting the right wing support struts. Following that contact, the wing fractured at the inboard attachment fittings and detached from the fuselage. The aircraft then impacted the ground inverted in a steep, nose-down attitude. Following the initial impact, the aircraft rotated to the right before coming to rest, inverted, a short distance from the initial impact point (Figure 5).

Inspection of the wreckage accounted for all components of the Cub, and established the continuity of all flight controls.

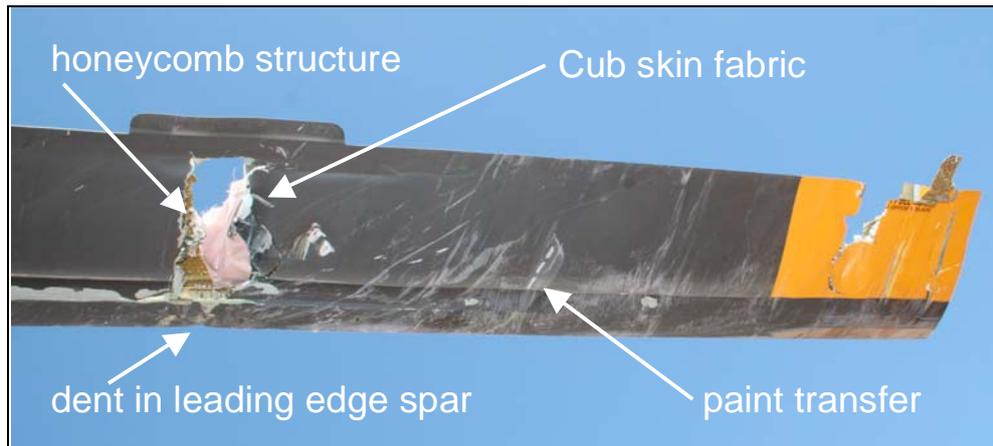
Figure 6: R44 main rotor blade damage

Examination of the R44 revealed substantial damage to one of the main rotor blades consistent with the mid-air collision (Figure 6). A section of the blade's skin and honeycomb structure was forced upwards between the leading edge spar and the trim tab, with part of the Cub's wing skin fabric retained within the blade. In addition, the blade tip had a section of the skin and honeycomb missing at the trailing edge. Both main rotor blades showed paint transfer along the majority of their length, in addition to creases on the lower surface of the blades' skin.
