# Fumes event

## 275 km WSW of Sydney, NSW

### 25 February 2008

INFRA-08495

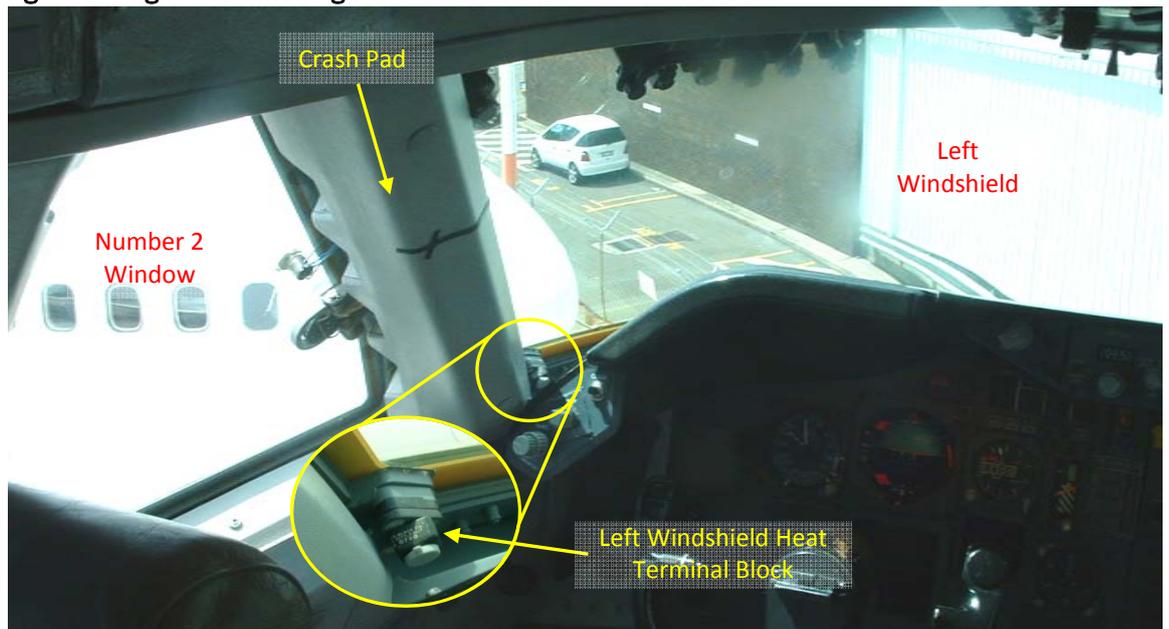
**Figure 1: Flight Deck showing the left windshield heat terminal block<sup>5</sup>**

An inspection was carried out of the flight deck by the operator's maintenance personnel, but found nothing conclusive. The aircraft was ground run with no fault found and the operator decided to carry out an assessment flight of the aircraft. While taxiing for that flight, a faint electrical odour was noted and a particle counter/sensor was used to determine that fumes were emanating from the lower left corner of the left, or pilot in command's, windshield (Figure 1).

Inspection of the left windshield by the operator determined that the electrical arcing and subsequent odour was the result of loose windshield heat element terminal connections. The terminal for that heat element was close to the crash pad<sup>6</sup> between the windshield and number 2 window (Figure 1).

The fumes that were experienced by the flight crew were consistent with an electrical arcing event as highlighted by the aircraft manufacturer in Boeing Service Bulletin (SB) 747-30-2081. The correct operation of high voltage equipment, such as the windshield heater, requires positive contact with the relevant terminals. Any wiring insecurity increases electrical resistance and the risk of electrical arcing. The identification by the operator of loose terminal connections to the left windshield heat element suggested that had been the case in this instance.

- The loose terminal connections to the left windshield heat element increased the electrical resistance and resulted in electrical arcing and fumes on the flight deck.

The left windshield and heat controller were replaced and a second assessment flight was carried out without incident. The operator cleared

The potential for the recent maintenance in the vicinity of the left windshield/crash pad to have contributed to the insecurity of the left windshield terminal connections could not be determined. In any case, the redesign of the windshield by the manufacturer to improve the security of the windshield heater wiring connection should address the risk of electrical arcing.
