INFRA-08270

# Collision with terrain – 7 km NNW Hornsby, NSW

## 1 March 2008

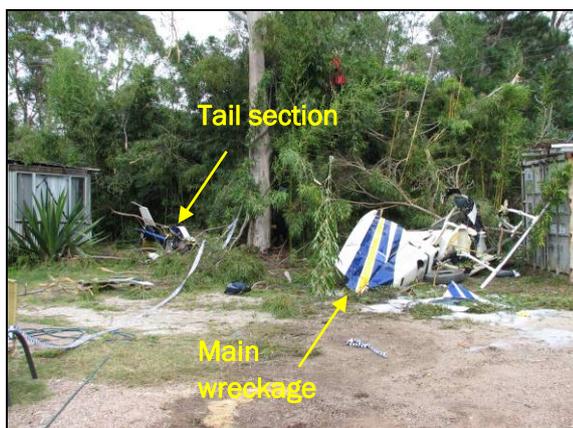
**Figure 1: Main wreckage**

The helicopter cockpit, cabin and fuselage were destroyed by impact with the trees and resulting dynamic forces. The helicopter cabin was severely damaged by the initial impact and separated into several sections (Figure 1).

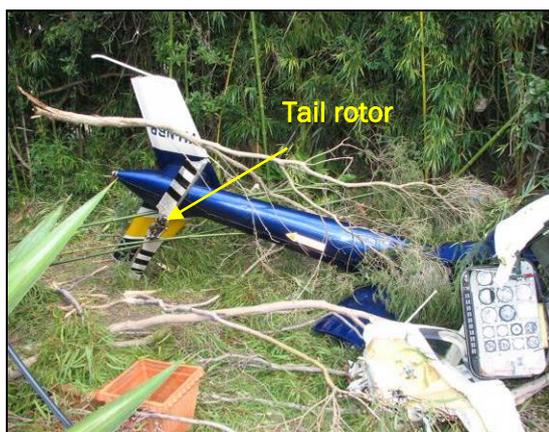
**Figure 2: Separated tail section**

The main rotor head, with parts of the blades attached, had separated from the transmission and main rotor mast and was lodged in the trees. The main rotor blades were destroyed by impact with the trees. That damage was indicative of the blades operating at significant RPM. Reconstruction of the main rotor blades indicated that the blades were intact prior to impact with the trees. The tail section, with the tail rotor gearbox and tail rotor still attached, was separated from the fuselage (Figure 2). The tail rotor blades had sustained impact-related damage.

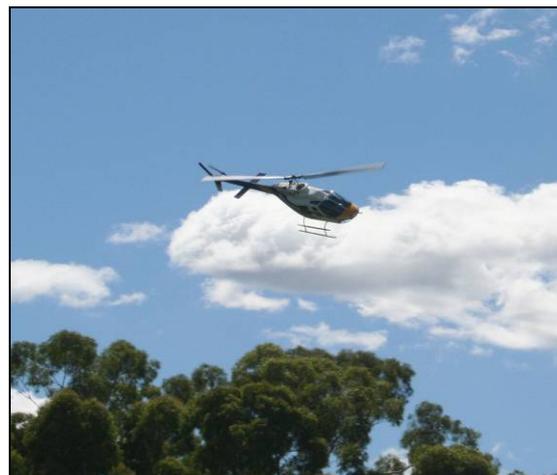
**Figure 3: Photograph of helicopter turning**

Two witnesses on the ground working at another nearby property, reported that the helicopter was low flying. One of the witnesses on the ground at the property had made a video recording of the flight of the helicopter using a camcorder. The video confirmed witness reports of low flying prior to the helicopter impacting the trees. Another witness at the party took a photograph of the helicopter while it was turning prior to the low-flying pass (Figure 3).
