Aviation Occurrence Investigation AO-2008-021

**Collision with terrain  
7 km north-east of Camden, NSW  
18 March 2008**

**VH-NUK, Pitts S-2A**

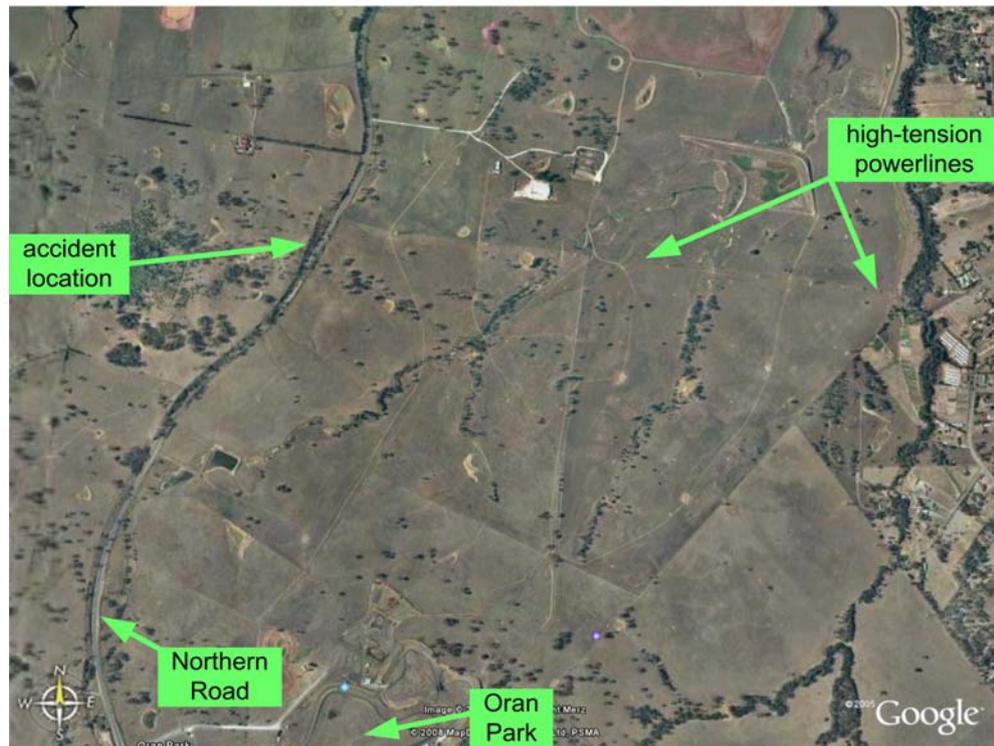
**Figure 2: Accident location**

The instructor asked the candidate to state his intentions and he replied that he was aiming for a field off the left wing (the fields the instructor had in mind when he asked the candidate to track towards 2RN, and which he considered to be more suitable, were to the aircraft's right.) Given the aircraft's position when the candidate replied, the aircraft would have to fly across a line of high-tension powerlines running approximately south-east/north-west (Figure 2) to reach the aiming point selected by the candidate.

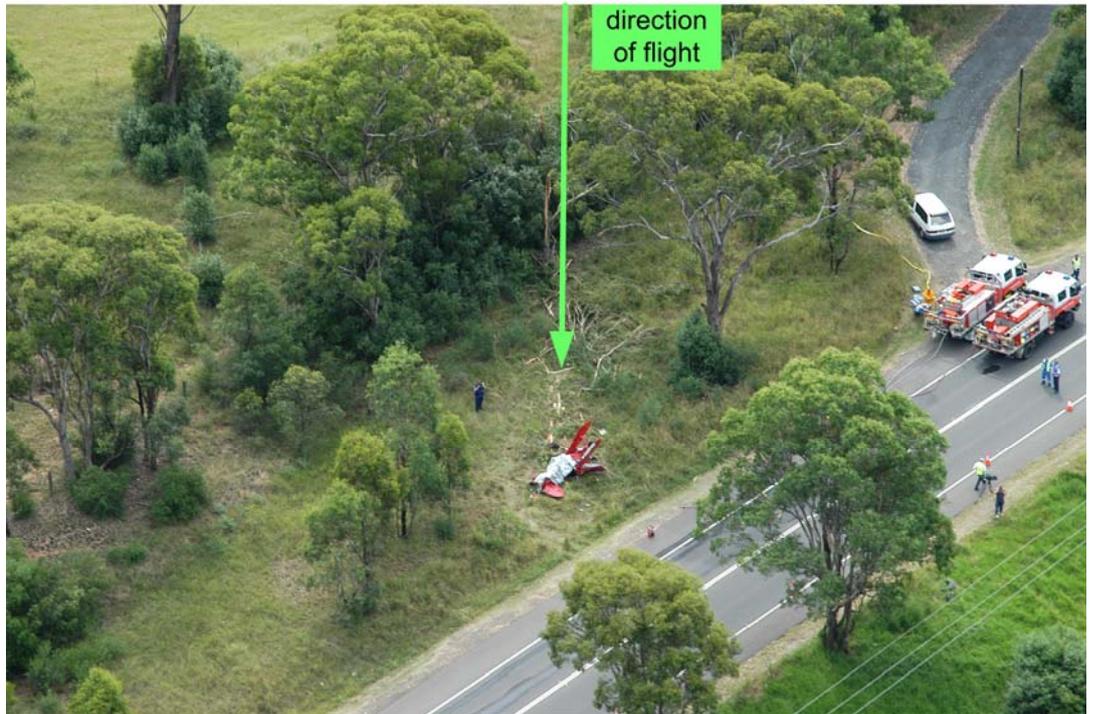
**Figure 3: Crash site and aircraft wreckage**

The terrain at the accident site was flat and surrounded by trees (Figures 2 and 3). The aircraft came to rest facing back along the flight path, with the fuselage partly inverted and resting on its left side. The rear right side of the fuselage, in the area where the candidate was seated, had been broken open by impact forces.

The propeller and spinner exhibited rotational and impact damage consistent with having struck trees and the ground, and some fallen tree branches showed evidence of damage from the propeller.

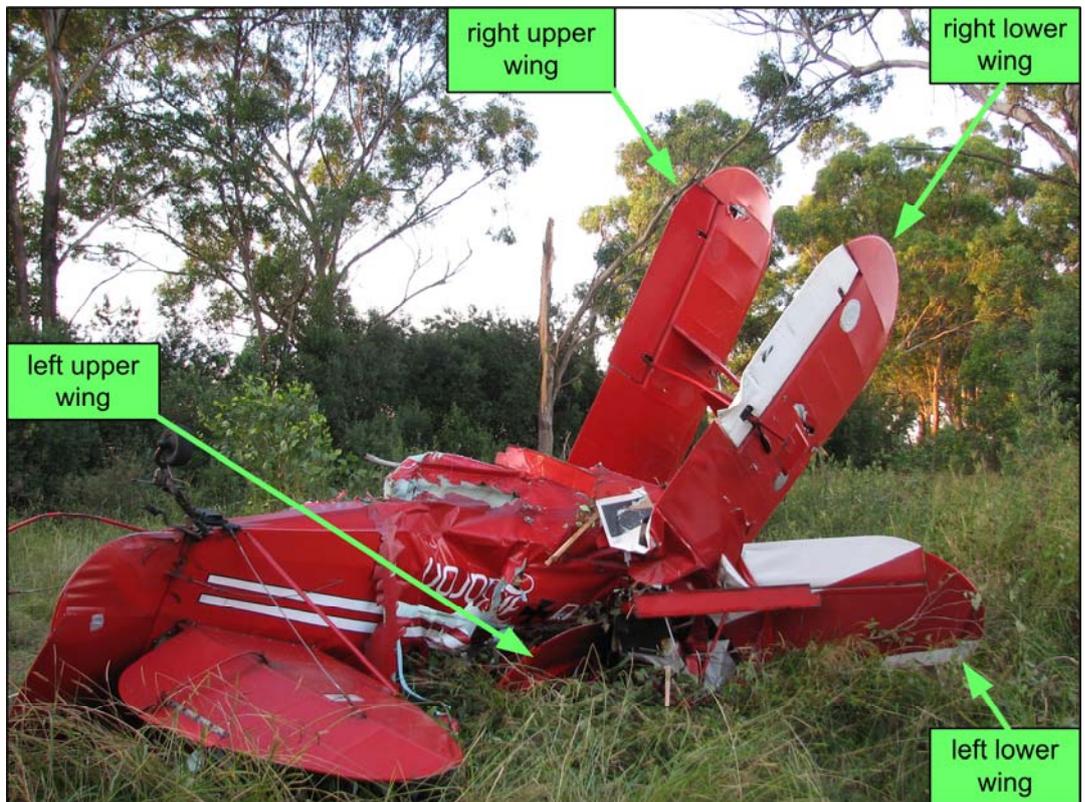
**Figure 4: Aircraft wreckage**

The instructor felt the aircraft begin to stall and applied right rudder to prevent the left wing dropping. He recalled feeling the aircraft recover from the stall, but that the recovery came too late to avert an impact with trees in the fence line beside the Northern Road. The aircraft struck two trees and impacted the ground between the fence line and the road, coming to rest after turning through almost 180 degrees to face its point of entry to the accident site, and with the fuselage twisted anti-clockwise with respect to the wings (Figures 3 and 4).

The fuselage had twisted anti-clockwise relative to the wing structure (Figure 4). Both the right upper and right lower wings were substantially intact and pointing upwards. The left lower wing had been bent underneath and across the fuselage. The left upper wing had been bent backwards beneath the fuselage.

The right tailplane, elevator and trim tab had mostly detached from the aircraft and were located among broken branches on the ground approximately 5 m from the nose of the aircraft. The elevator and tailplane were held together by the trim tab rod.
