ATSB TRANSPORT SAFETY INVESTIGATION REPORT  
Aviation Occurrence Investigation No. AO-2008-021  
Preliminary

# Collision with terrain VH-NUK, Pitts S-2A 7 km NE Camden, NSW

18 March 2008

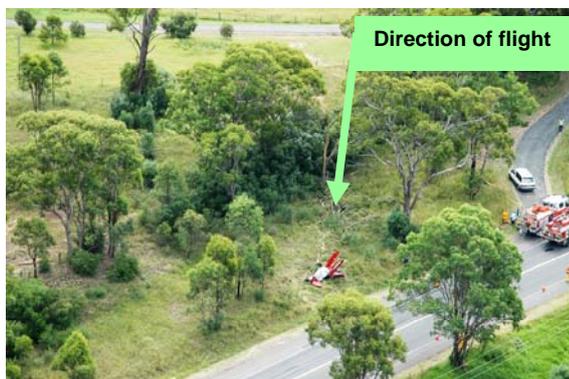
**Figure 3: Crash site and aircraft wreckage**

The terrain at the accident site was flat and surrounded by trees (Figures 2 and 3). The aircraft came to rest facing its point of entry to the site with its fuselage partly inverted and the right side of the fuselage facing away from the ground. The rear right side of the fuselage, in the area where the candidate was seated, had been broken open by impact forces.

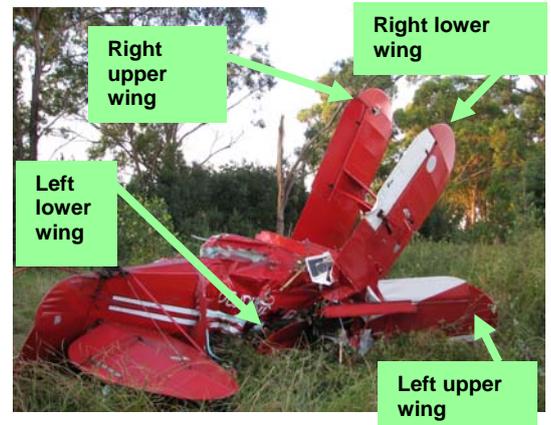
**Figure 4: Aircraft wreckage**

The fuselage had twisted anti-clockwise relative to the wing structure (Figure 4). Both the right upper and right lower wings were substantially intact and pointing upwards. The left upper wing had been bent underneath the fuselage. The left lower wing had been bent backwards beneath the fuselage.

The right tailplane, elevator, and trim tab had mostly detached from the aircraft and were located among broken branches on the ground 5 metres from the nose of the aircraft. The elevator and tailplane were held together by the trim tab rod.
