ATSB TRANSPORT SAFETY INVESTIGATION REPORT
Aviation Occurrence Investigation AO-2008-026
Interim Factual Report

Collision with water – 19 km SE Sydney, NSW

9 April 2008

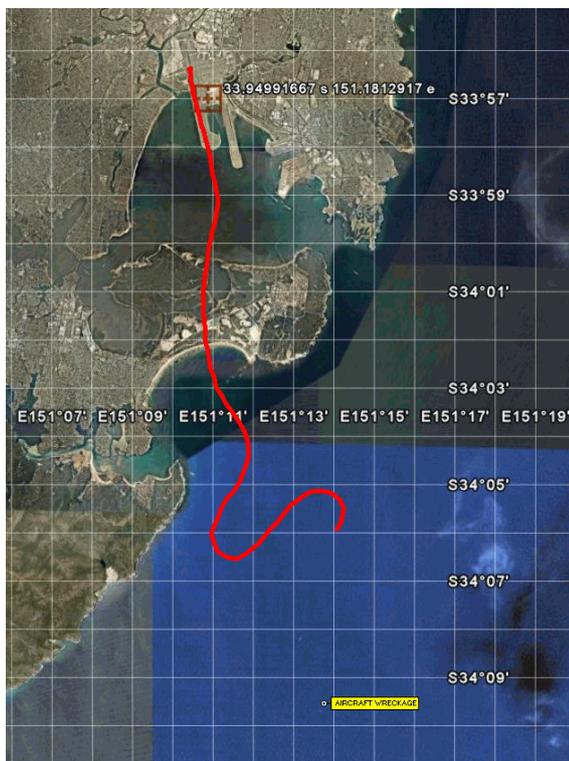
Figure 2: Radar track of aircraft on departure

No further transmissions were received from the pilot. The radar returns over the next 70 seconds showed the aircraft completed a left turn followed by a right turn before disappearing from radar (Figure 2). The last recorded radar return indicated an altitude of 3,900 ft.

The subsequent search and rescue response located floating wreckage and freight believed to be from the aircraft at 0444 on 10 April 2008. This was to the south of the last recorded radar position, as shown at the bottom of Figure 2.

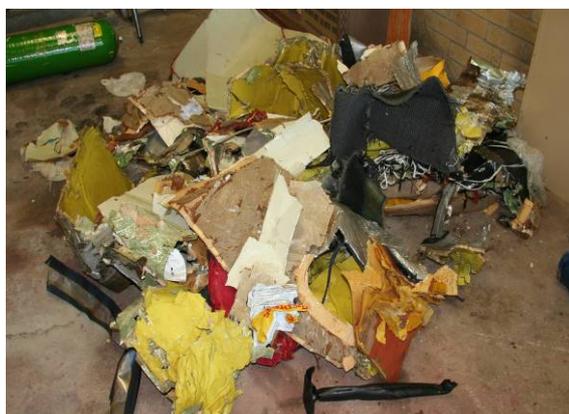
Figure 3: Recovered floating wreckage

Preliminary examination of the recovered wreckage (Figure 3) indicated that the aircraft had impacted the water at high speed. The pilot was fatally injured and the aircraft was destroyed.

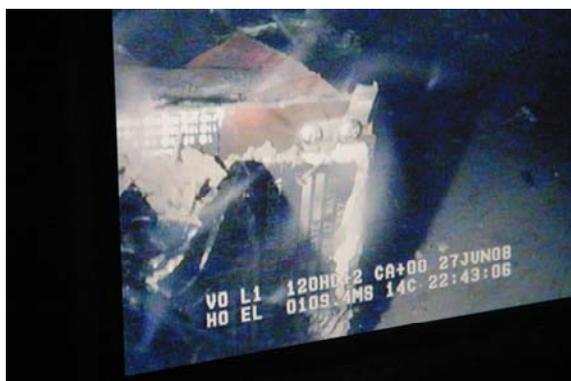
On 27 June 2008, the wreckage field, together with the cockpit voice recorder (CVR) (Figure 5), was located at position 34.05.76S 151.14.12E. The CVR was recovered from a depth of 109 m on the ocean floor the following day and numerous other items of wreckage were located and photographed.

Figure 5: Cockpit voice recorder on the ocean floor at a depth of 109m displayed on the ROV monitor.

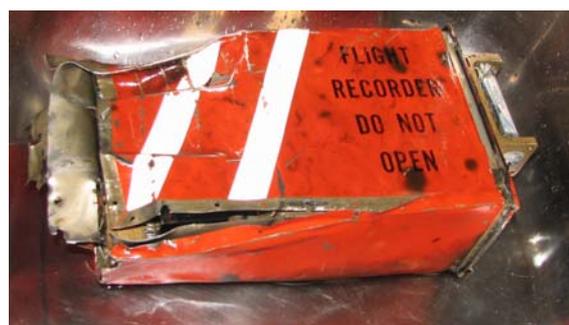
Figure 6: Fairchild model A100A cockpit voice recorder from VH-OZA

The recovered Fairchild CVR had been subjected to substantial impact forces (Figure 6). Identification of the recovered recorder was not possible since a placard affixed to the recorder, indicating the unit configuration, had been damaged; obliterating the last two significant part numbers. In addition, the manufacturer's data plate was missing. The CVR was washed and inspected and the impact damage was assessed. Some discolouration of the external paint was observed. The CVR was then dismantled and the recording tape recovered. The tape was in reasonable physical condition and, after cleaning, was replayed using the Bureau's CVR replay equipment. The recovered recording on the tape contained audio signals on three channels (two flight crew positions and the area microphone) with a duration of about 30 minutes.

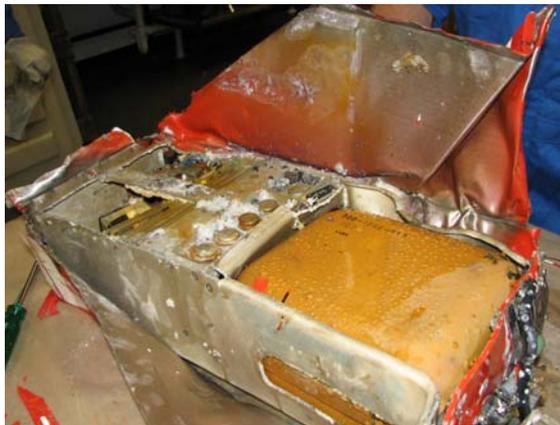
Figure 7: VH-OZA flight data recorder during disassembly showing crash protected enclosure and associated electronics

The FDR had been subjected to substantial impact forces, which had resulted in the fracture of the crash-protected enclosure. Some discolouration of the external paint was observed. The recorder was dismantled (Figure 7) and the recording tape was extracted for replay. The tape was in reasonable condition and, after cleaning, was replayed using the Bureau's FDR analysis workstation. The tape contained about 25 hours of good quality digital signals recorded across eight tracks. The transition from oldest to newest recorded information was confirmed by examination of all tracks.

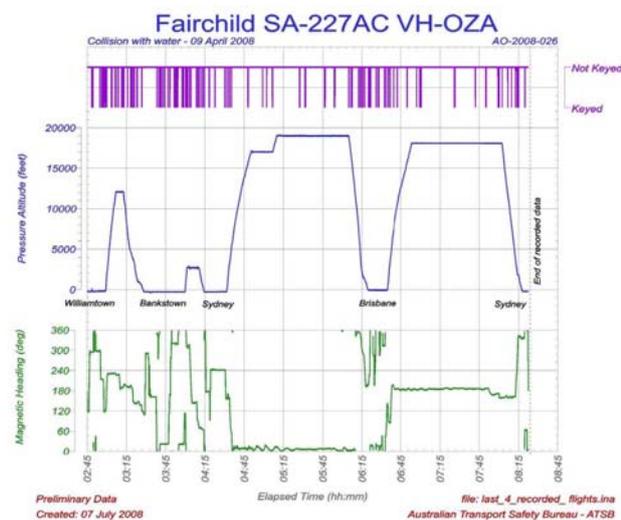
Figure 8: Plot of the last 5.5 hours of recovered FDR data

Figure 8 shows the last four sectors (about the last 5.5 hours of operation) of flight data that was recovered. The aircraft trip logs confirmed that Williamtown - Bankstown - Sydney flights were carried out on 8 April 2008. The aircraft then flew Sydney - Brisbane - Sydney on the morning of 9 April 2008.

Microphone keying recorded by the FDR was compared with the timing of radio conversation between VH-OZA and ATC recorded on the CVR. The elapsed time between conversations recorded on the CVR closely correlated with the microphone keying recorded on the FDR. In addition, conversations regarding runway and taxiway direction recorded on the CVR correlated with FDR data. It was therefore confirmed that the CVR recording was of the flight and landing at Sydney Airport on the morning of 9 April 2008 (the flight preceding the accident flight). Both the CVR and FDR recordings ended with what would seem to be a normal aircraft shutdown.
