ATSB TRANSPORT SAFETY INVESTIGATION REPORT  
Aviation Occurrence Investigation No. AO-2008-026  
Preliminary

# Collision with water – 19 km SE Sydney, NSW

9 April 2008

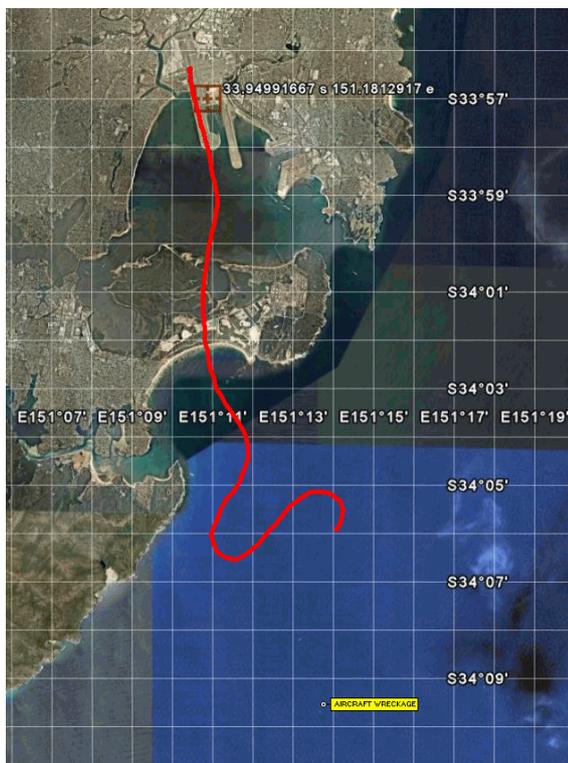
**Figure 2: Radar track of aircraft on departure**

No further transmissions were received from the pilot. The radar returns over the next 70 seconds showed the aircraft completed a left turn followed by a right turn before disappearing from radar (Figure 2). The last recorded radar return indicated an altitude of 3,900 ft.

The subsequent search and rescue response located floating wreckage and freight believed to be from the aircraft at 0444 on 10 April 2008. This was to the south of the last recorded radar position, as shown at the bottom of Figure 2.

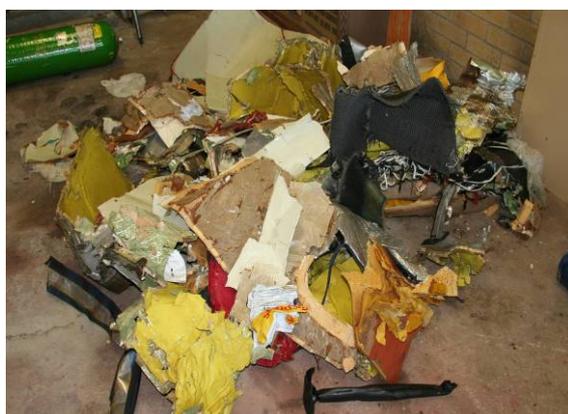
**Figure 3: Recovered floating wreckage**

Preliminary examination of the recovered wreckage (Figure 3) indicated that the aircraft had impacted the water at high speed. The pilot was fatally injured and the aircraft was destroyed.

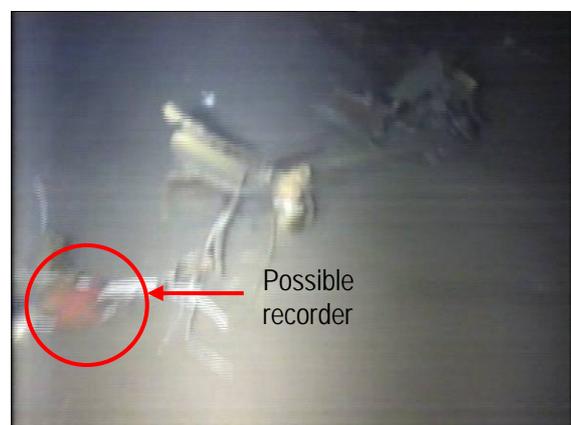
**Figure 4: Wreckage on the ocean floor**

On 12 May 2008, a significant wreckage field was identified and recorded by the ATSB investigation team (Figure 4). That wreckage was spread over an area approximately 1,200 m long and 400 m wide. While it was believed that the aircraft recorders were contained within this field, they were unable to be retrieved at that time.
