Missing aircraft, VH-WRT, GA-8 Airvan, Buckingham Bay, NT. 16 Oct 2008

INFRA-08361

Abstract

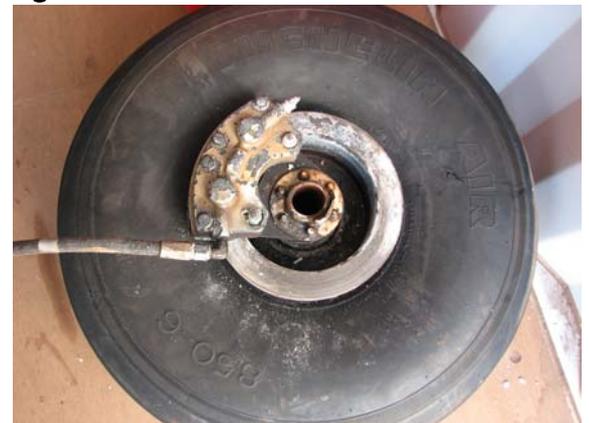
Figure 4: Left main wheel

Fracture of the left main landing gear wheel (Figure 4) had occurred transversely through the welded transition between the stub axle and landing gear leg. The fracture surfaces were typical of a ductile shear mechanism, and their form was consistent with failure occurring under bending overstress conditions. The nose wheel yoke had separated from the oleo at the bolted connection between the two components. Both the left main wheel and the nose wheel components showed significant levels of corrosion and associated metal-loss that attested to their period of immersion in salt water.

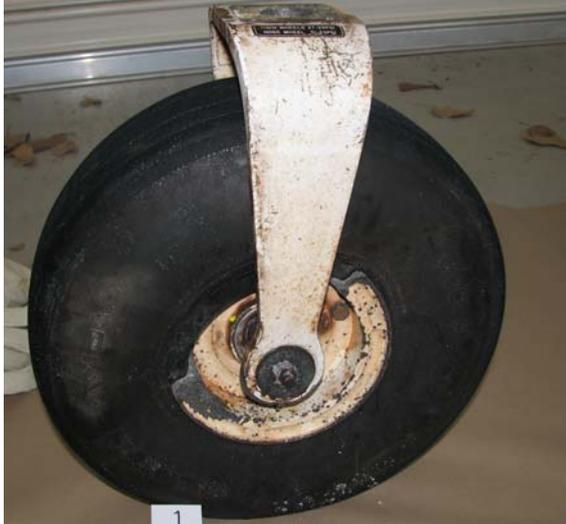
Figure 5: Nose wheel

Items of wreckage were recovered from the south-western part of Buckingham Bay by parties from Elcho Island and by the Australian Customs Vessel 'Roebuck Bay'. This included the left main wheel, the nose wheel, nineteen 20 L jerry cans, six seat bases, one seat back, and miscellaneous cargo, including school stationery (Figures 4 to 6).

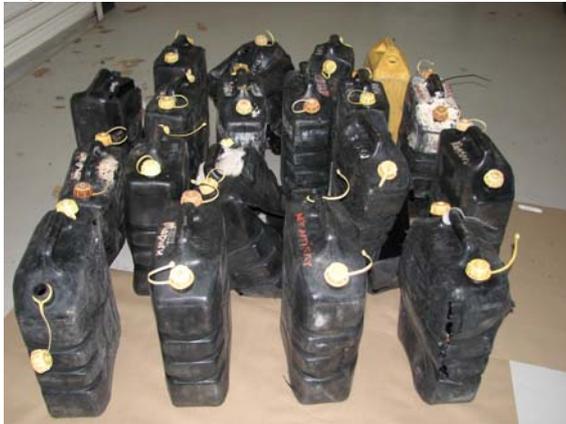
Figure 6: 20 L jerry cans

Around half of the 20 L jerry cans recovered had ruptured in a manner consistent with their exposure to the abrupt hydraulic pressure effects created within the internal liquid, as the aircraft impacted the water (Figure 6).
