Wire Strike – 13 km north of Murray Bridge, SA

19 November 2008

INFRA-08370

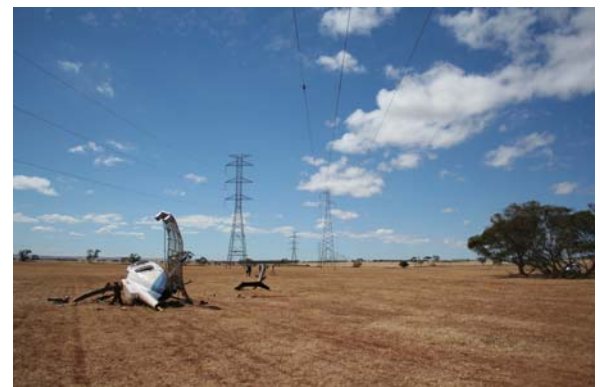
Figure 1: Accident site

impacted the ground (Figure 1). One linesman was fatally injured and the other sustained minor injuries, while the pilot sustained serious injuries.

The helicopter came to rest on its left side, pointing towards tower 30. The helicopter's engine continued to operate after the accident until the fuel supply was shut off by the pilot.

The helicopter fuselage came to rest on the left side facing north-north-west, opposite to the direction of flight.

The tail boom had separated from the fuselage during the impact sequence and was about 10 m from the main wreckage. One of the main rotor blades was 126 m north-east of the main wreckage and the damper from that blade was found 147 m east of the main wreckage. The four other main rotor blades remained attached to the hub, but exhibited significant damage consistent with contacting the ground while under power. Witness marks near the tips of two of the blades were consistent with them having contacted a conductor.

The outside working platform was buckled in an 'S' shape and had partially detached from the landing skids.

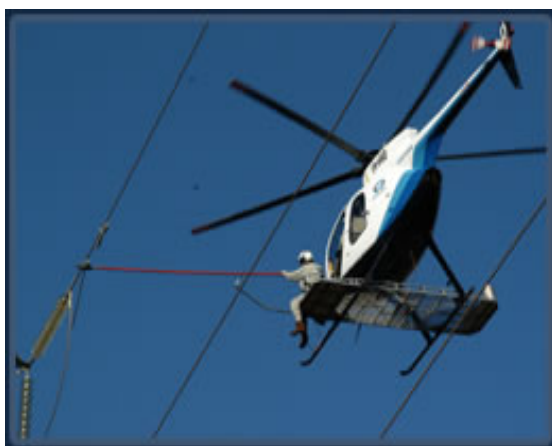
Figure 2: Helicopter and probe in position

The linesman on the platform had test equipment to be placed at the joint (Figure 2). His role was to extend a 4.5 m pole (a hot stick) horizontally from the platform to a predetermined length. The pole had a sensor and a remote camera attached at its end nearest the conductor. The pilot manoeuvred the helicopter to enable the sensor to be placed on either side of the joint to take resistance measurements. Those resistance measurements were transmitted to a laptop computer used by the linesman in the cabin to record the readings. That process normally took less than 20 seconds. If the equipment did not read correctly or the reading was irregular, further readings were taken to ensure their accuracy. The platform operator then withdrew the probe and the pilot manoeuvred the helicopter clear of the powerlines before proceeding to the next joint.

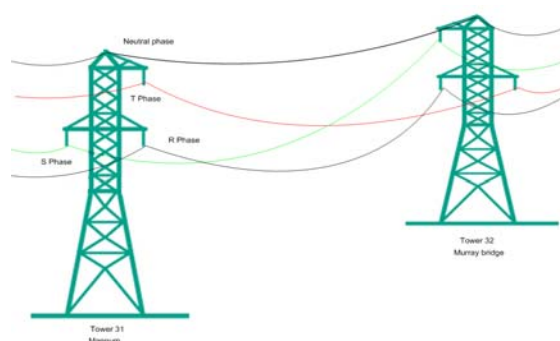
Figure 3: Transposition of powerline conductor

helicopter to where the refuelling vehicle was positioned on a nearby road. Fuel was added and the helicopter took off to resume the inspection from tower 31 towards tower 32. That section included a 'transposition' in the span (Figure 3). The refuelling personnel moved off towards the next refuelling point.

On a typical, non-transposed span, individual conductors are strung between insulators occupying the same position on consecutive towers. In a transposition, a conductor can be connected to insulators on the other side or at different levels of a subsequent tower.

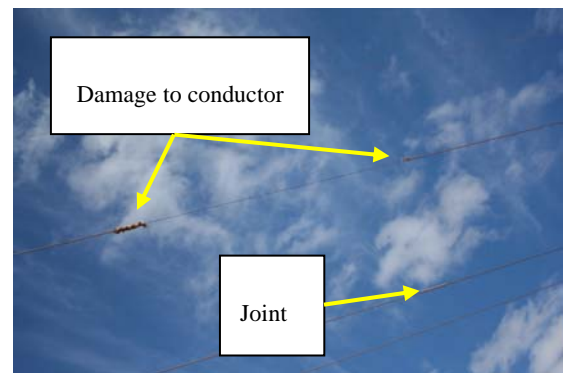
Figure 4: Damaged conductor

Examination of the powerline near the accident site revealed joints in close proximity to each other in all three conductors above the position where the helicopter cabin section came to rest and one of the conductors was damaged (Figure 4).

Approximately 8 m of the conductor had been damaged and the majority of the damage had occurred to the outer and intermediate layers of aluminium wire near the top section of the conductor. The aluminium wires at the Mobilong end had been severed and splayed outward from the main weave, while the Mannum end had been bunched into a loosely coiled 1 m length.

Two distinct failure modes for the aluminium wires were identified at the point of initial contact. Fourteen of the aluminium wires had been cleanly severed while the remaining 16 wires had failed from tensile overload.

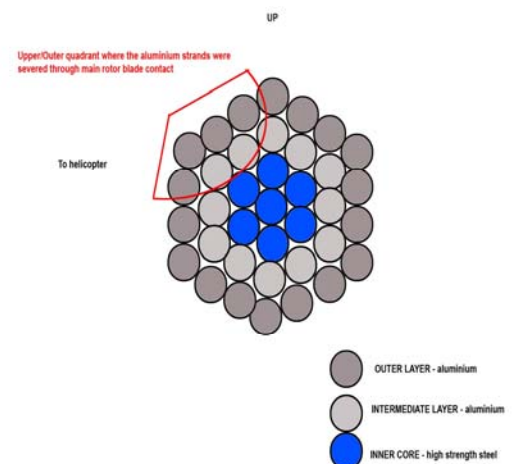
Figure 5: Conductor cross section

After the powerline had been repaired, the ATSB took possession of the damaged section of conductor. Examination of that section revealed that the conductor was comprised of an outer and intermediate layer of counter-woven aluminium alloy (18 and 12 wire strands respectively), and an inner core of high-strength steel (seven wire strands). The aluminium wires were used for their electrical conductivity properties while the steel wires comprising the inner core provided the strength necessary for suspension between transmission towers.
