Wirestrike - 25km NW Leongatha Aerodrome, Vic. 25 December 2008

INFRA-08487

Abstract

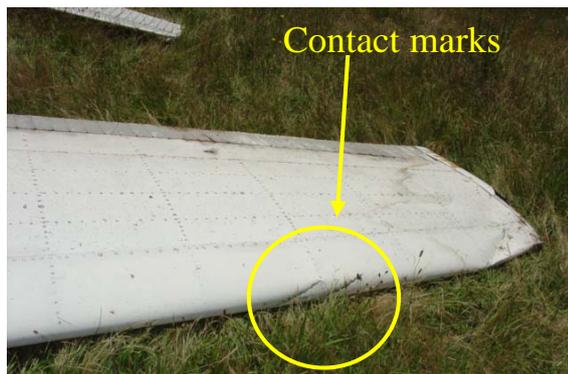
There were powerline contact marks 3 m from the left wing root and a double strand section of severed powerline cable was caught between the horn balance on the starboard elevator and the adjacent horizontal stabiliser (Figures 2 and 3).

Figure 2: Powerline contact marks on the left wing
