# Mid-air collision VH-UPY Cessna A150, VH-CGT Piper PA-28-161 3 km NW Moorabbin, Vic. 27 August 2008

## Abstract

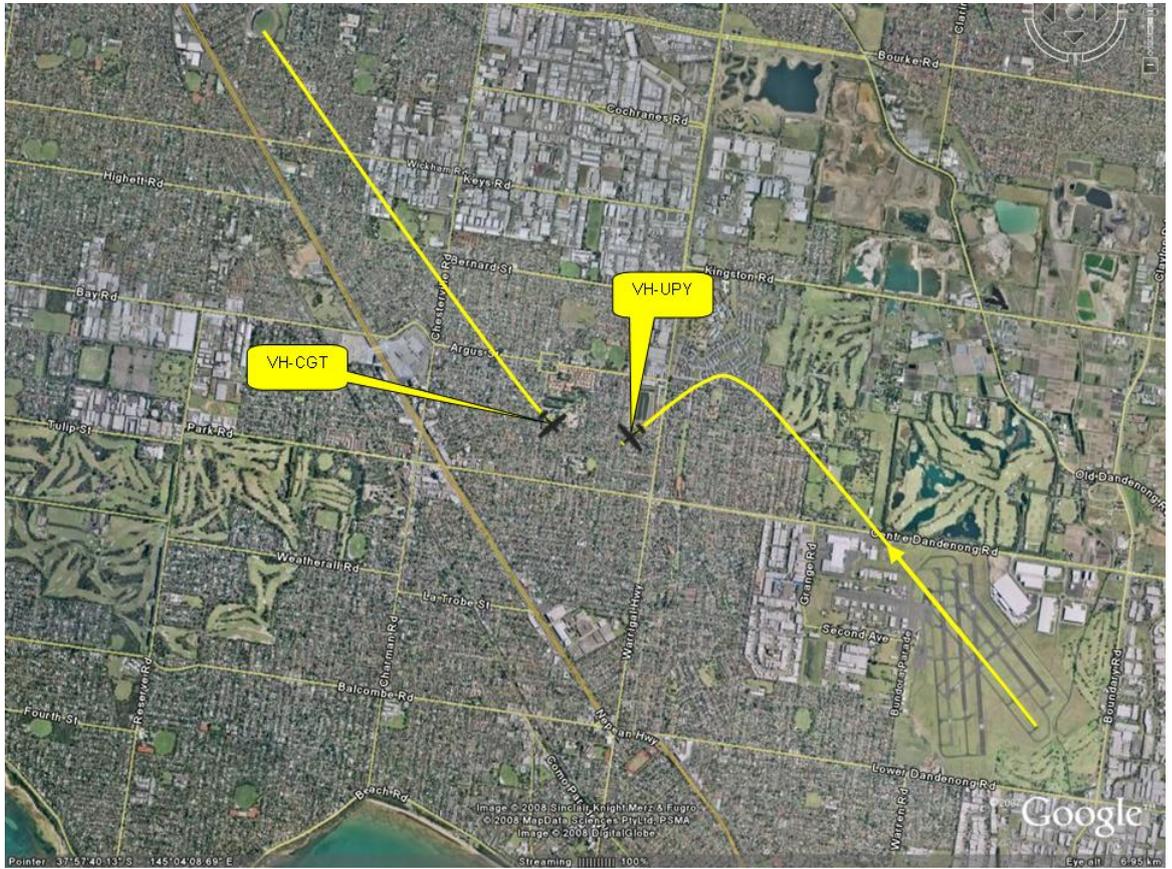
**Figure1** Position of aircraft shortly before the collision

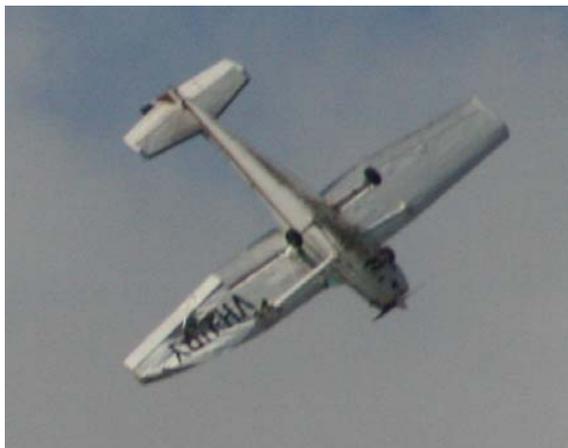
The left wing of VH-UPY and the left main landing gear, the left wing, flap, and the left rear fuselage of VH-CGT collided. The left tailplane of VH-CGT was struck, detaching the outer section and folding the remainder of the left tailplane upwards and rearwards. The left fin of VH-CGT was also impacted during the collision sequence (Figures 2 and 3).

**Figure 2:** VH-UPY descending after collision

The outer section of the left wing of VH-UPY was crushed at the leading edge. The aircraft descended almost vertically after the collision and was seen to roll at least three times before impacting the ground. The impact was not survivable.

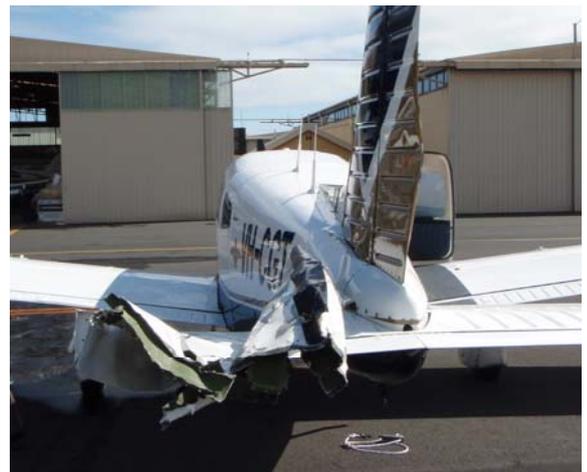
**Figure 3:** VH-CGT collision damage
