Cargo fire on board the bulk carrier *Jin Hui*

25 January 2008

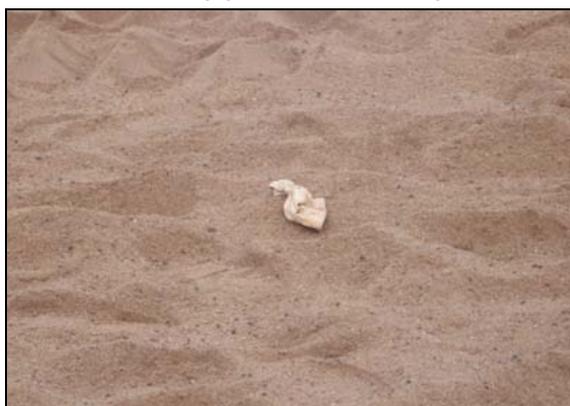
Figure 2: Fumigant buried in the cargo with only the top part of the sock exposed.

Before the cargo hold hatch covers were closed, a fumigation contractor added fumigant to each cargo hold at a rate of two grams of phosphine per cubic metre of cargo. The plan was to place socks containing aluminium phosphide tablets on the surface of each cargo hold. However, it was raining so the socks were buried in the cargo in an attempt to protect the fumigant from the rain (Figure 2). The cargo hold hatch covers and

The socks containing the fumigant on board *Jin Hui* were buried in the cargo. The surrounding cargo would have slowed the dissipation of heat from the reacting fumigant tablets. As a result, it is likely that the local temperature rose to a level above the auto-ignition temperature of the diphosphine gas and that the gas subsequently ignited.

While it appears that the contractor considered the risks associated with the fumigant becoming wet, he did not adequately consider the risks associated with burying it in the cargo.

The fumigation contractor did not adequately consider the risks associated with burying the aluminium phosphide fumigant in the cargo.

The Australian Transport Safety Bureau advises that ship owners, operators, masters and fumigation contractors should consider the safety implications of this safety issue and to take action where it is considered appropriate.

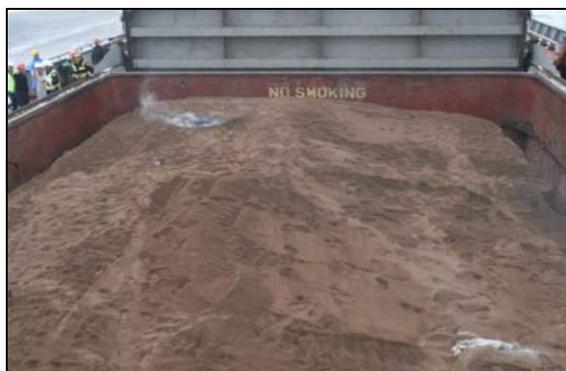
small areas of the cargo's surface, each less than two metres in diameter, were smouldering (Figure 3).

Figure 3: The fire affected areas of cargo

A small amount of water was sprayed onto each of the smouldering areas of cargo and the hold was thoroughly inspected to make sure there were no other hot spots.

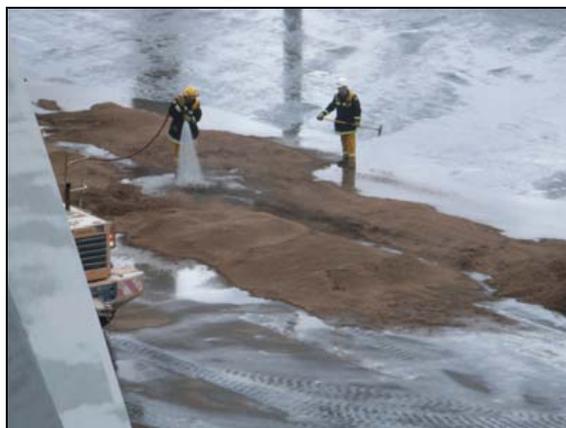
At about 1500, the two areas of smouldering cargo were removed from the hold with a grab and placed on the wharf. The cargo was then spread out and hosed down to ensure that the smouldering material was extinguished (Figure 4).

Figure 4: The cargo on the wharf being hosed

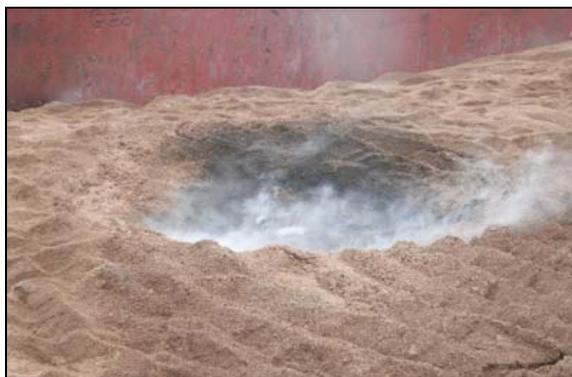
Both fire affected areas had burnt in a circular pattern that was centred on the location of a fumigation sock (Figure 5). However, the fires had not grown in size over the ensuing days because as they developed they had consumed the available oxygen in the cargo hold. It is likely that the amount of oxygen in the cargo hold atmosphere fell to a level that would not support flame (below 15 per cent) fairly quickly. The fires then slowly smouldered until the cargo hold hatch covers were opened and they were extinguished with water.

Figure 5: Circular pattern of burnt cargo

- The fires continued to burn, consuming oxygen from the air inside the cargo hold, until the oxygen content in the cargo hold atmosphere was below 15 per cent, at which time there was insufficient oxygen to support a flame. The fires then continued to slowly smoulder.

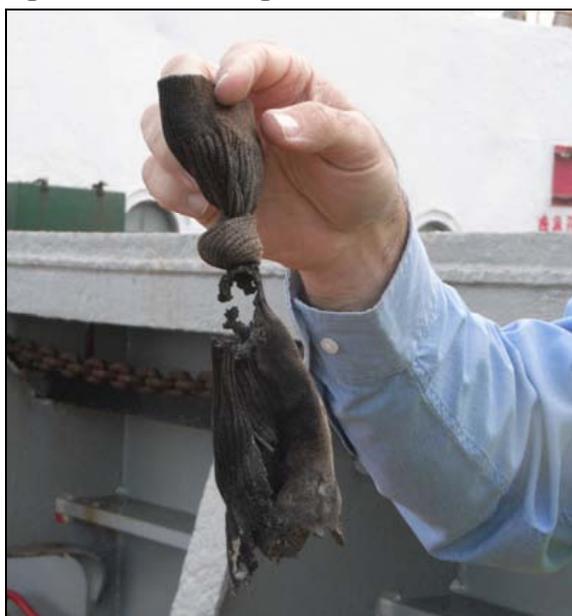
Figure 6: Burnt fumigant sock

Only two areas of cargo showed any sign of fire. However, when the fumigation socks were removed from each of the other cargo holds, it appeared that many of them had been burnt (Figure 6).
