Derailment of Freight Train 6MP9 near Hines Hill, Western Australia 10 March 2008

INFRA-08438

ABSTRACT

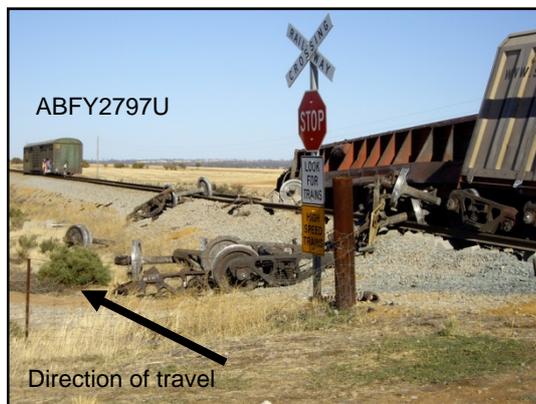
Figure 1: View of derailment site

Note: wagon ABFY2797U without bogies

One of the drivers walked back and noted that the train had separated, and that a number of wagons were derailed in the middle of the train. He found that wagon ABFY2797U was separated from the front portion of the train and was still on the track, but without bogies, (Figure 1). The next 10 trailing wagons were also derailed. Beyond the derailed wagons, he also noticed what appeared to be a bushfire burning in the distance.

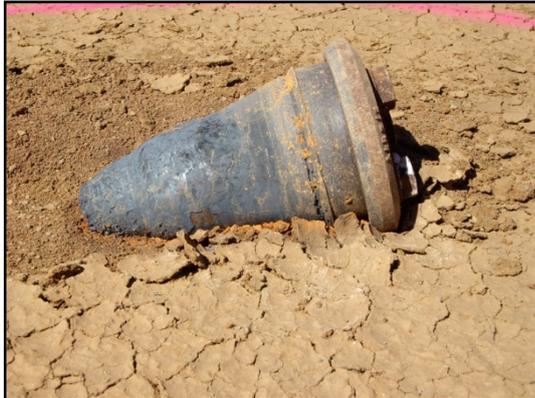
Figure 2: Axle journal stub in situ

An examination of the derailment site was conducted and revealed an axle journal stub (Figure 2) lying in a clay pan adjacent to the track about 45 m from the point of separation (262.007 km point). The axle journal stub had originated from the first wagon to derail, ABFY2797U. Inspection revealed that aside from the failed axle, the bogies from wagon ABFY2797U appeared to be in serviceable condition with components that indicated normal running. Similarly, there were no signs of irregular wear on the rest of the wagon to indicate uneven loading or abnormal bogie tracking.

After departing Adelaide on 8 March 2008, train 6MP9 passed through condition monitoring stations at Port Germein, SA, Nectar Brook, SA, Parkeston, WA and Bonnie Vale, WA. In each case, data indicated that train 6MP9 was running normally. When the train was passing through Booraan, a landowner noted unusual noises coming from a wagon in the middle of the train consist. By the time the train had travelled a further 34 km, the failing bearing had generated and transmitted sufficient heat to the axle journal to make it 'plastic' and allow the end carrying the failed roller bearing assembly to 'screw off'.

After the axle stub separated from the bogie, the wheelset travelled a further 17 m at about 106 km/h (the train speed obtained from the locomotive data logger) before derailing at 261.990 km. The derailed wagon then travelled a further 2790 m, before striking a level crossing formation, losing both bogies and coming to rest 67 m further on.

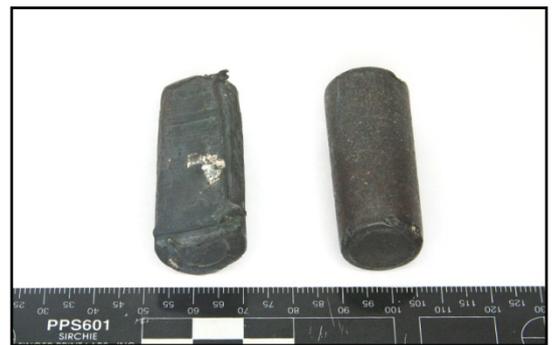
Figure 3: Tapered rollers from ABFY2797U

Two tapered rollers were examined, (Figure 3). Those rollers were found in the immediate vicinity of the axle stub.

The physical condition of the rollers did not indicate any pre-existing condition that may have led to a failure of the bearing. Due to the components having been exposed to extreme heat, the microstructure or mechanical properties of the steel before the derailment could not be accurately ascertained. A sample from one of the rollers was prepared for composition testing. The results from that test indicated that the material used was in accordance with the standard specified by Timken, the Association of American Railroads and Australian Standard 7516.2-2007 *Rolling Stock Axle Bearings: Freight Rolling Stock*.
