Derailment of train 3DM4 near Manton Dam NT

22 April 2008

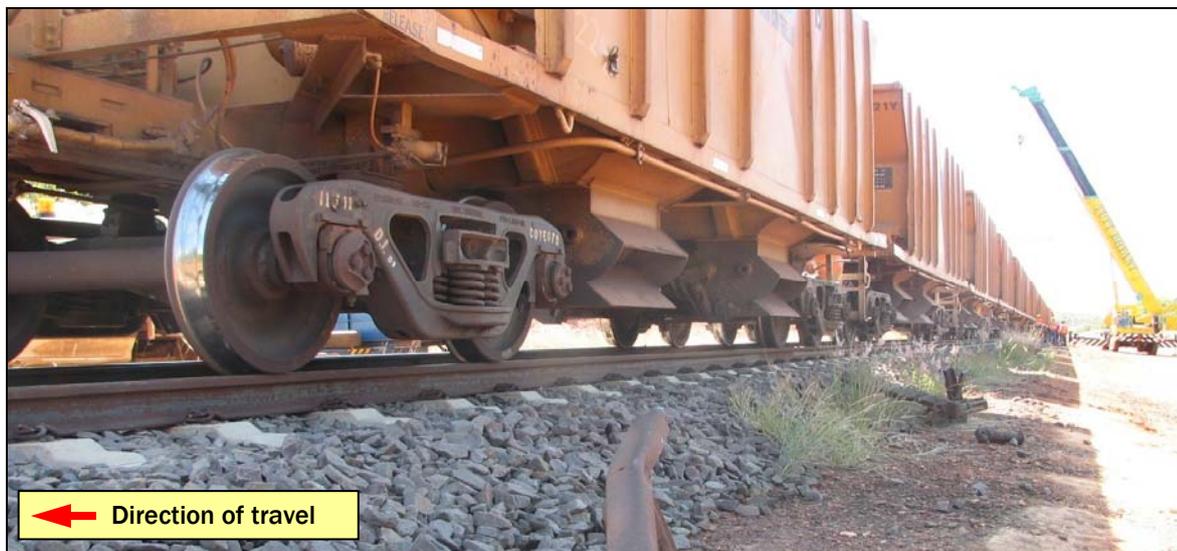
Figure 1: Wagon CHQY-739C, damaged wagon components and recovery of derailed wagons.

Within the separated rear portion of the train (14 wagons) the second, third, eighth and thirteenth wagons had derailed. All wagon underside components suffered moderate to significant damage, including brake rigging, hopper doors, bogies and wheel flanges.

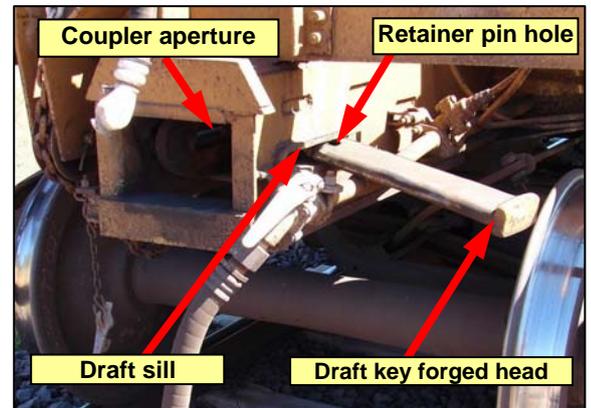
Wagon CHQY 739C was the 31st wagon in the train consist and was coupled immediately ahead of the first derailed wagon, CHQY 721Y. The coupler on the leading end of CHQY 739C had been pulled out of the headstock and had fallen between the rails. The draft key had almost completely withdrawn from the draft sill area and was found resting over the train brake pipe and against the wheel flange (Figure 3).

Figure 3: Disengaged draft key on wagon CHQY 739C (as found).

The draft key was the type which had a forged head at one end and a drilled hole that accepts a 'T' shaped retainer pin in the other end. It was evident that the retainer pin had dislodged which had allowed the draft key to work its way out of the draft sill. No parts from the retainer pin assembly were found during a search of the derailment site, precluding further examination or analysis of those components.

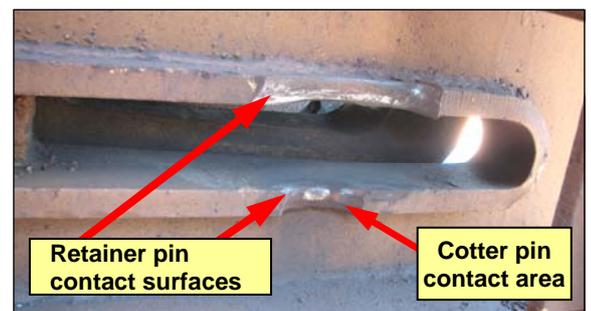
The lips on the draft sill on wagon CHQY 739C showed severe hollowing as a result of regular hard contact with the draft key retainer pin assembly (Figure 4).

Figure 4: Retainer pin contact wear areas on draft sill lips on wagon CHQY 739C.

Conversely, the draft sill lips on the other side of the underframe showed no signs of regular contact with the forged head end of the dislodged draft key. This indicates that the load on the draft key was biased in a way which increased the contact between the retainer pin assembly and the adjacent draft sill lips.

It is likely the failure sequence began when the cotter pin failed or dropped out of the base of the 'T' shaped draft key retainer pin. The wear marks on the lower draft sill lip (Figure 4) indicated that the cotter pin had probably worn away over a period of time by periodic hard contact with the face of the sill lip.

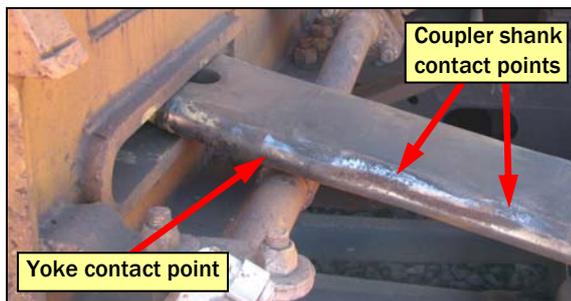
Although the function of the draft key is to secure the yoke and coupler as a unit within the underframe, it is designed to float freely within the confines of the draft sill aperture. Wear marks and polishing on the leading and trailing edges of the dislodged draft key (Figure 8) showed friction contact points where the coupler shank had gripped the draft key during the compression and tension phases of the train's movement.

Figure 8: Draft key showing uneven contact wear

The unevenness of wear marks is further evidence suggesting that the forces on the draft key were biased on the retainer pin side, subjecting the cotter and retainer pins to abnormal wear as they were in more frequent hard contact with the draft sill lips. Had an anti-wear collar been fitted over the retainer pin end, contact wear would have been distributed over a larger area and the life of the cotter pin would have been extended. However, without appropriate maintenance it would have eventually failed. It is likely that misalignment and wear in the draft key slots within the yoke and/or the coupler shank had led to the biased forces on the draft key under operating conditions.
