Derailment of Train 5WX2 near Winton, Victoria 31 July 2008

INFRA - 08247

Abstract

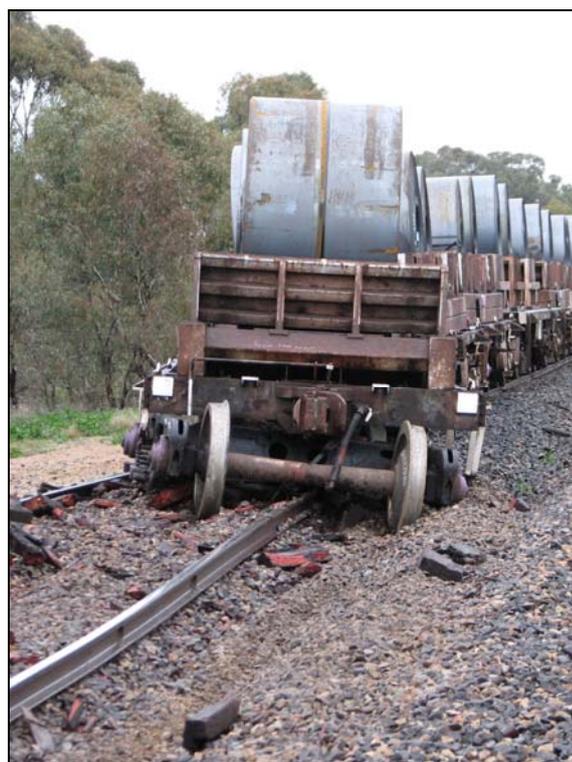
- One of the right-hand wheels from a wagon carrying coiled steel climbed and travelled over the top of the rail to the right-hand side of the track.
- As train 5WX2 continued towards Benalla, the derailed wheels impacted with the timber sleepers. The sleepers ultimately failed to maintain track gauge which allowed further wagons to derail.
- The train parted behind the 30th wagon as the following wagons began to jack-knife. Wagons continued to derail and jack-knife as the rear

Figure 1: Derailed wagon carrying coiled steel
