# Loss of separation involving Boeing 717, VH-NXQ and Boeing 737, VH-VXM

near Darwin Airport, Northern Territory | 2 October 2012

**ATSB Transport Safety Report**  
Aviation Occurrence Investigation  
AO-2012-131  
Final – 2 October 2014

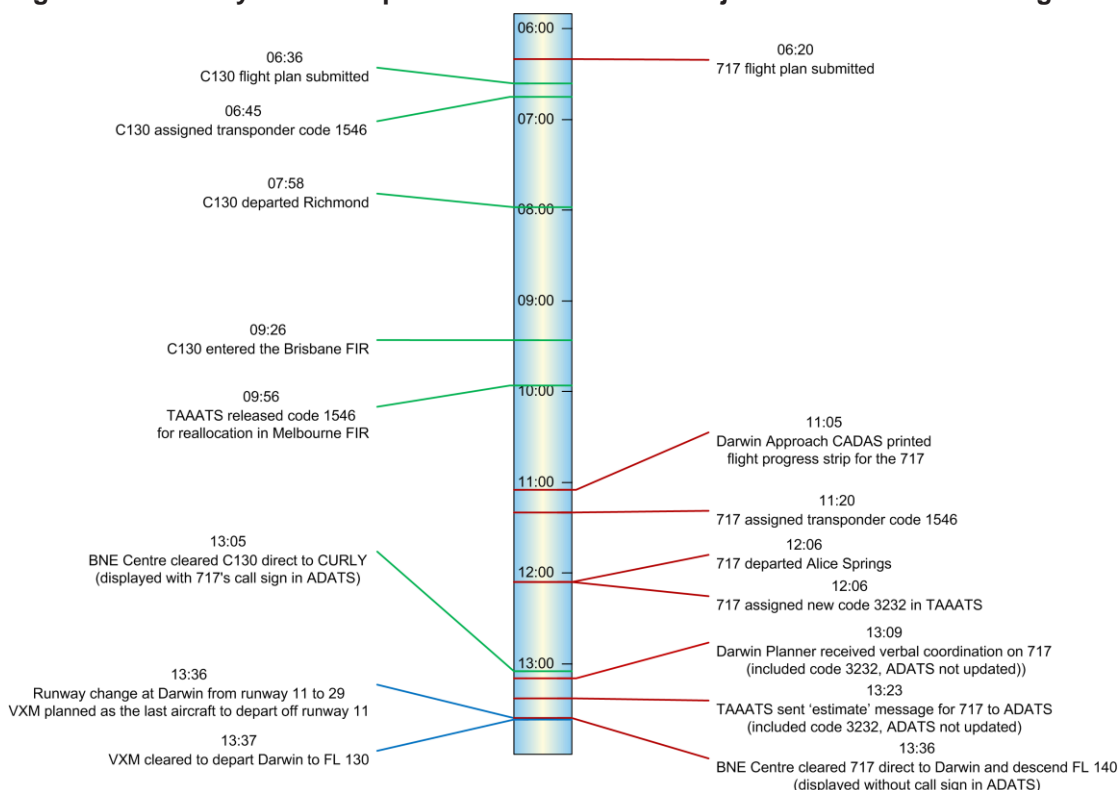
**Figure 1: Summary of events prior to transfer of control jurisdiction for the Boeing 717**

The main events associated with the occurrence, prior to the transfer of control jurisdiction for the 717 to Darwin ATC, are summarised in Figure 1 and are explained in more detail in the sections that follow.

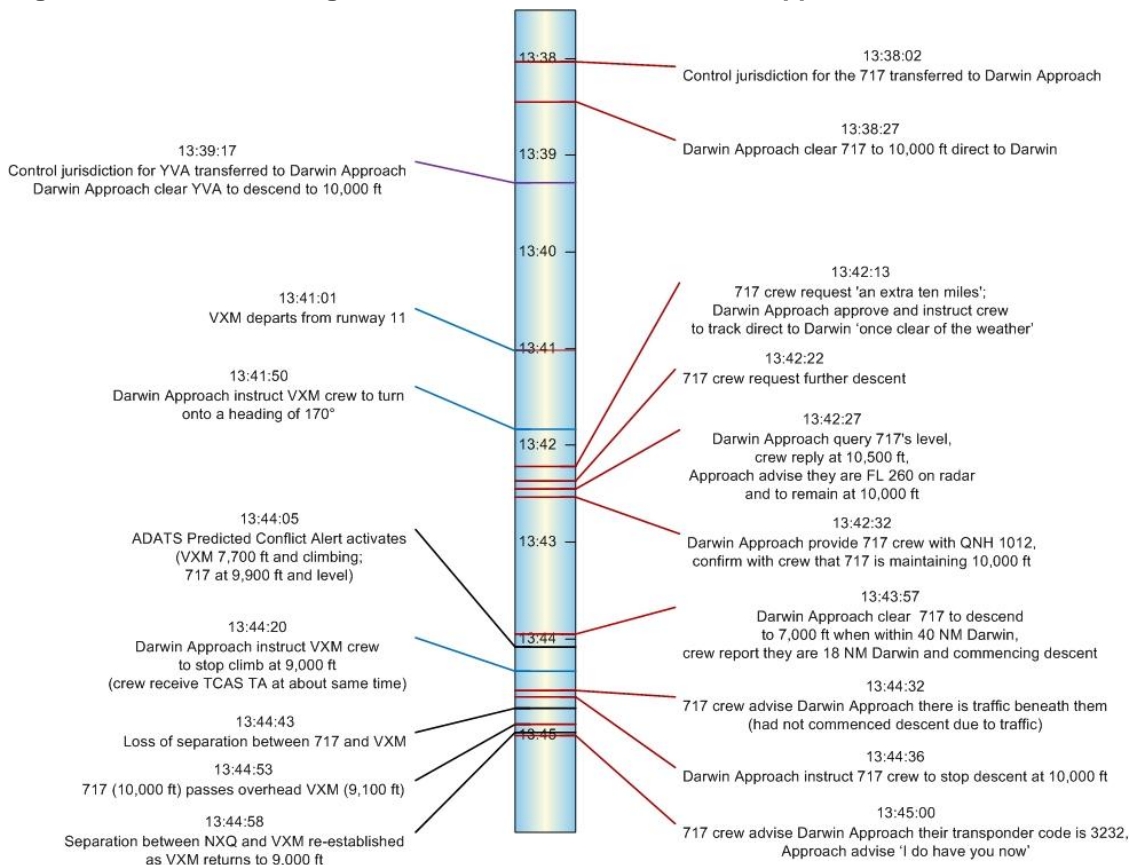
**Figure 5: Events following the transfer of the 717 to Darwin Approach**

The main events after the transfer of control jurisdiction for the 717 to Darwin Approach are summarised in Figure 5 and are explained in more detail in the sections that follow.

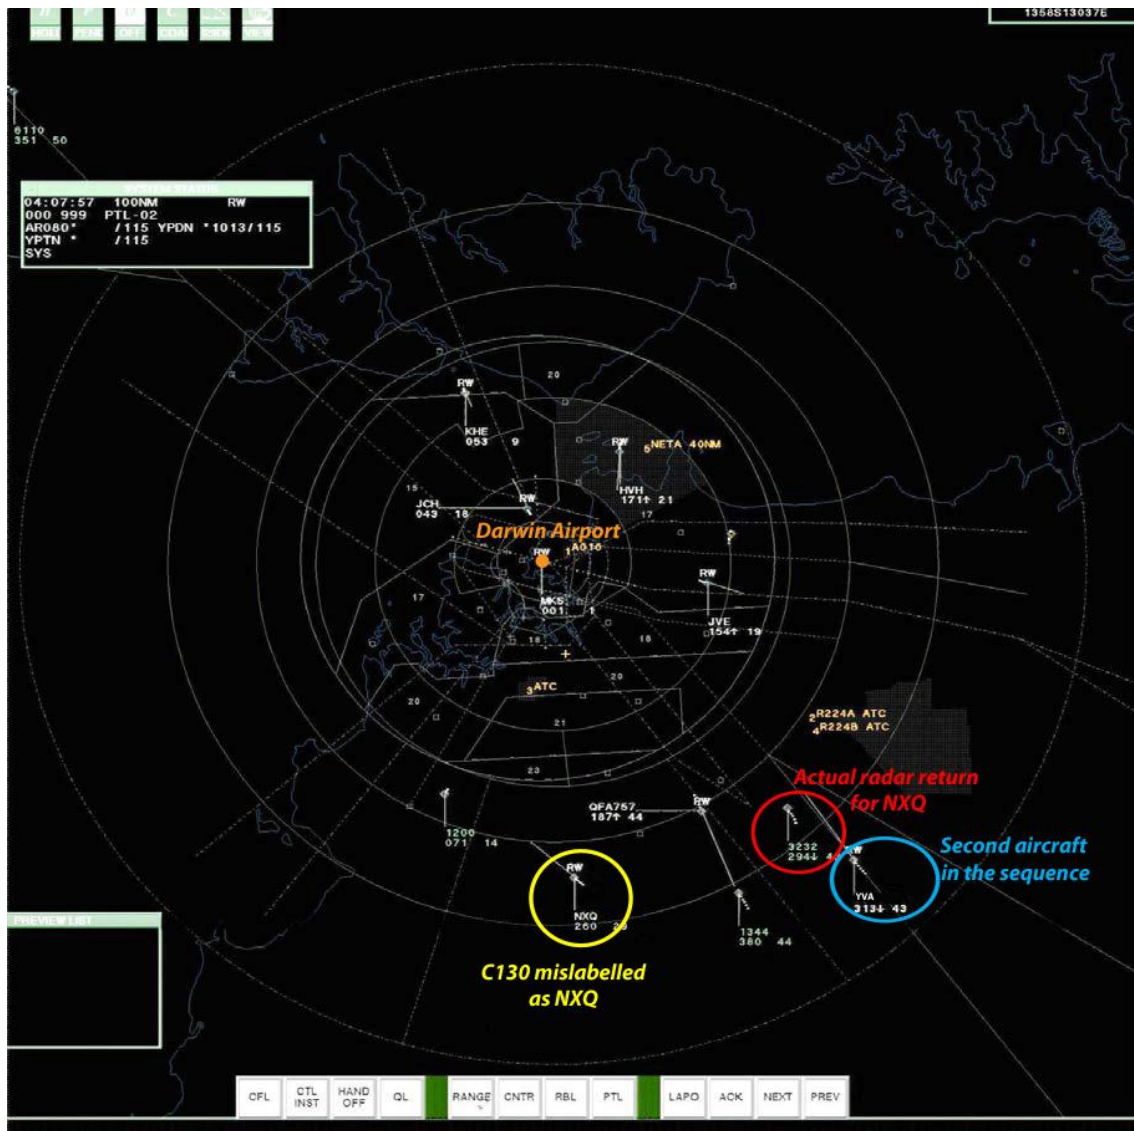
Figure 6: APR long-range display at 1337:57 on 100 NM (185 km) range

At 1338:02, the Brisbane Centre controller handed over control jurisdiction of the 717 to the Darwin APR controller. During the verbal radar handoff, the Brisbane Centre controller stated 'south east that is NXQ'. The handoff coordination was conducted by the Brisbane Centre controller in accordance with documented coordination requirements established with Darwin ATC. At that time, the 717 was 59 NM (109 km) to the south-east of Darwin descending through FL 292, and the C130 was 56 NM (104 km) to the south of Darwin maintaining FL 260 (Figure 6).

As the radar return for the 717 was outside the 45 NM (83 km) set range of the APR position's main situation data display (SDD), the APR controller referred to the supplementary long-range display to accept the transfer of control. The APR controller later reported that they observed the radar return labelled as 'NXQ' south of Darwin and assumed that the disparity between the 717's observed position and its expected position was due to the amended direct tracking instruction for runway 29 coordinated by the ASPR. After consultation with the ASPR, it was decided that YVA would be sequenced ahead of the 717, based on the perceived position of the 717 relative to an approach to runway 29.

Note: the range set on the APR situation data display at the time of the occurrence was 45 NM (83.3 km).

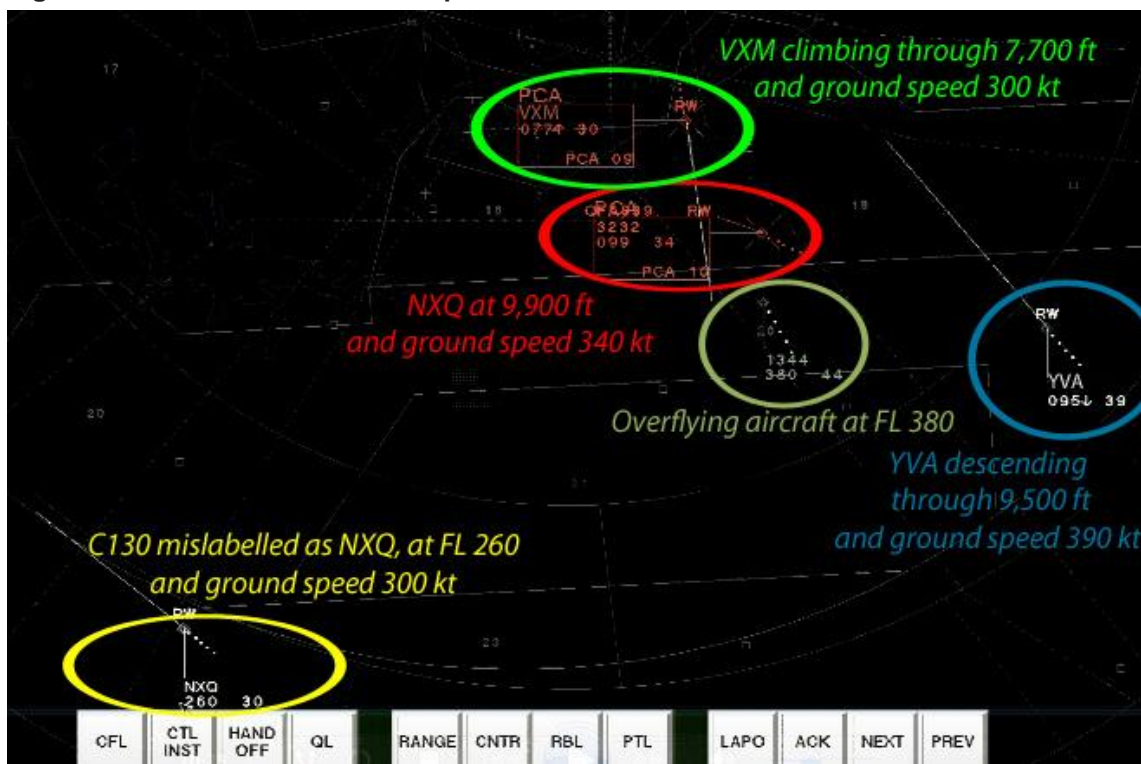
Figure 8: Activation of the ADATS predicated conflict alert at 1344:05

The APR controller reported that they thought the PCA was spurious so they initially disregarded it. The ASPR reported that they were mentally processing the information from transmissions between the 717's flight crew and the APR controller regarding the aircraft's reported position when they saw the PCA activate between VXM and the radar return squawking code '3232'. In response to the APR controller stating that it was a spurious alert, the ASPR instructed the APR controller to stop VXM's climb at 9,000 ft. At 1344:20, the APR controller instructed VXM's flight crew to stop their climb at 9,000 ft, as the aircraft's radar displayed altitude was 8,300 ft. No safety alert was issued and no traffic information was passed.

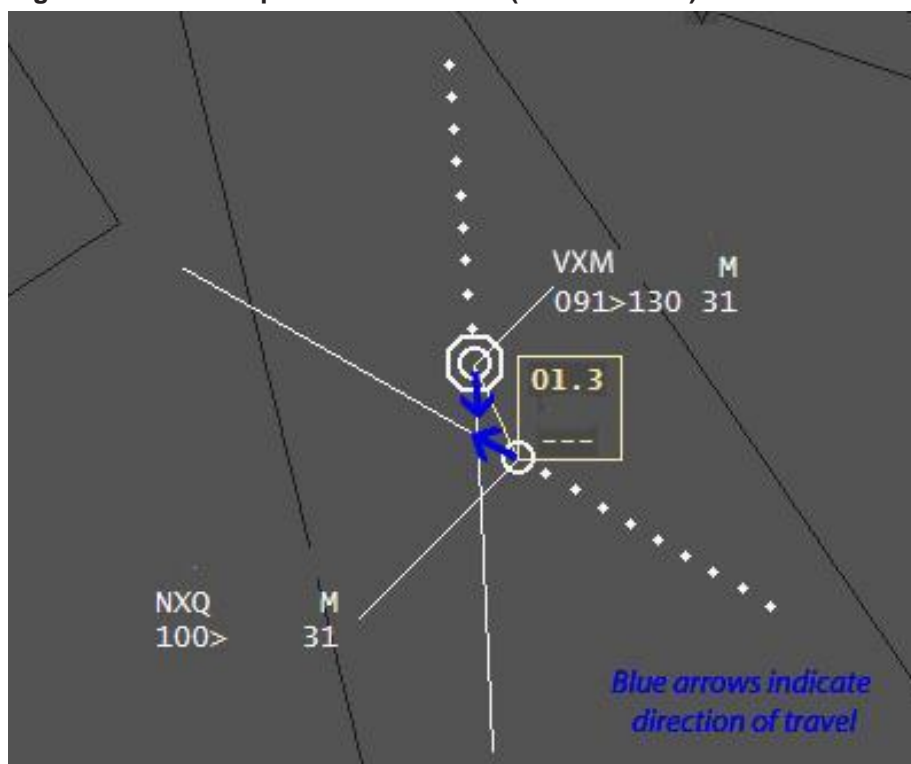
**Figure 9: Loss of separation at 1344:43 (TAAATS data)**

1,000 ft vertical separation or 3 NM (5.6 km) radar separation, there was a LOS. At 1344:45, the ADATS PCA changed to a conflict alert (CA).

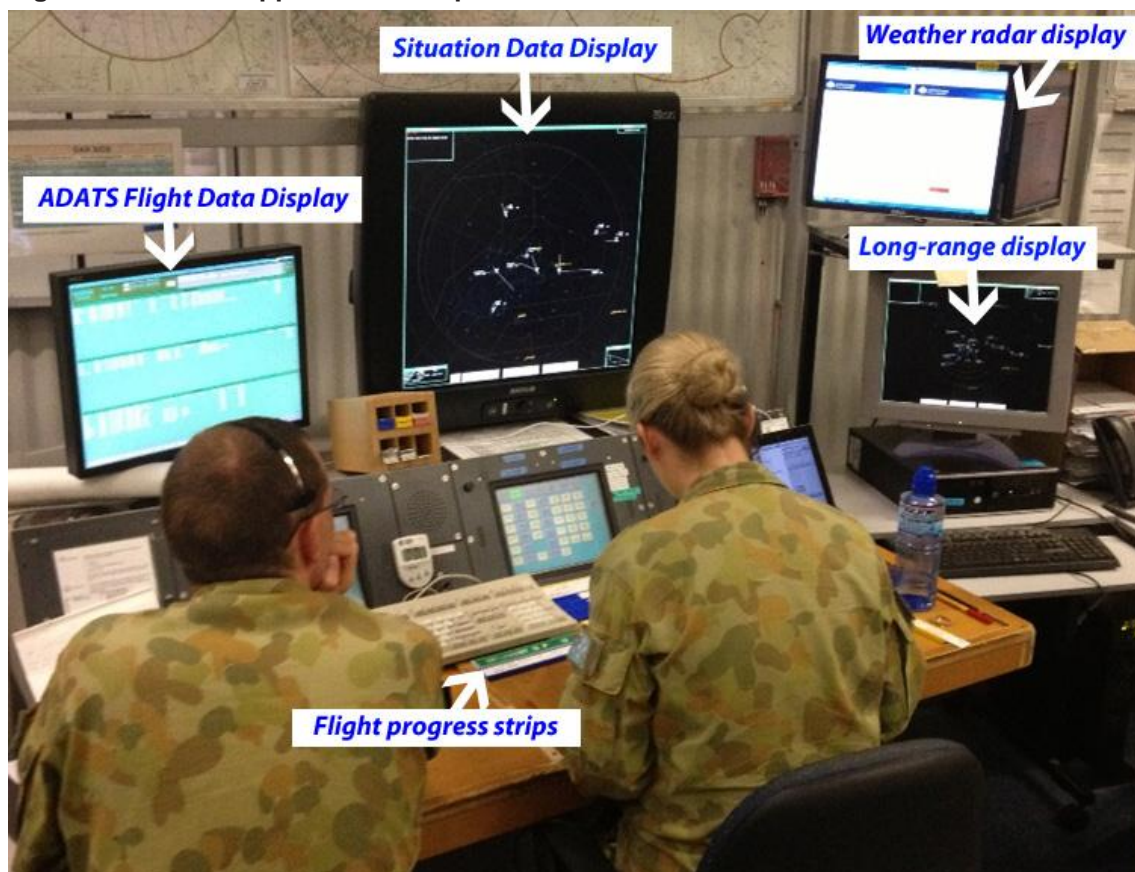
**Figure 10: Darwin Approach Radar position console**

The APR West console consisted of the main ADATS situational data display (SDD), flight data display (FDD), long-range display, weather radar display, flight progress strip board, communications facilities, portable electronic device (for the display of airport approach and departure procedures and aircraft type information) and flight progress strip bay (Figure 10).

A number of Darwin-based controllers reported that due to the low resolution and screen position, they found it difficult at times to see the details in aircraft labels on the long-range display. It was also reported that they found it more effective to increase the range of the SDD to view aircraft outside of their usual setting, as the targets and label details were more clearly defined. In addition, if controllers had aircraft under their jurisdiction that were operating outside of their usual SDD range, many but not all would increase the range on the SDD to ensure that those aircraft were visible. It was identified during the ATBS's investigation that some Darwin APR controllers were using the long-range display to accept aircraft.
