Aircraft cabin water leak event involving an Airbus A380, VH-OQD

near Los Angeles, USA, 2 July 2014

ATSB Transport Safety Report
Aviation Occurrence Investigation
AO-2014-116
Final – 15 October 2014

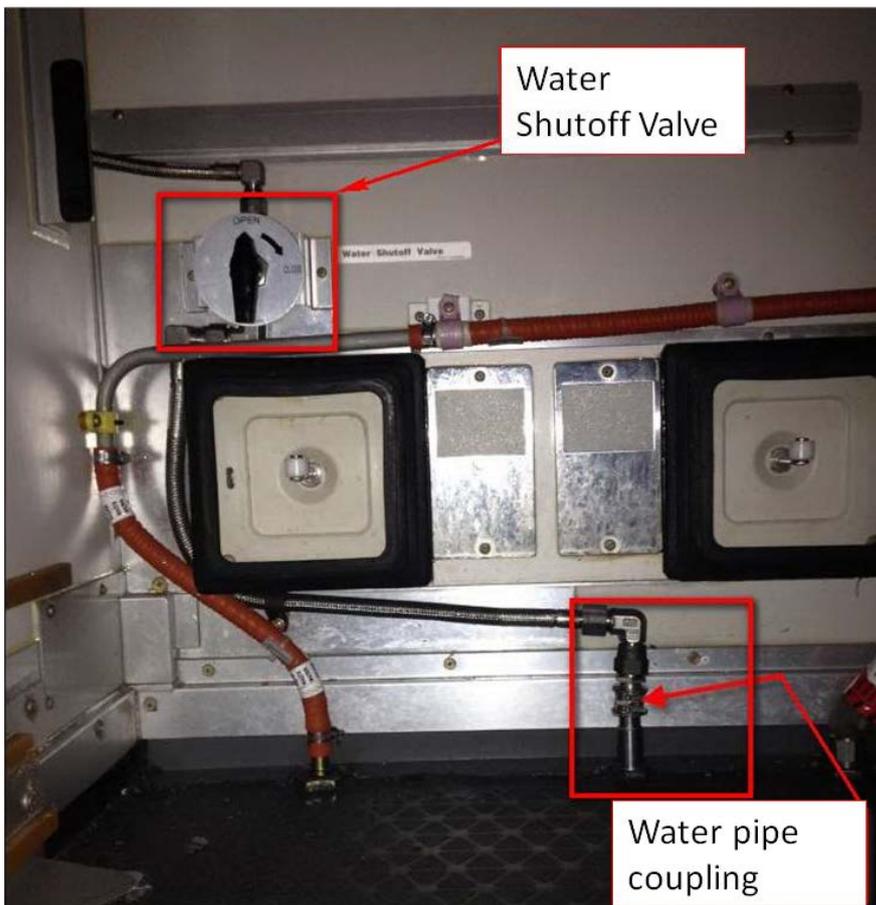
The cabin supervisor then entered that galley and pulled the carts forward to access and switch off the water shut off valve (Figure 1), but that did not stem the flow of water. The cabin attendant contacted the flight crew and alerted them to the situation. The cabin crew used blankets and pillows in an attempt to direct the water down the drain; however the water flow rate was too high and the water continued to flow into the aircraft cabin.

Figure 1: Galley shut off valve and clam shell location

A second officer went back into the cabin to determine how much water had leaked and confirmed that the valve was switched off. He advised the captain that there was quite a large flow of water coming from a loose water pipe coupling (Figure 1). The flight crew contacted maintenance watch ground staff who advised the crew that there was a main switch to the potable water on the flight attendants' panel (FAP). The cabin crew located the switch and selected it to 'OFF', which then stopped the water flow. The second officer observed the tank quantity indicator on the FAP

An initial engineering inspection found that the coupling that joins the water pipe at the floor level where the water supply enters the galley was unlatched.

There was evidence that the rope-style mops used by cleaners may have contributed to the coupling coming undone. Fleet-wide inspection of the fittings found strands of cleaning mops tangled in the brackets, with evidence of couplings rotated in opposing directions.

Within 72 hours of the incident, a fleet wide inspection of all Qantas A380 aircraft was carried out and temporary preventative action taken on all similar galley installations. Each clamp was inspected, cleaned and refitted and then tested with the water tanks pressurised. When nil leakage was ensured, the clamp was then protected.

As an interim measure and in consultation with Airbus, aluminium tape has been double wrapped around the couplings to avoid the likelihood of unintentional disturbance. The aircraft are to be cleaned under the galley bench areas using sponge style mops instead of cotton rope mops.

A subsequent fleet wide inspection will be carried out on 14 September 2014. At this inspection, Qantas proposes fitment of lock-wire to prevent the clamp coming adrift.
