# Ground collision with a refuelling vehicle, involving a Grob G-115, VH-ZYM

Jandakot Airport, Western Australia, 6 June 2014

**ATSB Transport Safety Report**  
Aviation Occurrence Investigation  
AO-2014-104  
Final – 15 October 2014

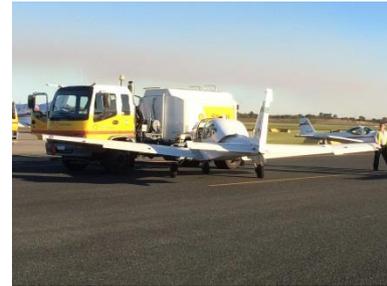
**VH-ZYM and fuel vehicle**

Shortly after, the aircraft's left wing struck the front grille of the vehicle and the aircraft swung rapidly left. The student quickly applied the brakes, and the aircraft came to a stop with the propeller a few centimetres from the truck's diesel tank (Figure 2). The diesel tank was located directly beneath an 8,450 L Avgas tank. The fuel vehicle operator had seen the aircraft taxiing in, and realising a collision was imminent, had pressed the emergency stop button to stop the flow of Avgas through the refuelling hose. He ran around the front of the truck and called to the pilot to shut down the aircraft. He also sought assistance from nearby students to help convey that message. About half a minute later, the student (who later reported being in shock) shut down and then exited the aircraft. The student pilot was not injured; however, the aircraft and fuel vehicle sustained minor damage.

The fuel vehicle was parked about 1.5 -2 metres off the taxilane for that taxiway, and the taxiway was about 10 metres wide.

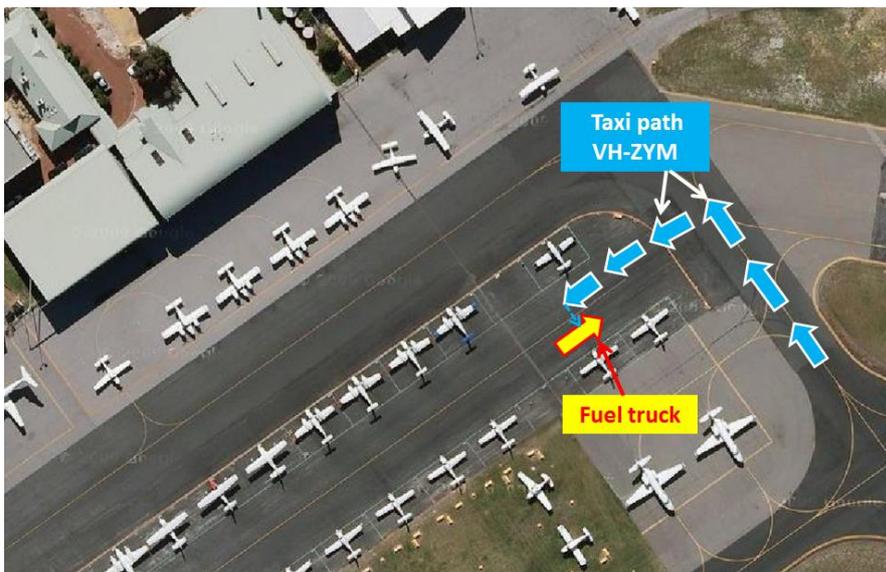
**Figure 1: Jandakot Airport southern apron parking area**

The flight progressed without incident, and after landing at Jandakot, the crew taxied the aircraft to company parking on the southern apron (Figure 1). The student then had a break for lunch.

At the completion of the solo circuits, at about 1530 western standard time (WST), the student taxied back to the southern apron, to park the aircraft. As the aircraft arrived at the company parking area, the student saw the fuel truck operator refuelling an aircraft on the left side of the taxiway. He assessed that there was sufficient room to taxi past the vehicle, and entered this taxiway, with the vehicle on his left (Figure 1).
