Breakaway of *Grand Pioneer* and *AAL Fremantle*

Port of Fremantle, Western Australia | 17 August 2014

ATSB Transport Safety Report
Marine Occurrence Investigation
313-MO-2014-009
Preliminary – 21 October 2014

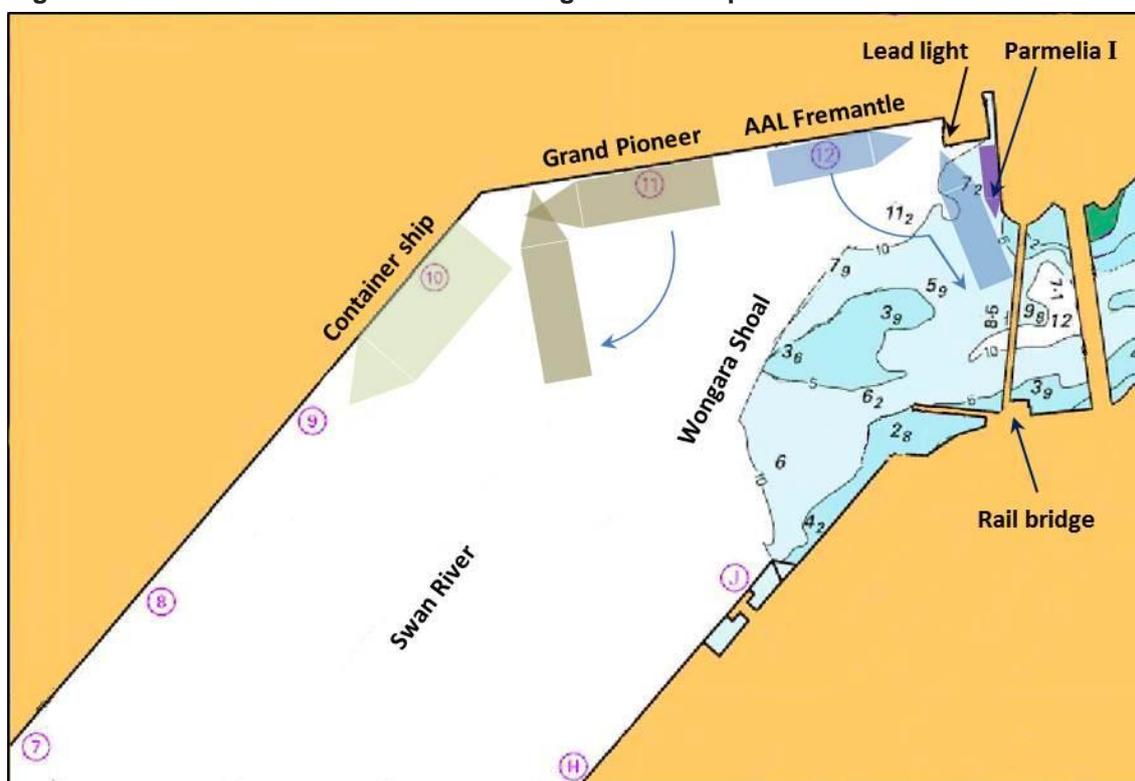
Figure 1: Section of chart Aus 113 indicating berthed ships and their later movement

At 1712¹ on 17 August 2014, the 190 m long car carrier, *Grand Pioneer*, berthed in Fremantle at berth 11 (Figure 1). Berthed astern of the car carrier was the 140 m long general cargo ship, *AAL Fremantle*, loading and unloading cargo using its two, port side mounted cranes.

By 2210, *Grand Pioneer* had swung until its port shoulder was about 15 m from the container ship at berth 10 (Figure 1). *Grand Pioneer's* head lines and forward spring lines had held and its port anchor was let go. The bow thruster and main engine were used to maintain the ship's position.

At 0115, two tugs had been made fast to *AAL Fremantle*. As there was insufficient water over Wongara Shoal (Figure 1) for the aft tug to manoeuvre close to the ship, its line was attached to a ship's mooring line.

By 0300, *AAL Fremantle* was all fast at berth H (Figure 1).

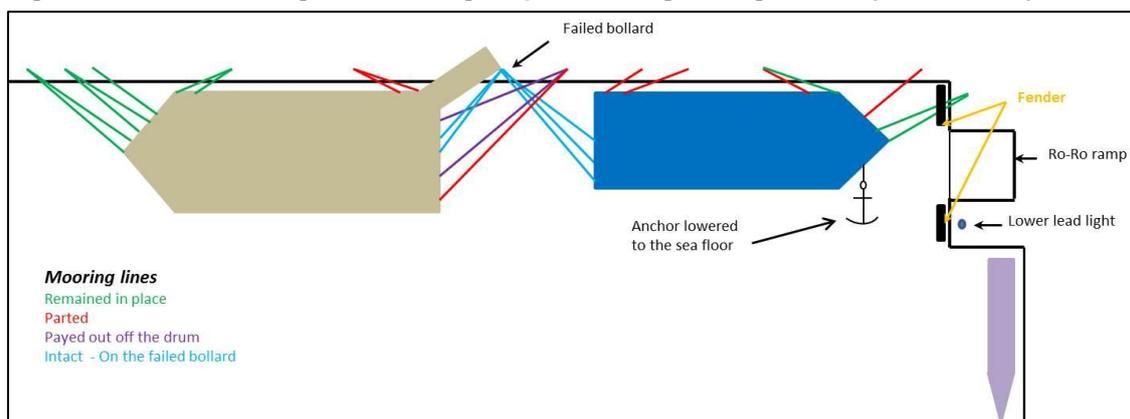
Figure 2: Indicative diagram showing ships' mooring arrangements (not to scale)

In his cabin, *AAL Fremantle's* master heard the sudden rise in wind speed. From the aft facing cabin window, he saw the ship's stern moving away from the wharf and the three stern lines could no longer be seen (Figure 2). Concerned, the master immediately went to the bridge and started preparations to manoeuvre the ship.

During the sudden weather event, the bollard that had held all three of *AAL Fremantle's* stern lines and two of *Grand Pioneer's* stern lines broke away from the wharf and fell into the water. Other mooring lines on both ships had also parted or payed out, resulting in both ships breaking away from the wharf.

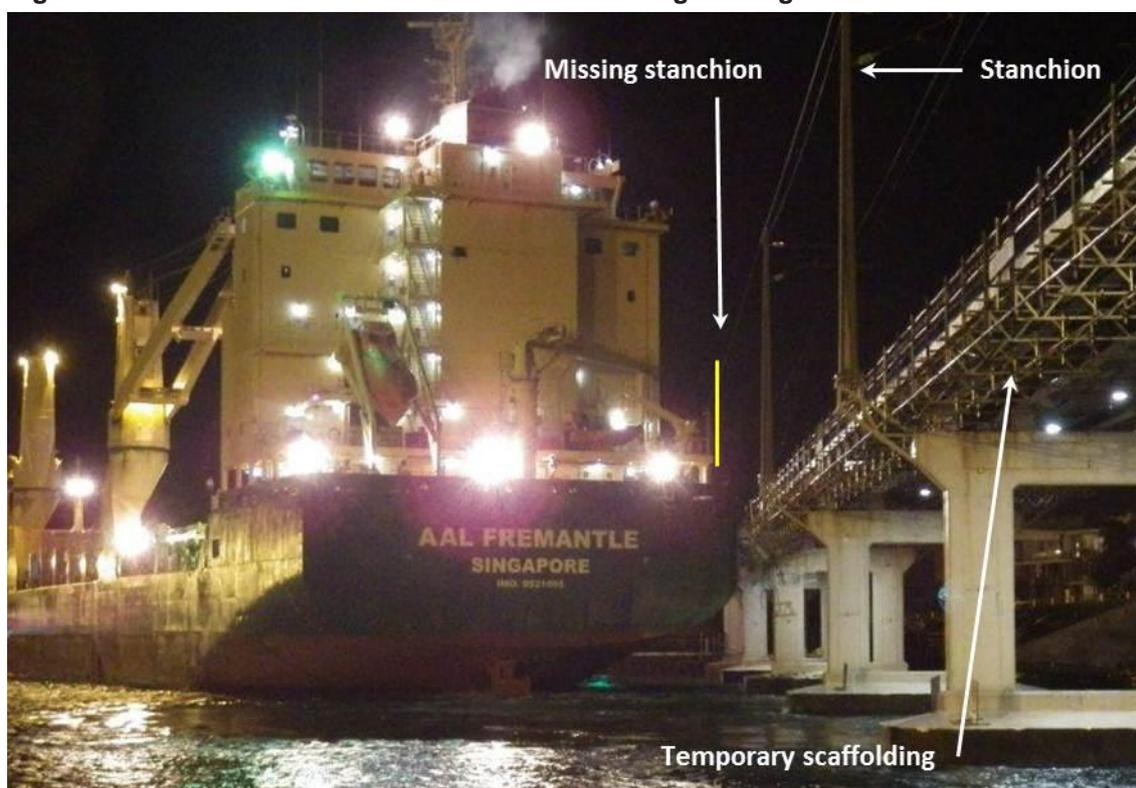
Figure 3: *AAL Fremantle* near the Fremantle rail bridge during the incident

At 2208½, *AAL Fremantle's* starboard quarter struck a stanchion⁵ on the Fremantle rail bridge and brought it down. Temporary scaffolding on the side and under the bridge was damaged, and the track's alignment was disturbed (Figure 3). Moments later, *AAL Fremantle's* hull, about midships, contacted the starboard shoulder of the bunker barge, *Parmelia I* (Figure 1), and then stopped moving astern. *AAL Fremantle's* two remaining head lines were slack but the remaining forward spring line was still under tension.
