Engine room fire on board the bulk carrier *Marigold*

Port Hedland, Western Australia, 13 July 2014

ATSB Transport Safety Report
Marine Occurrence Investigation
312-MO-2014-008
Preliminary – 23 October 2014

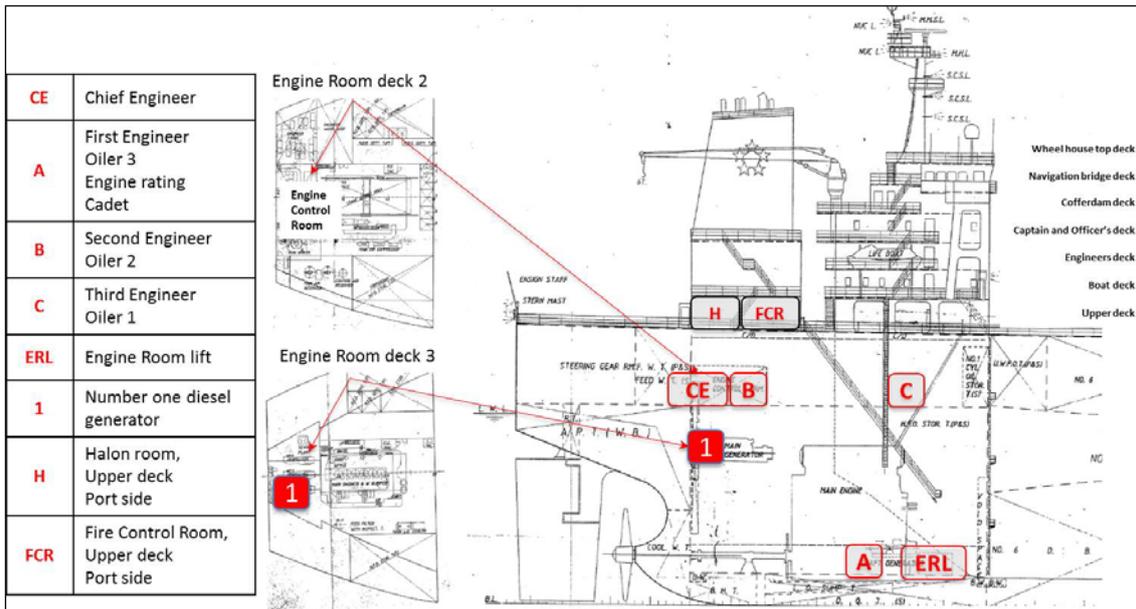
Figure 2: Diagram showing crew locations in the engine room when the fire started

At 1453, the chief, first, second and third engineers and oiler 2 left the engine room through the steering gear room (Figure 2). Oiler 1 took a different exit route and came out through the forward funnel door. He was the last crew member to be accounted for at the muster stations.

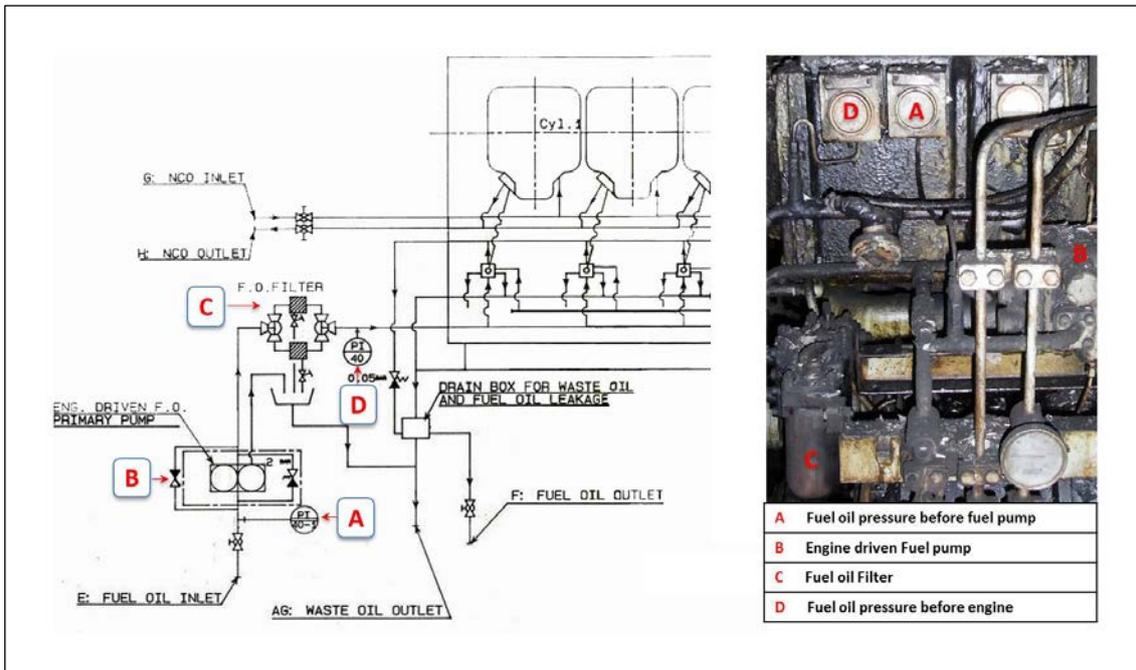
Figure 3: Diesel generator fuel oil supply system

On 13 July, a fire started in the engine room of *Marigold* while the ship was berthed at Port Hedland. The evidence indicates that a fuel oil pipe coupling on number one diesel generator had failed. Pressurised fuel oil and mist from the coupling ignited and resulted in a fire around the generator turbocharger.

The generator fuel system (Figure 3) included a feed pump to supply fuel oil from a service tank. A camshaft-driven low pressure fuel pump supplied fuel to the main injection pumps via a duplex filter. The condition of the fuel filters was monitored by two pressure gauges (as shown in Figure 3) to indicate the fuel pressure before and after the filter.

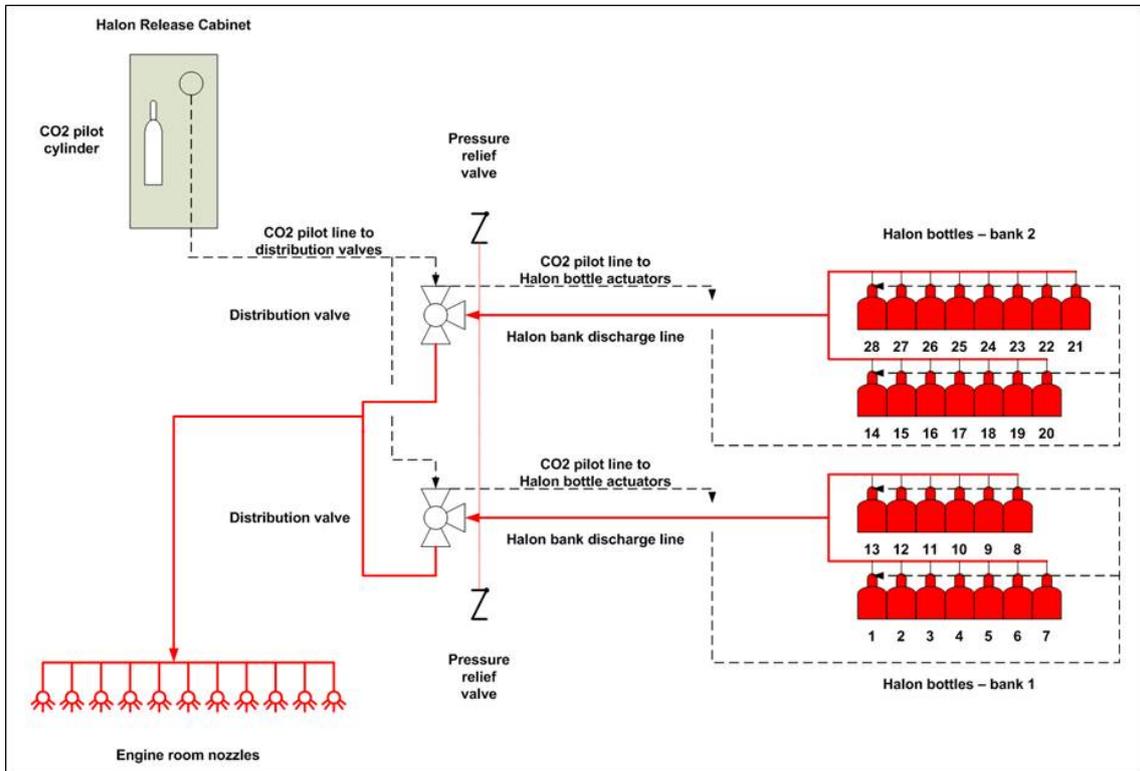
Figure 4: *Marigold's* Halon fire suppression system

At 2233, *Marigold*'s master and chief engineer, accompanied by the pilots, inspected the Halon room. They found that of the two banks of Halon bottles, one bank had been partially released and the other bank had not been released at all. They also found that only one of the two Halon gas distribution valves to the engine room had opened. The chief engineer attempted to manually release the remaining Halon bottles but was unsuccessful.

Attempted firefighting measures included deploying the ship’s Halon gas fixed fire suppression system for the engine room. However, a full release of Halon gas did not occur and the engine room was not properly closed. Consequently, the fire continued for about 12 hours until it burnt itself out.

The Halon was stored under pressure in two banks of cylinders in the Halon room, located on the port side of the upper deck (Figure 2). The system was designed to simultaneously discharge gas into a common manifold system leading to the engine room Halon discharge nozzles.
