# A flight navigation instrument event, involving a Beech 1900, VH-YOA

13 km north of Kingscote Airport, South Australia, 19 March, 2014

**ATSB Transport Safety Report**  
Aviation Occurrence Investigation  
AO-2014-066  
Final – 3 December 2014

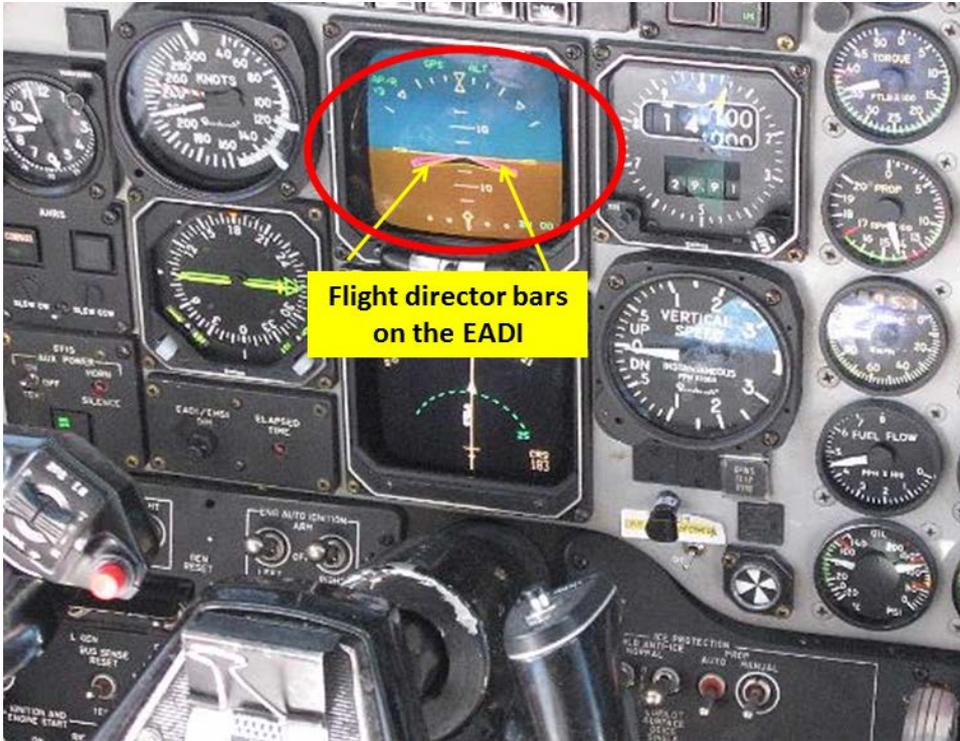
**Figure 1: Rockwell Collins Electronic Attitude Director Indicator (EADI)**

During the test de-briefing, the CASA officers queried why the flight director (FD) bars on the Rockwell Collins electronic attitude director indicator (EADI) (Figure 1), which the FO was following, were not agreeing with the information presented by the Bendix King KLN90B Global Positioning System (GPS) (Figure 2). The course direction indicator (CDI)<sup>3</sup> linked to the GPS, was about half scale deflection out, when the flight director bars were followed. A disconnect between the information given by the FD bars, and that given by the GPS, occurred when the GPS re-scaled<sup>4</sup> in the latter part of the approach. As the majority of the company flight crew reported not engaging the flight director bars when conducting an RNAV approach, the issue had not been previously identified.

1900D aircraft, erroneous information was presented to the flight crew when the FD bars were selected. The crew reported that sometimes the error was from the captain's flight director, and sometimes from the first officer's. The only consistency was that the fault occurred when the GPS was re-scaling during the latter part of the approach. It was determined that there was no error with the KLN90B GPS.

Company procedures have been amended to preclude the use of RNAV approaches with the FD selected.
