Safety summary

On 12 September 2013, a twin-engine Beech Aircraft Corporation, Model 200 Super King Air was conducting a passenger charter flight from Utirik Atoll to Marshall Islands International Airport (Majuro Atoll). About 40 minutes into the flight, while in cruise to the destination, the pilot observed abnormal oil pressure indications for the left engine and approximately 2 minutes later the engine failed. The crew secured the engine and elected to continue with the original flight plan. The aircraft landed at Majuro Atoll without further incident.

The Beech Aircraft Corporation, Model 200 Super King Air, registered VH-ZMP, serial number BB-259, was manufactured in the United States in 1977 and first registered in Australia in 1988. At the time of the occurrence, the aircraft had accumulated 18,964 hours total time in service. Aircraft propulsion was provided by two Pratt and Whitney Canada (P&WC) PT6A-41 turboprop engines.

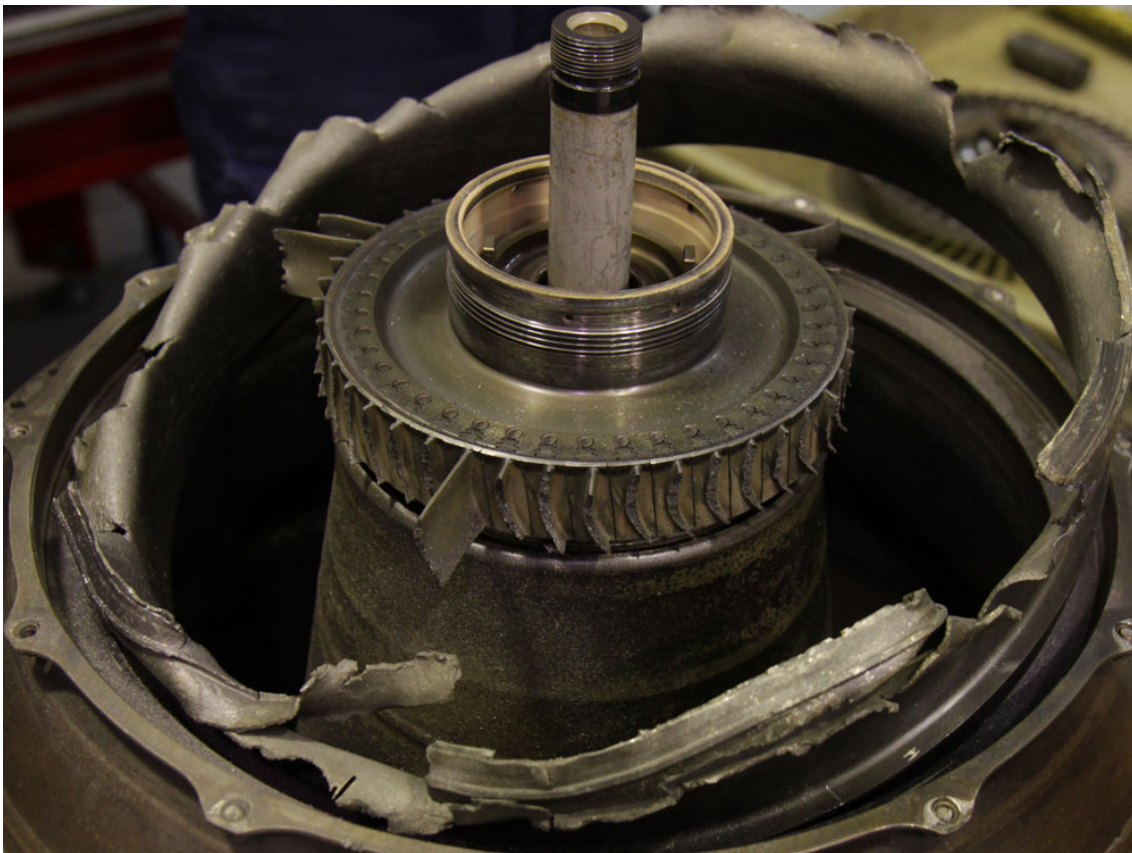
Figure 3: Second-stage power turbine disk

- Most of the blades from the second-stage power turbine disk had fractured and released at their base at the blade platform (Figure 3). The fracture surfaces of the remnant blade stubs were consistent with failure by overstress with no evidence of any pre-existing defects or progressive crack growth. The power turbine housing successfully contained the released blades.

The fatigue failure and subsequent breakdown of the first-stage sun and planet gear teeth in the reduction gearbox from the occurrence engine resulted in the above-described disconnection between the power turbine and propeller reduction gearbox. This led to an immediate 'loss of load' of the power turbine, allowing it to accelerate and shed its blades due to the resulting overstress.

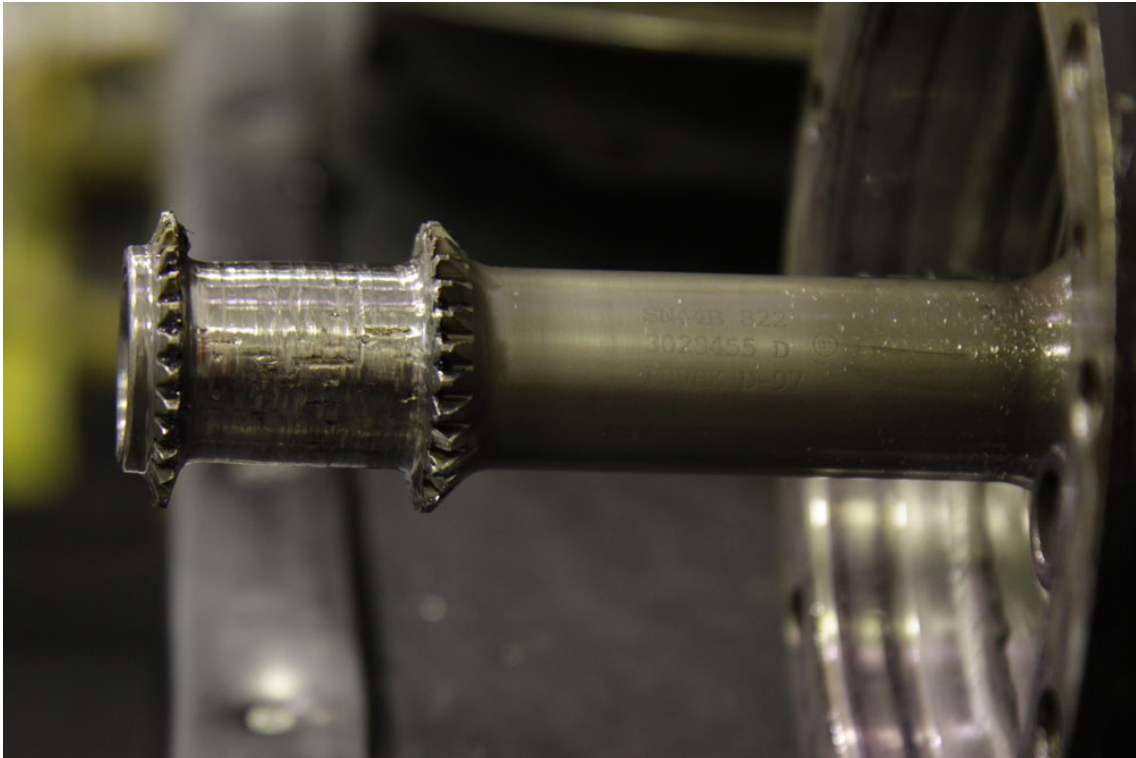
Figure 4: Remnant first-stage sun gear

- Within the reduction gearbox:
 - All of the teeth on the first-stage sun gear had been effectively ‘machined’ from the shaft (Figure 4).
 - All three first-stage planet gears showed significant deformation and chipping of the gear teeth, some of which had fractured by a fatigue cracking mechanism (Figure 5 and Figure 6).

- The engine failure resulted from fatigue cracking and accelerated breakdown of the first-stage sun and planet gears in the propeller reduction gearbox that led to a subsequent loss of load and consequential overspeed of the second-stage power turbine.

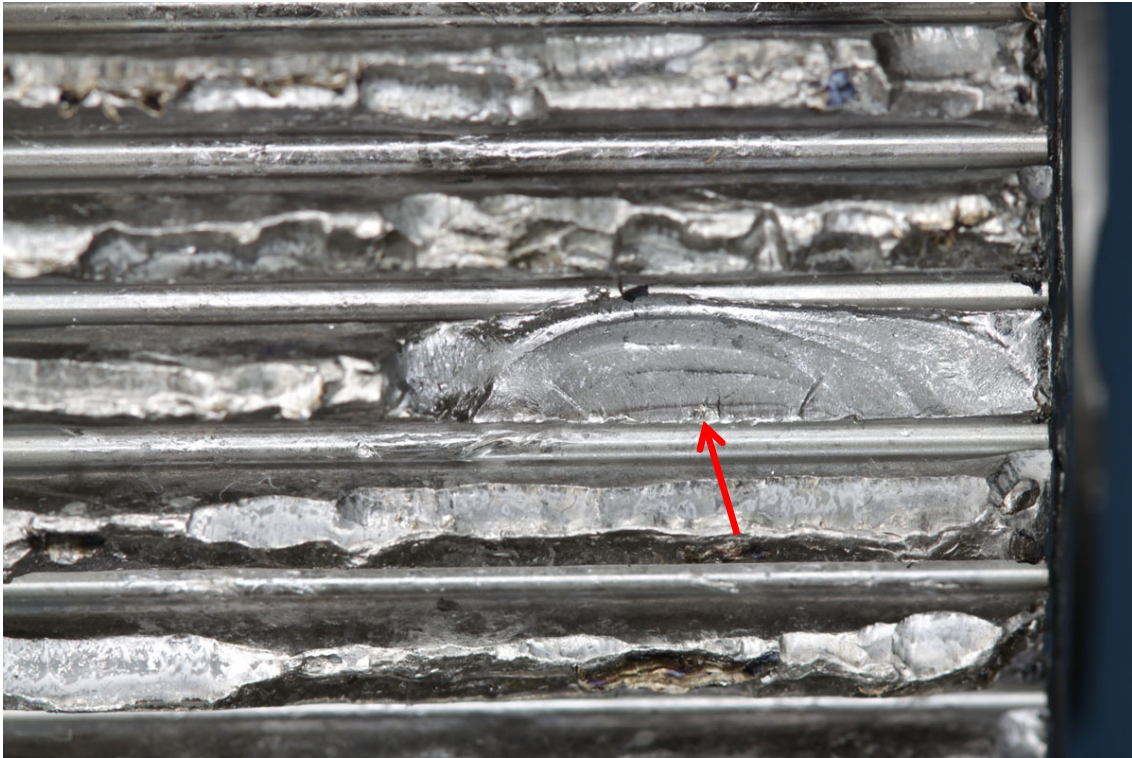
Figure 6: Example of fatigue cracking (arrowed) on a first-stage planet gear tooth

A metallurgical examination of the recovered engine components showed that several teeth from each first-stage planet gear within the reduction gearbox had failed due to the initiation and propagation of fatigue cracking. The examination also showed that virtually no remnants of the contact portion of teeth from the mating sun gear remained. No identifying features that could have initiated the cracking, such as corrosion pitting, excessive wear or mechanical damage, were observed around the fatigue crack origins from the planet gears. The appearance and location of the fatigue cracks in the tooth fillet radius was consistent with exposure to cyclic bending loads.

A comprehensive review of the available maintenance documentation for the engine revealed that the failed first-stage sun gear and planet gear set had accumulated 12,426 hours total time in service and 10,216 cycles. In the absence of any identified contributory defect, maintenance or operational issues, it was probable that the development of the fatigue cracking was related to their high time in service and that the gears had reached the end of their fatigue life.

The discrepancy in first-stage reduction gear service life was subsequently addressed by the manufacturer's September 1999 introduction of the mandatory requirement to replace the first-stage reduction gears at every overhaul. However, engines that have not been overhauled since 1999 (including the subject engine) could still be operating with first-stage reduction gears in excess of the 12,000 hour life limit, while still complying with AD/ENG/5 Amdt 9 and the manufacturer's baseline TBO requirements. Pratt and Whitney Canada (P&WC) have indicated that, based on the current rate of in-flight shut downs (one per 10,000,000 flight hours) relating to reduction gear deterioration, and provided that the engine is maintained in accordance with P&WC's instructions for continuing airworthiness, there is no immediate action required in these situations. Nevertheless, the ATSB encourages operators and maintainers of affected engines to review their maintenance records and give consideration to the replacement of high-time gearsets.

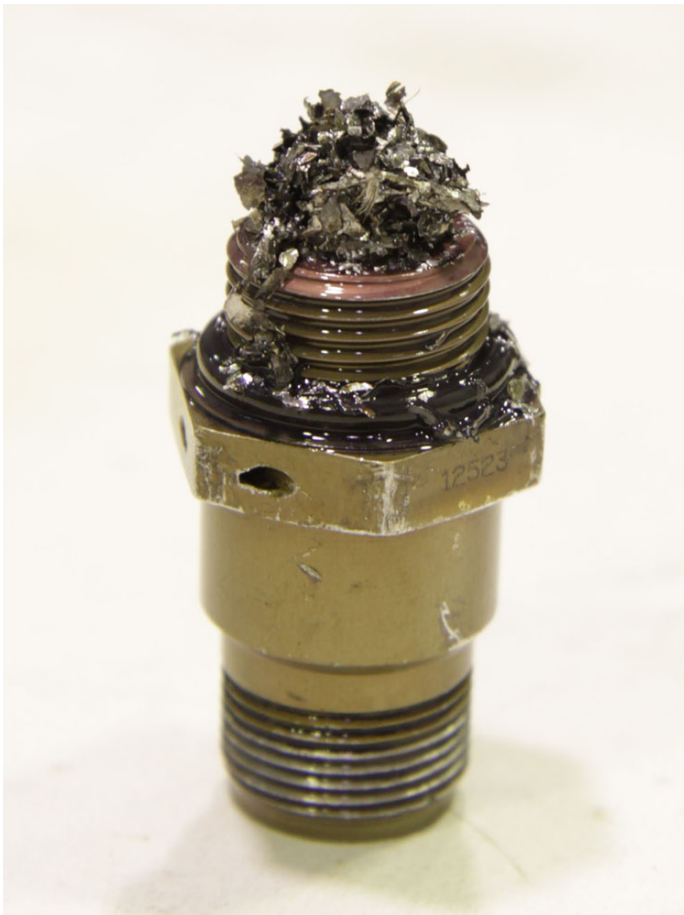
Figure 7: The contaminated magnetic chip detector plug

- The reduction gearbox magnetic chip detector and sump screen had captured a significant quantity of metallic debris (Figure 7). Subsequent analysis revealed the captured debris to be similar in composition to the alloy used in the reduction gear set.

Engines experiencing an accelerated rate of failure may trigger momentary or intermittent illumination of chip detector warning lights, or popped circuit breakers with no associated chip detector light, resulting from the rapid build-up of large amounts of metallic debris. This scenario was considered a likely explanation for the lack of an otherwise expected chip detector warning light prior to the subject engine failure.
