Operational event involving an Airbus A320, VH-VNQ

Hobart Airport, Tasmania, 15 February 2014

ATSB Transport Safety Report
Aviation Occurrence Investigation
AO-2014-042
Final – 23 December 2014

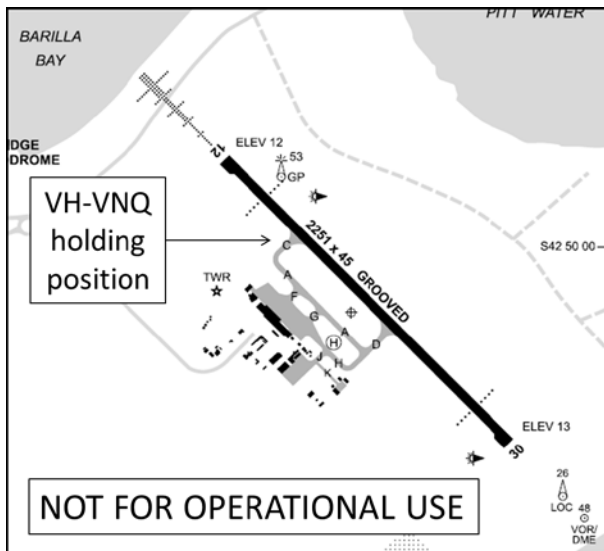
Figure 2: Hobart airfield diagram illustrating VH-VNQ's holding position (holding point Charlie)

With thunderstorms in the area, the captain elected to delay departure and wait at holding pilot Charlie for the weather to clear (Figure 2). The weather proved more persistent than anticipated, resulting in a delay of about 75 minutes, while the crew continued to wait at the holding point.

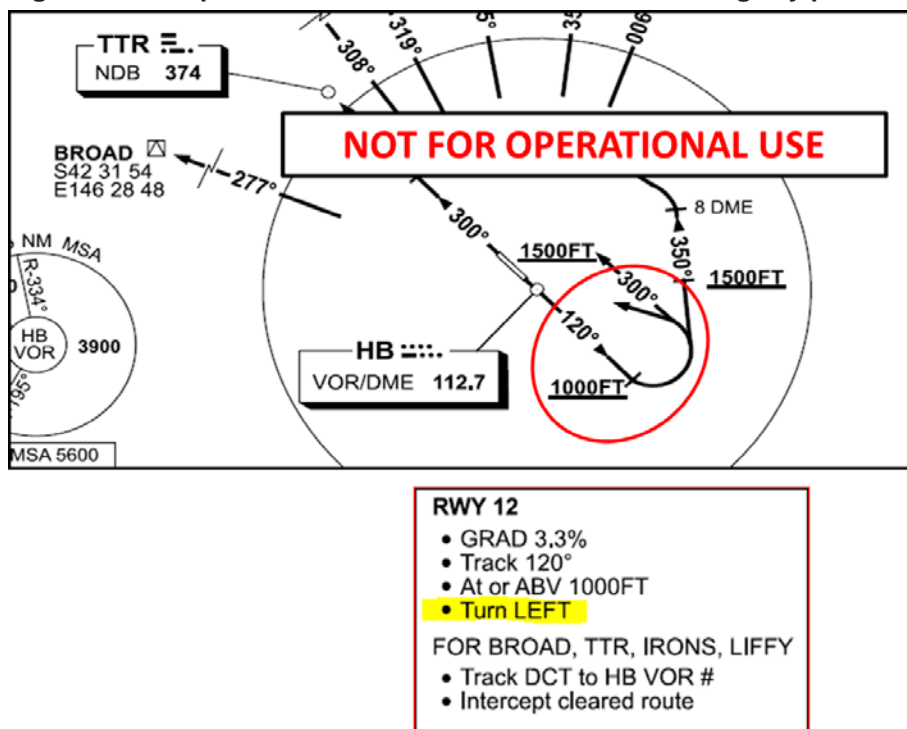
Figure 3: Excerpt from the Hobart SID North chart showing key points of the TTR One SID

At about 2140, satisfied that the weather had cleared sufficiently to facilitate a safe departure, the crew entered the runway and back-tracked toward the threshold of runway 12. As they back-tracked on the runway, the crew were able to build a better appreciation of the weather to the north of the airport and along the intended departure route. The captain discussed the weather and departure options with Air Traffic Control (ATC), and the crew were subsequently re-cleared to conduct the Tea Tree (TTR) One SID (Figure 3).

The initial part of the TTR One SID required that the aircraft climb straight ahead after take-off, before making a left turn at or above 1,000 ft. Upon loading the TTR One SID into the FMGS however, the crew noticed that the navigation display⁵ indicated a right turn during the departure, contrary to the left turn required by the published procedure. The captain was aware that all Hobart runway 12 SIDs required a left turn after take-off to avoid high terrain to the west, and that the indicated right turn was clearly incorrect.

In an attempt to clear the anomaly, the captain selected the reciprocal runway (runway 30) in the FMGS as the departure runway, before re-selecting runway 12. This was unsuccessful, and the navigation display continued to indicate that a right turn was required during the departure.

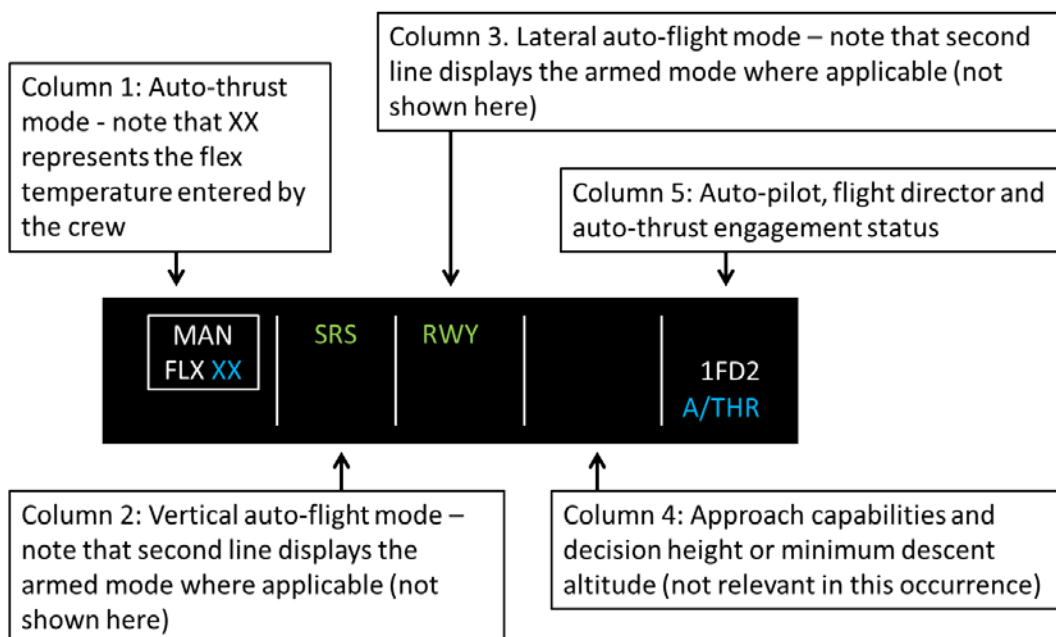
Figure 4: Representation of typical FMA indications during a flex temperature take-off when the thrust levers are set to the FLX/MCT detent

- The crew noticed that flight mode annunciator (FMA)⁸ indications were not as they would normally appear during a flex temperature take-off when the thrust levers are set to the FLX/MCT detent (Figure 4):

- Auto-thrust mode (column 1) normally displays MAN FLEX XX (where XX represents the flex temperature entered by the crew). In this case, available data indicates that no auto-thrust mode information initially appeared on the FMA.

- Vertical auto-flight mode (column 2) normally displays SRS (speed reference system), which provides guidance to maintain speed within defined parameters after take-off. In this case, available data indicates that no vertical auto-flight mode information initially appeared on the FMA.

- Lateral auto-flight mode (column 3) normally displays RWY (runway) which provides guidance with respect to the runway centre-line during take-off.⁹ In this case, available data indicates that no lateral auto-flight mode appeared on the FMA until the thrust levers were further advanced as the take-off continued (see following account).

- Column 5 normally indicates that both flight directors are engaged (1FD2) and that the auto-thrust system is armed (A/THR appears in blue). In this case, available data indicates that both flight directors were engaged as normal (although the flight director bars do not appear on the primary flight displays until the corresponding vertical or lateral mode is active), but the auto-thrust system status annunciation initially remained blank (the auto-thrust system did not arm as it normally would when the thrust levers were advanced).

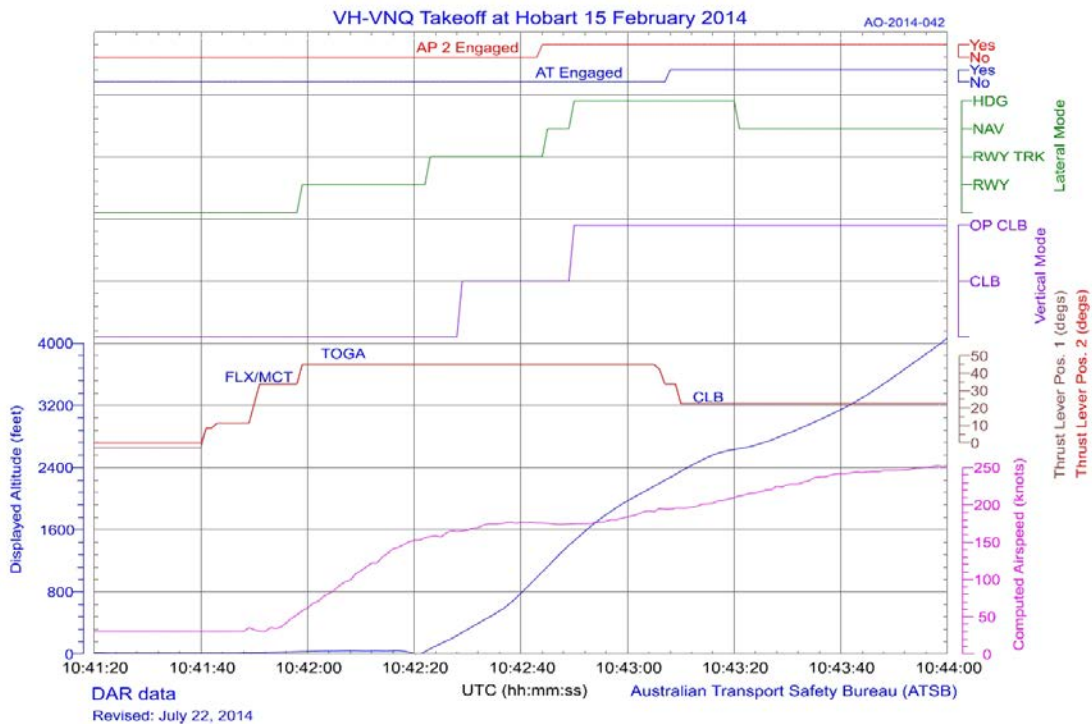
Figure 5: Flight data illustrating selected parameters and auto-flight guidance modes

During the initial part of the climb, the aircraft continued to accelerate, before the speed stabilised at about 175 kt. While the initial climb speed of the aircraft was higher than the speed that would have been commanded by SRS guidance had that mode been active, the initial climb angle still substantially exceeded the minimum climb performance requirements. The crew allowed the aircraft to accelerate further passing about 2,000 ft, following which the thrust levers were retarded to the climb (CLB) detent. The auto-thrust system was armed by the crew as the thrust levers were retarded, and sequenced to active when the thrust levers reached the CLB detent.¹¹ The crew re-engaged NAV mode as the aircraft climbed through about 2,700 ft and the flight to Melbourne continued uneventfully. A graphical representation of some relevant flight parameters, thrust lever position and auto-flight system modes is included below (Figure 5).
