Loss of control involving a Robinson R44, VH-NUZ

170 km N of Derby (Montgomery Reef), Western Australia, 15 September 2013

ATSB Transport Safety Report

AO-2013-156

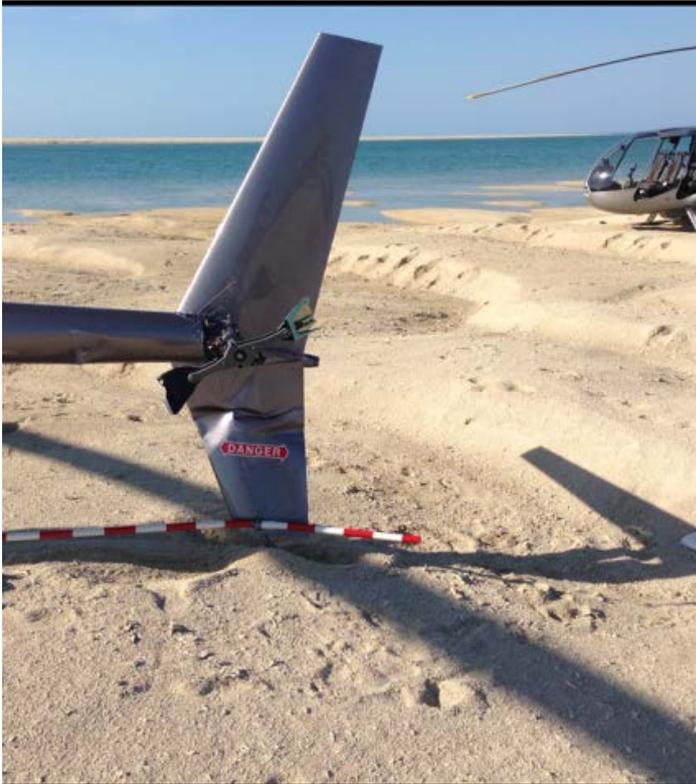
Figure 1: Damage to the tail assembly

The direction that the helicopter rotated could not be ascertained by the pilot or witnesses. The pilot and bystanders were not injured but the helicopter sustained substantial damage as a result of the hard landing. A subsequent inspection revealed that both tail rotor blades had broken off near the tail rotor hub, the vertical fin lower section and tail rotor guard were damaged, the tail rotor gearbox mounts had detached from the tail boom at two places and the landing gear skids were splayed (Figure 1).
