Collision with terrain involving a Robinson R44, VH-HLB

126 km ESE of Tindal Airport, Northern Territory on 23 September 2014

ATSB Transport Safety Report
Aviation Occurrence Investigation
AO-2014-154
Final – 23 December 2014

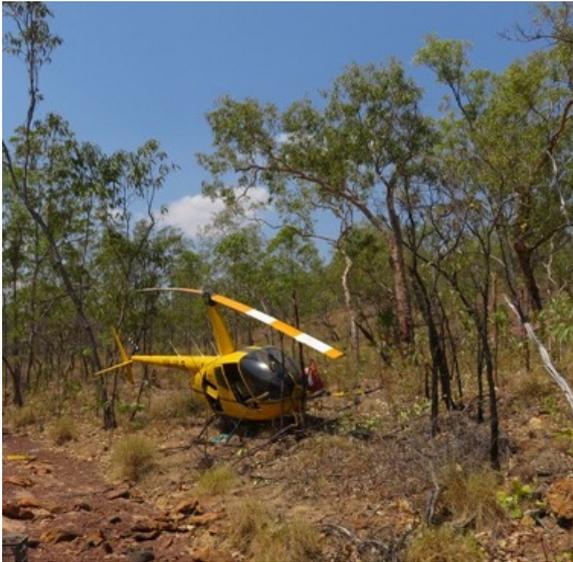
Figure 1: Accident site

The pilot then eased forward on the cyclic⁴ to increase translational lift⁵ and at about the same time, the low RRPM horn sounded. The helicopter continued to descend and the main rotor blades collided with multiple tree branches. The pilot turned the helicopter towards a small creek bed. When at about 6 ft above ground level, the helicopter rotated about 180° and landed hard with the left skid touching the ground first. The helicopter sustained substantial damage (Figure 1) and the pilot and passenger were uninjured.

- The combination of the air temperature and the lack of wind reduced the performance of the helicopter.
- The helicopter had departed with full fuel and at the time of the incident the tanks were about half full.
