Landing accident involving a Kavanagh Balloons D-84, VH-YPI

10 km south-south-west of Canowindra Aeroplane Landing Area (ALA), New South
Wales on 19 May 2014

ATSB Transport Safety Report
Aviation Occurrence Investigation
AO-2014-092
Final – 23 December 2014

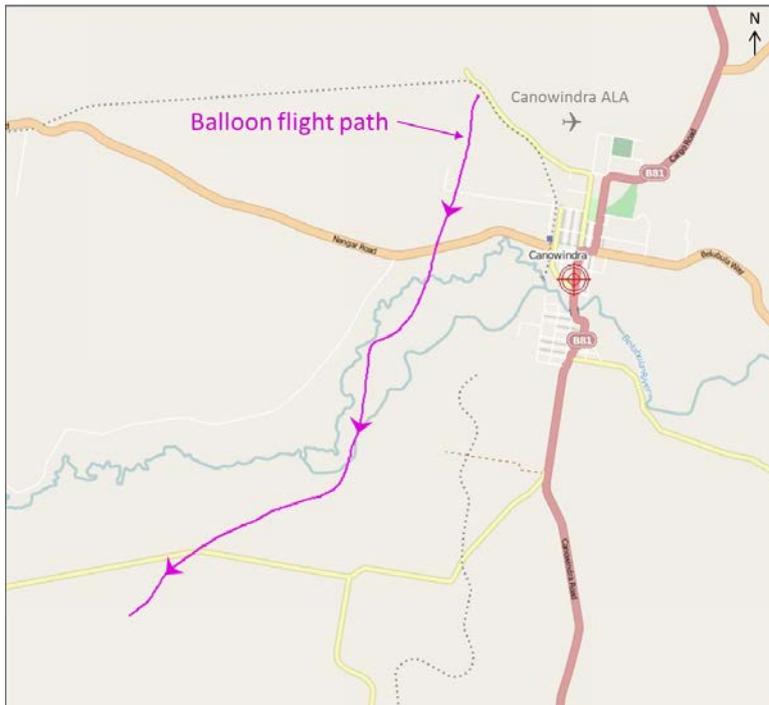
Figure 1: VH-YPI flight path

During the flight, the student conducted a number of approaches to land, but levelled off with intentional overshoot just above ground level. About 50 minutes into the flight, a number of possible landing areas were selected. The balloon flew low and level and a landing area that favoured the surface wind conditions was selected. A normal approach was made in a 10 kt wind using windy landing procedures. The balloon flew over a line of trees on the eastern side of the landing area and then descended. At about 30 ft above the ground, the student indicated to the instructor that they would be landing and turned off the burner pilot lights. At about 6 ft above the ground, the student pulled the smart vent¹ to land. The basket contacted the ground and the instructor was thrown forward and out of the basket while the student remained in the basket. The basket hit the instructor who was lying on the ground and the basket was dragged over him. The student continued to vent the balloon and it stopped a further 20 m downwind at about 0805 and 10 km south-south-west of Canowindra ALA (Figure 1).
