Fire on board the livestock carrier *Ocean Drover*

Fremantle, Western Australia, 9 October 2014

ATSB Transport Safety Report
Marine Occurrence Investigation
315-MO-2014-012
Preliminary – 15 January 2015

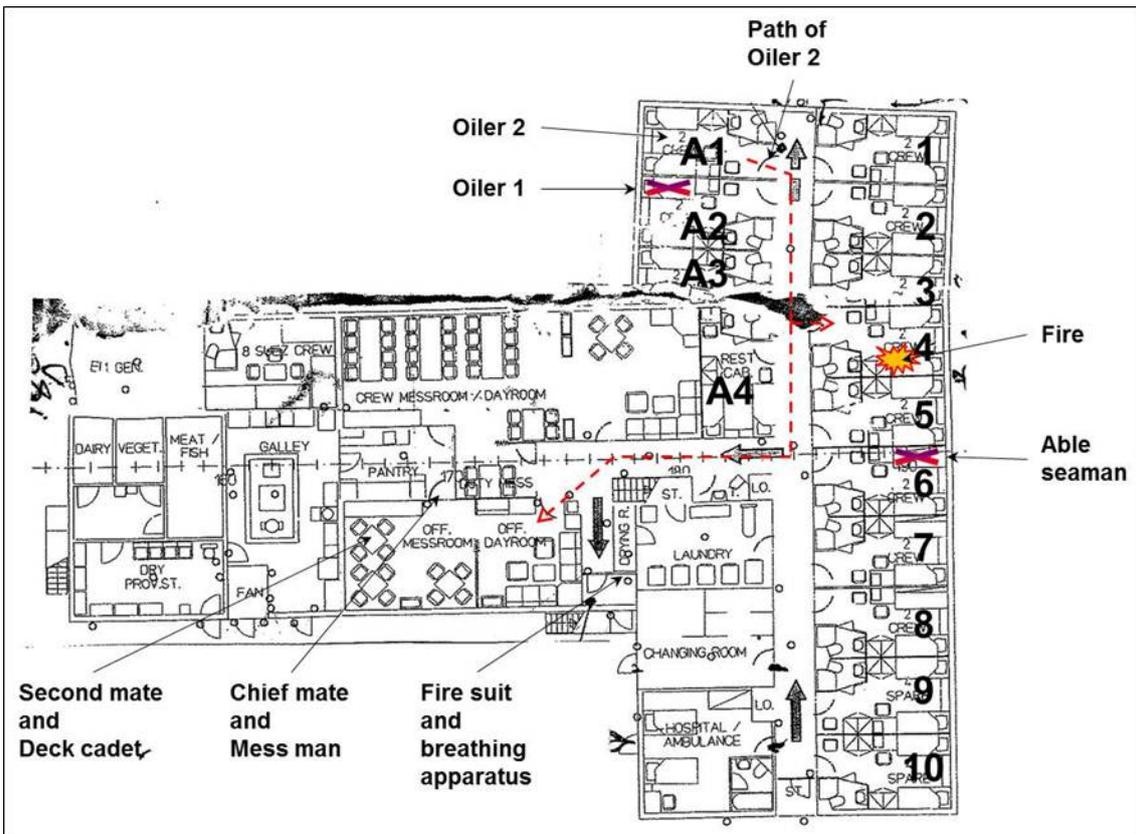
Figure 2: Diagram of upper deck accommodation showing key locations

At the time, most other crewmembers, including watch keepers, were in the accommodation spaces after breakfast. One able seaman (AB) and an oiler (oiler 1) were asleep in their cabins after their night watches. Another oiler (oiler 2), who was due to start work in the engine room, was in his cabin (A1 in Figure 2).

Shortly after 0745, oiler 2 left his cabin and immediately smelled smoke and heard a crackling sound. He traced the sound to a nearby cabin (number 4) and, upon opening its door, was confronted by flames, intense heat and thick black smoke. He dropped to his hands and knees and hurried away toward the officer's mess room to raise the alarm. The door of cabin number 4 was left open.

Preliminary analysis of the evidence suggests that the fire originated in one of the forward, upper deck cabins, probably cabin number 4.

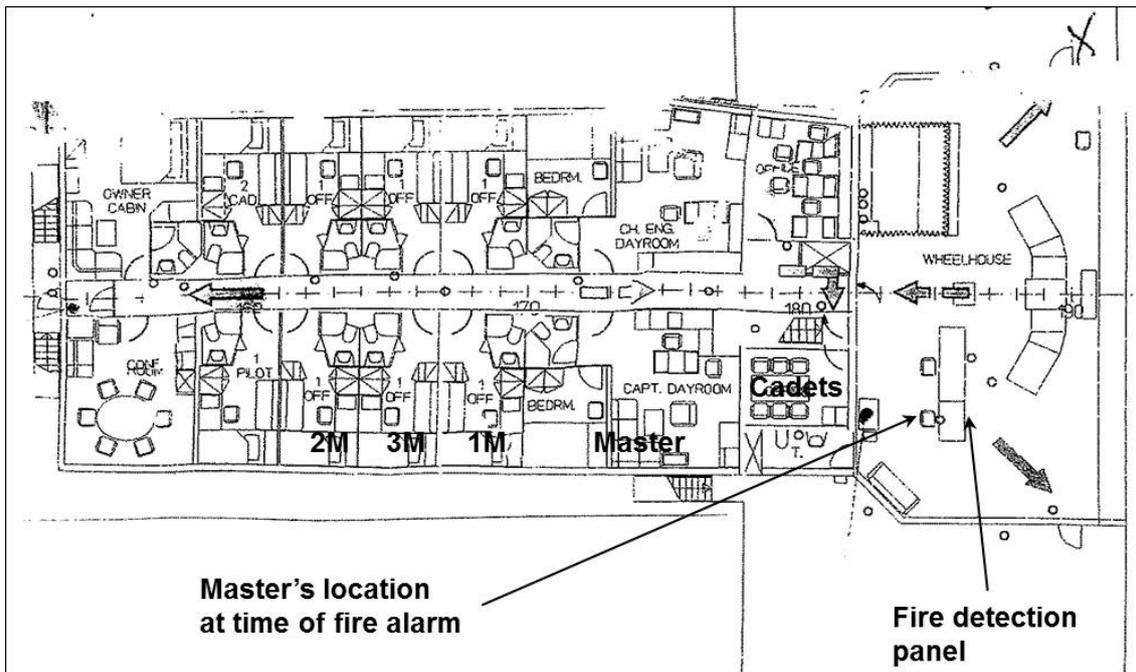
Figure 3: Bridge deck plan

At 0750, *Ocean Drover's* master was on the navigation bridge (Figure 3) when he was alerted by the bridge fire detection system panel indicating a fire in the accommodation.² Shortly thereafter, the ship's fire alarms began to sound. Opening the aft bridge door, the master saw and smelled the smoke, which was quickly spreading across the deck and up the stairwell.

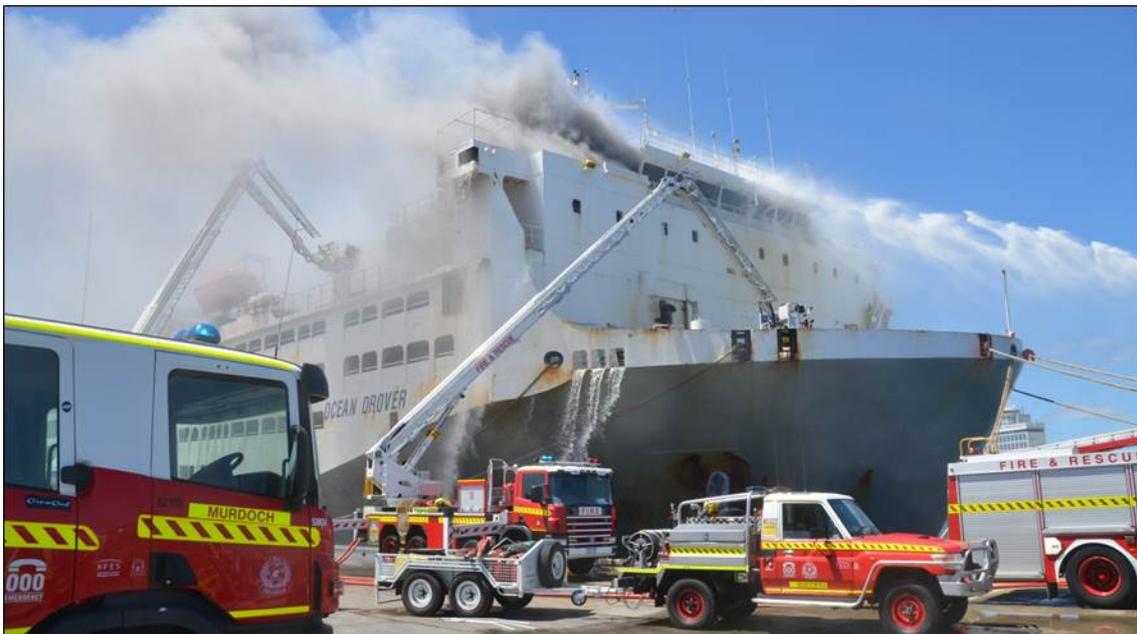
Figure 4: *Ocean Drover* firefighting efforts

The DFES response team continued to fight the fire for the rest of the day (Figure 4). More than 50 fire appliances and over 100 personnel were involved. All of the ship's crew were medically assessed on the wharf and four were taken to Fremantle Hospital. The injured AB was admitted to the hospital while the other three were treated and released.

At 0930 on 10 October, DFES handed over control of the situation and *Ocean Drover* to Fremantle Ports. The ship's bridge and accommodation areas were extensively damaged—the wheelhouse and the bridge deck (excepting one cabin), the wheelhouse top air handling room and the majority of cabins and crew spaces on the upper deck had been gutted by the fire.
