# Near collision involving a Grob G115, VH-BBJ and a Grob G115, VH-ZIM

near Merredin (ALA), Western Australia on 21 May 2014

**ATSB Transport Safety Report**  
Aviation Occurrence Investigation  
AO-2014-103  
Final – 27 January 2015

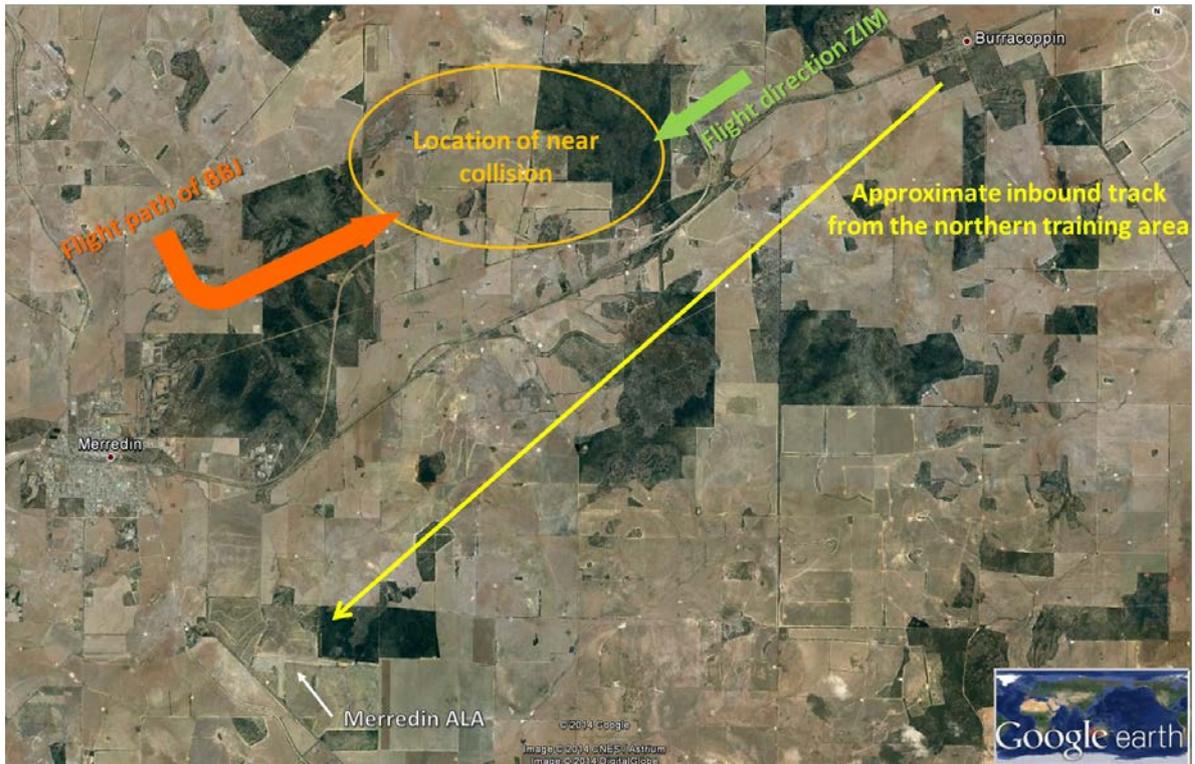
Figure 2: Approximate location of near collision

As ZIM turned to navigate toward Merredin ALA, the instructor observed BBJ, which appeared to take up almost the entire windscreen. She took control of the aircraft and took evasive action, by pushing the control column forward and descending. At about the same time, the instructor of BBJ observed ZIM straight ahead, at or just below the horizon coming towards them and took control of the aircraft from the student to take evasive action, pulling the control column rearward and climbing.
