Near collision involving an Evektor Sportstar 24-4467, and a PA28R Piper Arrow, VH-KGP

Wollongong Airport, New South Wales, 7 September 2014

ATSB Transport Safety Report
Aviation Occurrence Investigation
AO-2014-150
Final – 27 January 2015

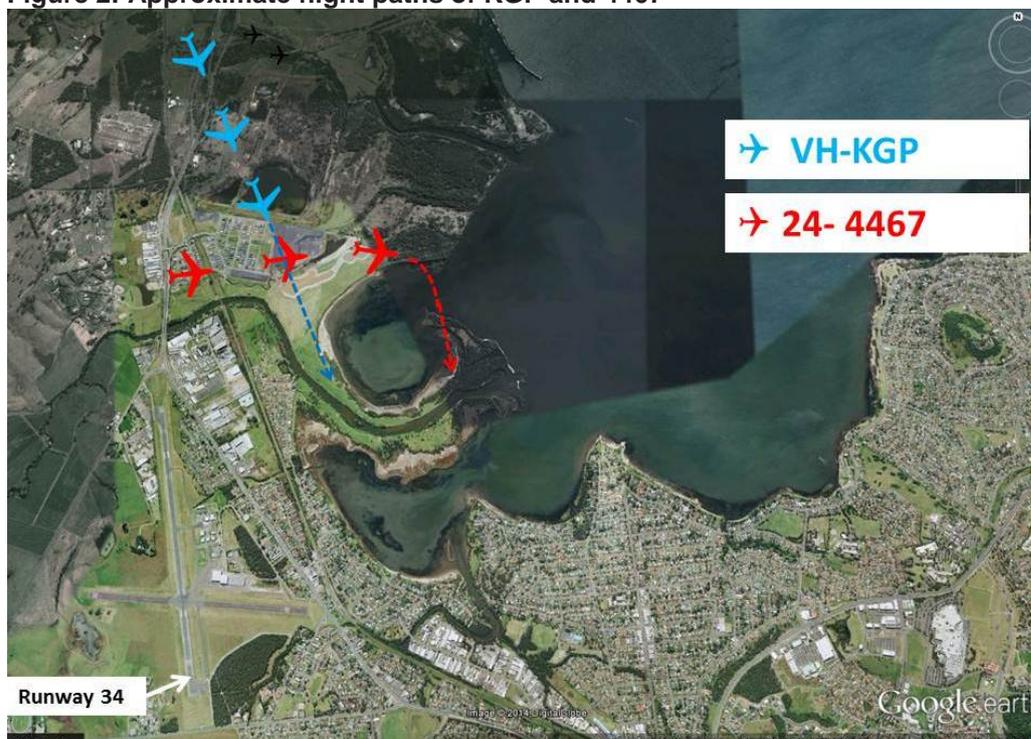
Figure 2: Approximate flight paths of KGP and 4467

The instructor and student in 4467 heard the pilot of KGP call inbound, and, although they did not communicate directly with the pilot of KGP, they broadcast their aircraft position and intentions (Table 1), making it clear that they were established in the circuit. Noting that runway 34 was in operation, the pilot of KGP began to manoeuvre the aircraft onto an oblique extended downwind leg (Figure 2).

When 4467 was on the crosswind leg for a right circuit for runway 34 (Figure 2), the crew noted KGP on their left, about 100 m ahead and at about the same level as them. KGP was about 800-900 ft above ground level on an oblique approach to the downwind leg. The pilot in KGP was still visually searching for 4467 as he joined the extended leg of the circuit and began to descend.

Concerned about the proximity and current track of KGP, the instructor in 4467 initiated a climbing turn. Shortly after, KGP passed underneath and just behind 4467. KGP continued to descend on downwind, and 4467 manoeuvred to allow KGP to be first in the sequence to land.

The instructor commented that although they had heard the 10 NM inbound call from KGP at 1303, no estimate for arrival in the circuit was given. Hence they were not expecting the aircraft to arrive as early as it did; nor join the circuit from the oblique angle that it did. KGP joined the circuit on the inside of the circuit being flown by 4467.

This incident highlights the importance of using standard phraseology, and making extra calls when there is any uncertainty regarding another aircraft's position when operating at non-controlled airports. As well as the regulated requirement for broadcasting, it is good airmanship to do so, considering the limitations of the See-and-Avoid Principle.
